# Hurdles in Framing Groundwater Management Strategies in A&N Islands in the Aftermath of Tsunami

Amlanjyoti Kar<sup>1</sup> and C.P. Gawri<sup>2</sup>

<sup>1</sup>Scientist-D, <sup>2</sup>Regional Director  
Central Ground Water Board  
E. Region, CP-6, Sector-V, Saltlake City, Kolkata - 700091  
email: amlanjyotikar@yahoo.com

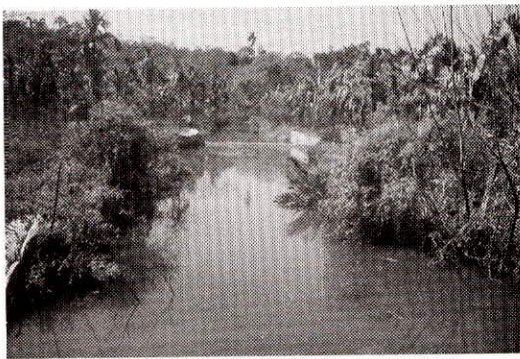
**Fig. 16.** Check dam affected by tsunami at Chouldari, S. Andaman.

- These waves contaminated the ponds, wells and all fresh water bodies along the coast (Figs 16 and 19).

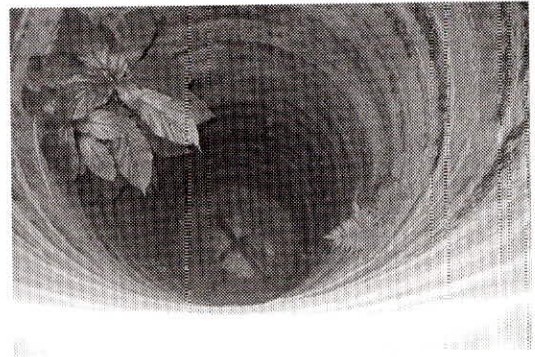
**Fig. 17.** Well dried up at high altitude, R.K. Pur, Little Andaman.

- In high altitude terrains, springs, check dams, ponds borewells (in South Andaman) are either dried up (Tables 3 and 4) or discharges are declined (Figs. 14, 15, 17, 21, 23).
- In lower topographic terrains especially in South Andaman the discharge of streams, springs, and water level (Tables 1 and 2) in wells are increased (Figs 18 and 20). In other places either the discharge is showing some rise or showing little decline or no change. However, in few cases the discharge ceased.
- In Havelock Island at Vijohnagar in the foothill region one good discharging spring generated. Pond was seen overflowing on 02.03.2005.
- On 26.12.2004, during the earthquake fresh water fountain (only reported from Car Nicobar) as well free flow on the ground surface was observed in Car Nicobar, Little Andaman, Neil, Havelock and in many places all along in South, Middle and North Andamans.

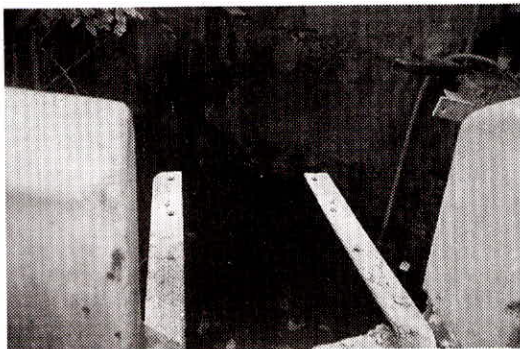
**Fig. 18.** Water level rise in well at low altitude near Gandhi Bhawan, Port Blair.

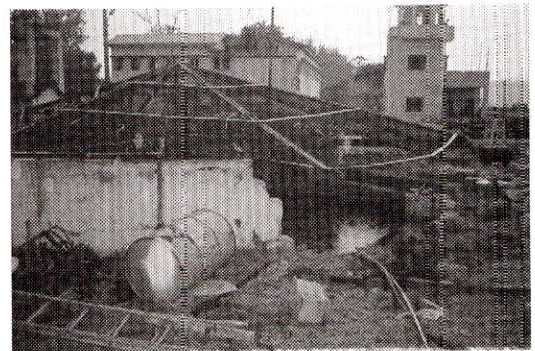
**Fig. 19.** Supply well affected by tsunami at Navy Airport, Campbell Bay (Great Nicobar).

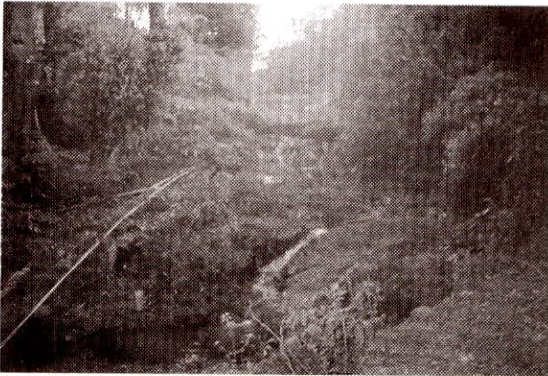
Fig. 20. Sudden rise in discharge of spring at low altitude near Brookshabad, Port Blair.

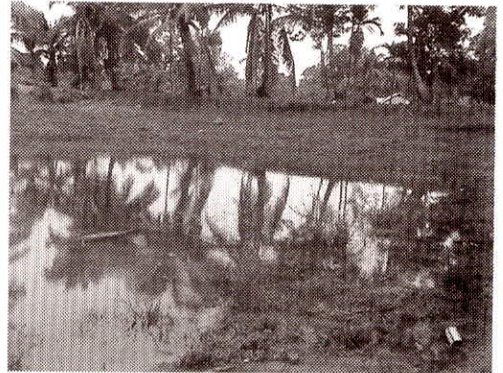
Fig. 21. Almost dried up pond at Kalipur, Diglipur, N. Andaman.

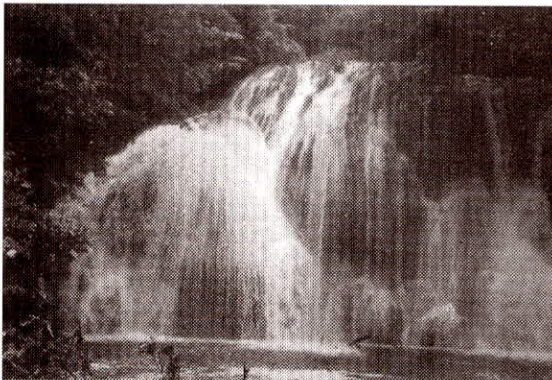
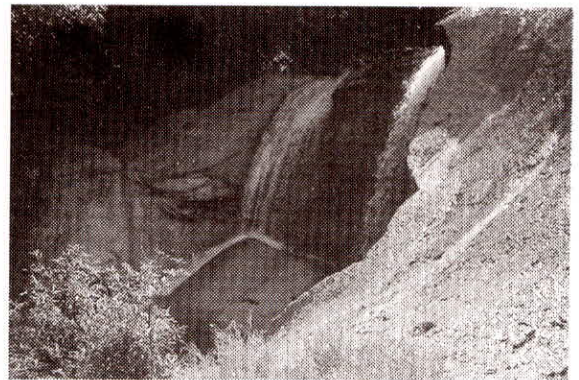
Fig. 22. Change in discharge in spring-fed waterfall at high altitude in Little Andaman.

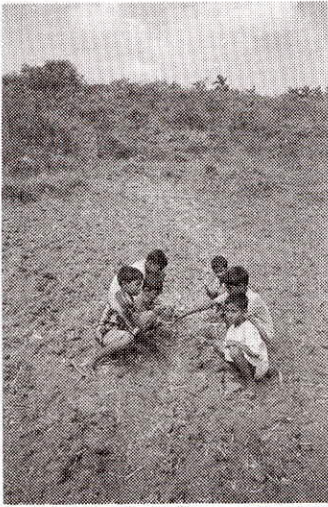
- Saline water was ejected (Fig. 23) at several places as in R.K. Pur (22 km), Ravindranagar (28 km) in Little Andaman, near Pema Junction Calicut, South Andaman and near Jarawa Tikrey, Baratang, Middle Andaman. This probably happened with the huge aquatic pressure exerted by the tsunami and synchronous fracturing of the geological formations by the mega earth quake (M = 9.3).
- Two earthen medium dams at R.K.Pur (Fig. 24) and Ravindranagar were highly damaged during the earthquake and water was seeped through cracks and fissures developed on the dam bed.
- Cracks were generated in the aquifers, which are cropping out in the surface.
- In Andaman district, the arable lands and ponds are highly damaged during earthquake (especially in North and Middle Andaman) causing decline in soil moisture of the agricultural land and water-holding capacity of the ponds.

**Fig. 23.** Trail of high mineralized water flown at highland near Rabindra Nagar, Little Andaman.

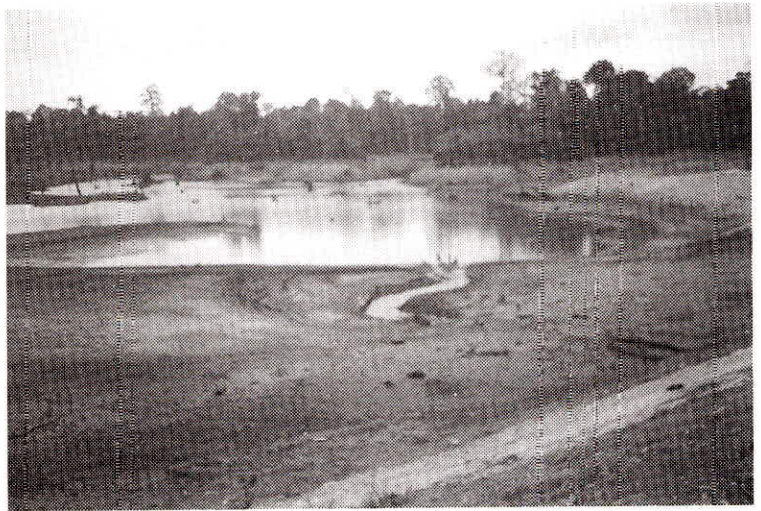
**Fig. 24.** State of R.K. Pur Dam, Little Andaman after 26.12.04 earth quake.
