Study of Physico-chemical Parameters of Killa Lake Water of Belgaum, Karnataka, India

ABSTRACT

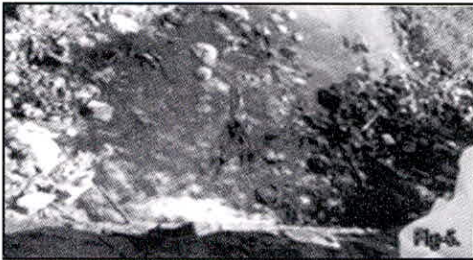
Fig. 5 : Entry of sewage into the Killa Lake

Earlier three major sewage entry points drained this lake. viz 1. Drain from circuit house corner 2. Drain from Shivaji nagar area and 3. Masonry channel near BUDA corner and through pipe culvert into the lake. The total discharge is 7764 cum/day (Fig-3-8). The storm water is the major source of inflow into the lake. The total runoff into the lake is thus estimated at 3037 ml. From these inlets both waste water and storm water enters the lake. Thus through the inlets the sludge has been accumulated and it measures about 85000 m³ at an over all average depth of 0.31m. There is no continuous outflow of water from the lake. The outlet is operated only when the water level exceeds the sill level during the monsoon season around June to September (3-4 months) of the year. Based on the meteorological department's information the water loss by evaporation is about 626 ml annually. Historically the lake

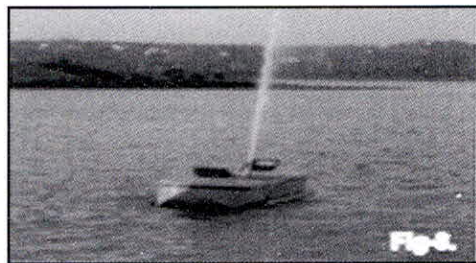
Fig. 8 : Aeration Fountain to increase the oxygen level in the Killa Lake
