# STATE OF ART REPORT

## FLOOD OF AUGUST 2006 IN ARID RAJASTHAN : *CAUSES, MAGNITUDE AND STRATEGIES*

Scientific contribution  
No: INCOH/SAR-29/2007

RETIRED ICAR EMPLOYEES WELFARE SOCIETY (RICAREWES), JODHPUR  
Editors: A.S. Faroda and D.C.Joshi

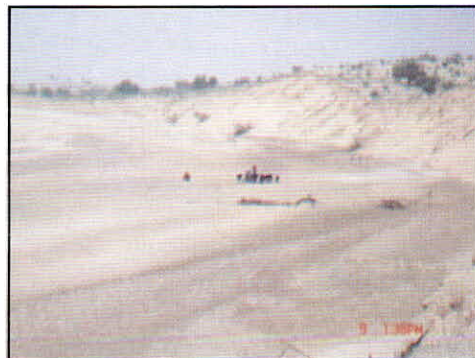
**Fig. 2 High sand dunes dissected with flood water**

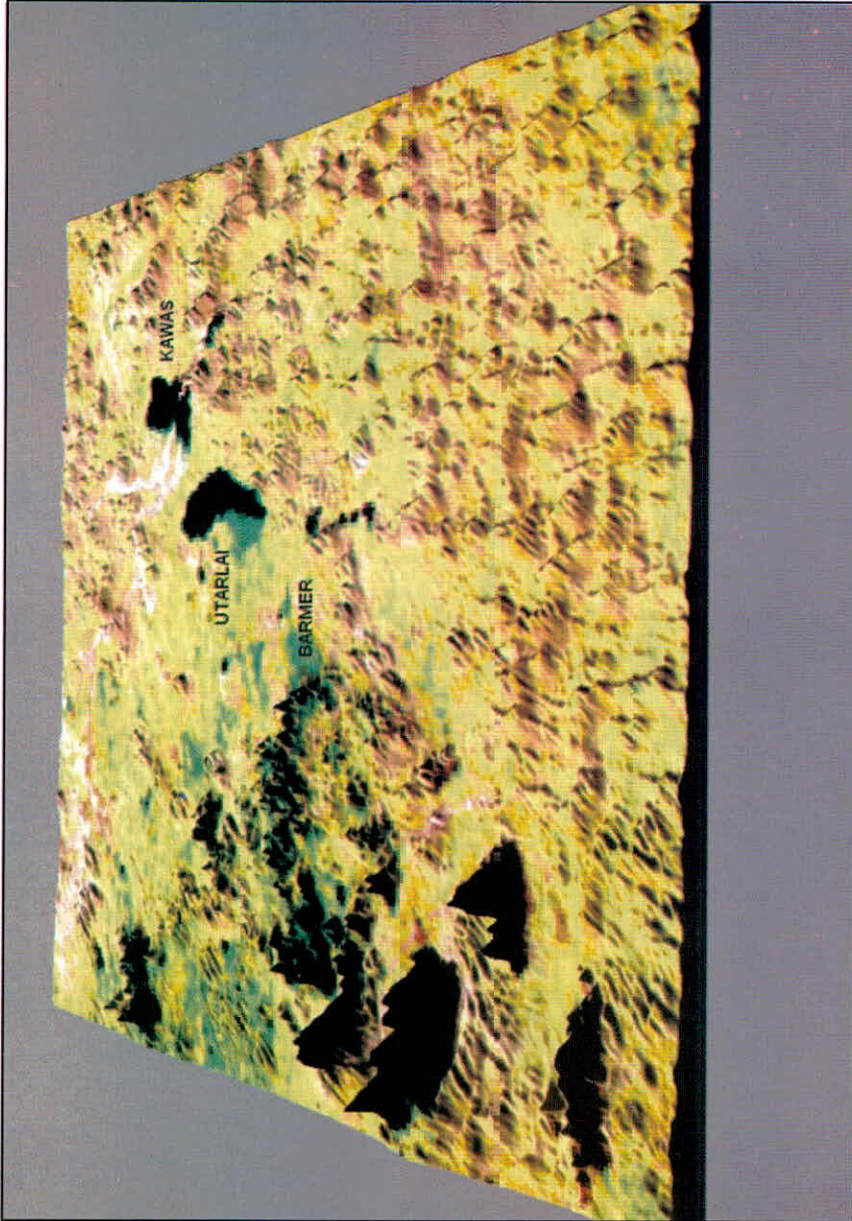
Fig. 5: 3-D perspective view of the MODIS-Terra FCC for 5 October 2006, superimposed on Shuttle Radar image from NASA, showing inundation by the Rohili River system at Kawas and by another river at Utarlai.

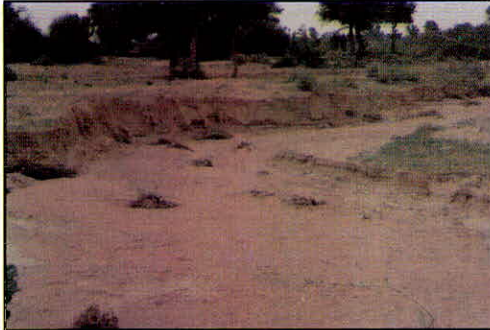
**Fig.1: Widening and deepening of channels**

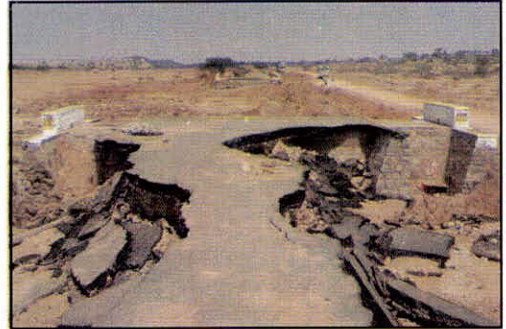
**Fig.2. Scouring of soils in flood**

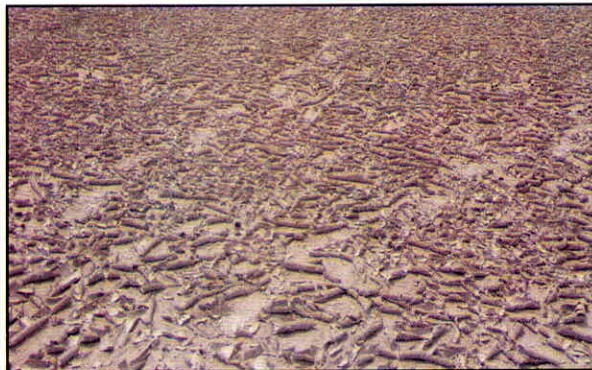
**Fig.3 Deposition of finer sediment**
