## **IMPORTANCE OF FIRST FLUSH IN RESTORATION OF LAKE WATER QUALITY: A CASE STUDY OF MANSAGAR LAKE**

**A. B. GUPTA, TUSHALI JAGWANI, PRAKASH VIJAYVARGIA AND AAKANKSHA RAMPURIA**

Department of Civil Engineering,  
MNIT, Jaipur, Rajasthan, India

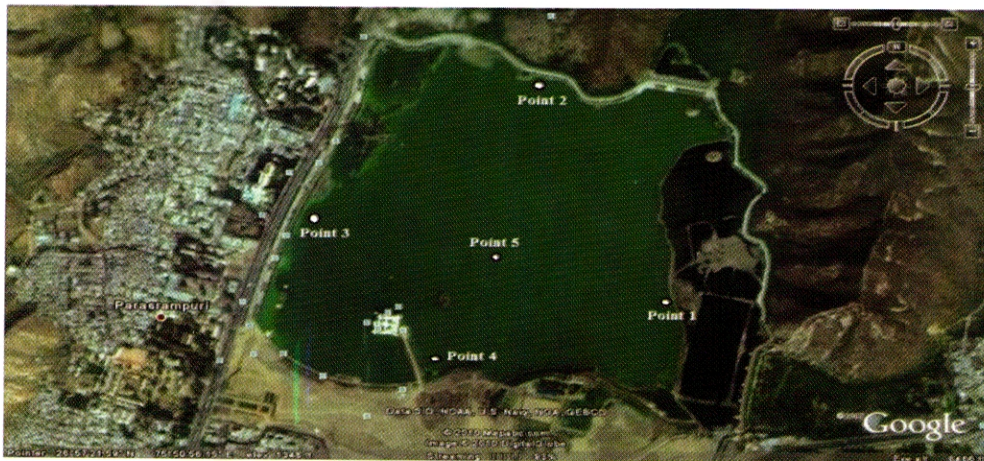
Slight variation in TSS of Brahmpuri Nalla was observed but the variations in Nagtalai Nalla were large because it carries suspended material deposited in Nalla or nearby area which is brought by storm water or from solid waste dumping sites. Both the Nallas bring high amount of TSS to the lake. The DO level of storm water carried by both Brahmpuri and Nagtalai Nallas was close to zero, whenever measured. The reason was the presence of lot of organic matter in the storm water exerting high oxygen demand. This type of storm water decreases the overall DO level of the lake making it unfit for aquatic life. Since in the years 2007-2009 the first flush was bypassed, the effect of it on lake water quality and hence the aquatic life was tolerable, however, fish in large numbers were killed in the Mansagar Lake in 2010 monsoons, when the first flush was again permitted to enter the lake due to protests from the villagers living downstream as it was resulting in spread of bad odours. DO levels of the lake measured at different points 1 to 5 shown in figure 1

**Fig. 1** Sampling Points in the lake (Source: Google Earth (5/8/11, 12:46:17 PM))

were 0.8, 0.3, 0.6, 0.5 and 2.5 mg/l respectively, as high oxygen demand was exerted due to storm water inflow (Shiv kumar, 2010). In 2011, it was again decided to bypass the first flush through discharge weir without entry to the lake.

Data were collected by monitoring the water quality parameters of Mansagar Lake between the months of June to October 2011. The quality of water of Mansagar Lake was analyzed pre monsoon and post monsoon to find out the effect of first flush on the lake water quality. Samples were collected through grab sampling from five different points shown in figure 1 from 1 m depth; four samples were collected from shore side and fifth sample was taken from middle of the lake with the help of boat. Samples were collected in autoclaved 1 L sample bottles.
