TR - 81

FIELD INVESTIGATIONS IN KOLAR SUBBASIN OF
RIVER NARMADA

NATIONAL INSTITUTE OF HYDROLOGY
JAL VIGYAN BHAWAN
ROORKEE - 247667 (UP)
INDIA .

1990

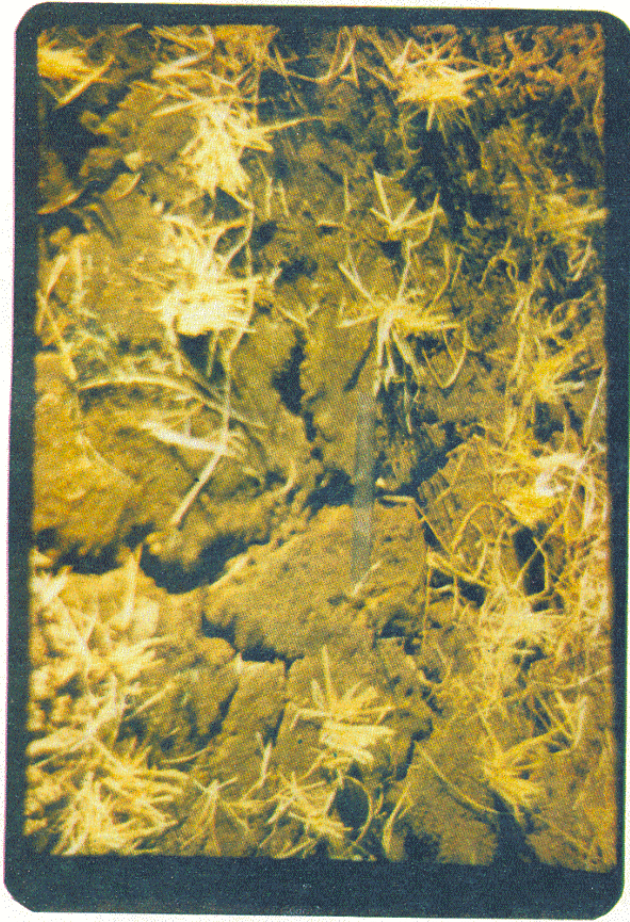
Fig. 9 : SOIL CRACKS IN AGRICULTURAL AREA

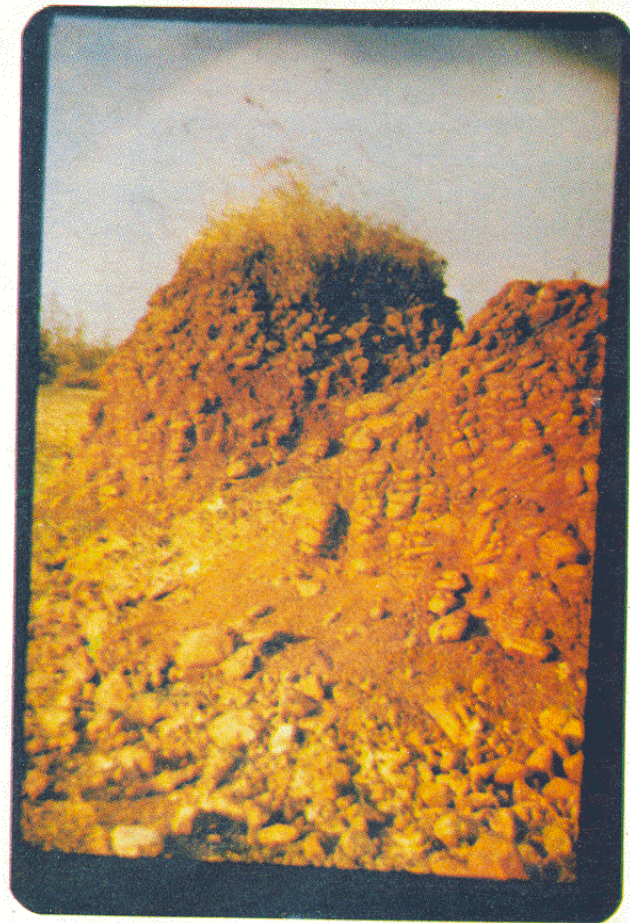
Fig. 10 : SOIL PROFILE IN DAM BORROW AREA

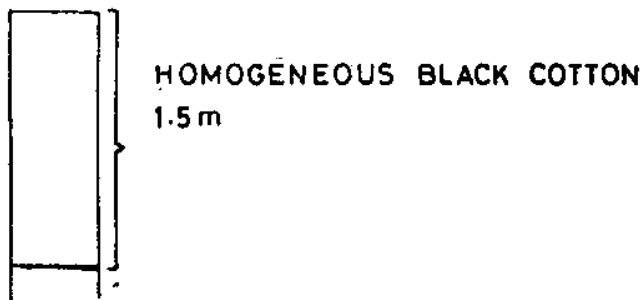
Fig. D.11 : Sketch of Site Bamla Dar

Pits : Two partial depth pits were dug: 4ba in wasteland and 4bb in the agricultural area (up to 1.8 and 1.5 m respectively). Pit 4bb had a shallow layer of red soil (0.3 m) mixed with soft rock and the infiltrometer test was performed there. In the 4ba 1.5 m of homogeneous black cotton soil was found. Root zone depth : 1.5 m.
