CASE STUDY

CS (AR) 158

**APPLICATION OF REMOTE SENSING
TECHNIQUES FOR WATER LOGGING STUDY
IN TAWA COMMAND AREA**

**NATIONAL INSTITUTE OF HYDROLOGY
JALVIGYAN BHAWAN
ROORKEE - 247 667 (INDIA)**

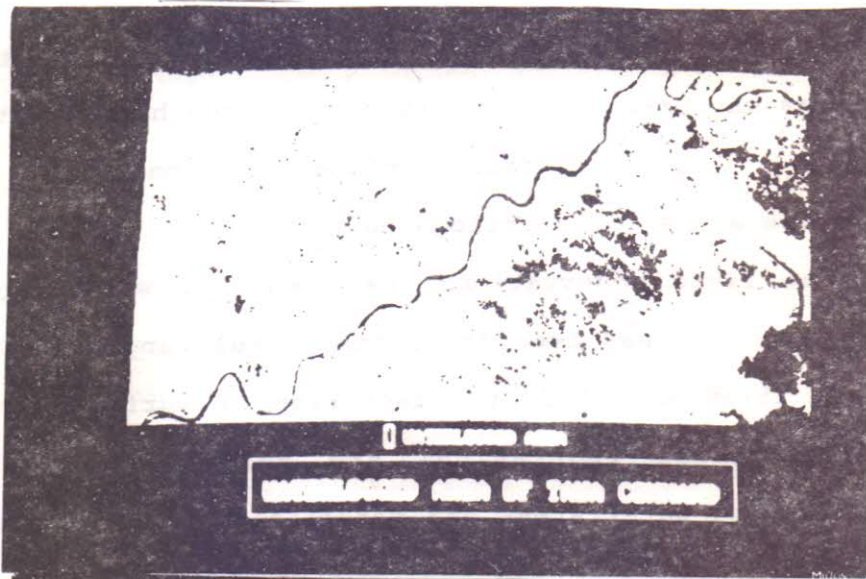
FIG 8 a

The result of the data analysis for the assessment of waterlogging for 20 October 1988 and 20 November 1989 are shown in Figs 8 abc and Figs 9 abc respectively. The assessment of waterlogged areas for 20 October 1988 are tabulated in tables 8 a & b.

Based on the field observations, maps showing waterlogged areas were finalised. It has been found that pixel ranges 15-25, (standing water) 15-26 and 15-28 manifestation of surface (soil moisture and perennial vegetation) are suitable for the assessment of standing water areas and potential sensitive areas for waterlogging.
