**ASSESSMENT OF WATERLOGGING IN  
SRIRAM SAGAR COMMAND AREA**

**NATIONAL INSTITUTE OF HYDROLOGY  
JAL VIGYAN BHAWAN  
ROORKEE - 247 667 (U.P.)  
INDIA  
1995-96**

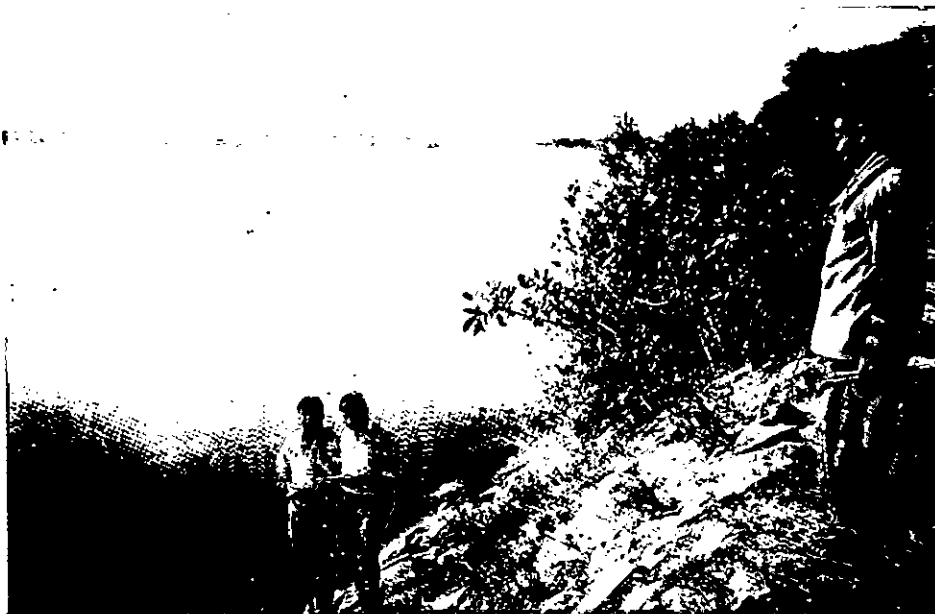
**Photograph 3. Radiometric measurements of water at Sultanabad tank in Sriram Sagar command area**

Radiometric data of water and soils from different sites in the command area have been collected (Photograph 2, 3, 4 and 5). The low radiance for water and dry soil as the highest radiance values were used to obtain the corresponding IRS pixel values.

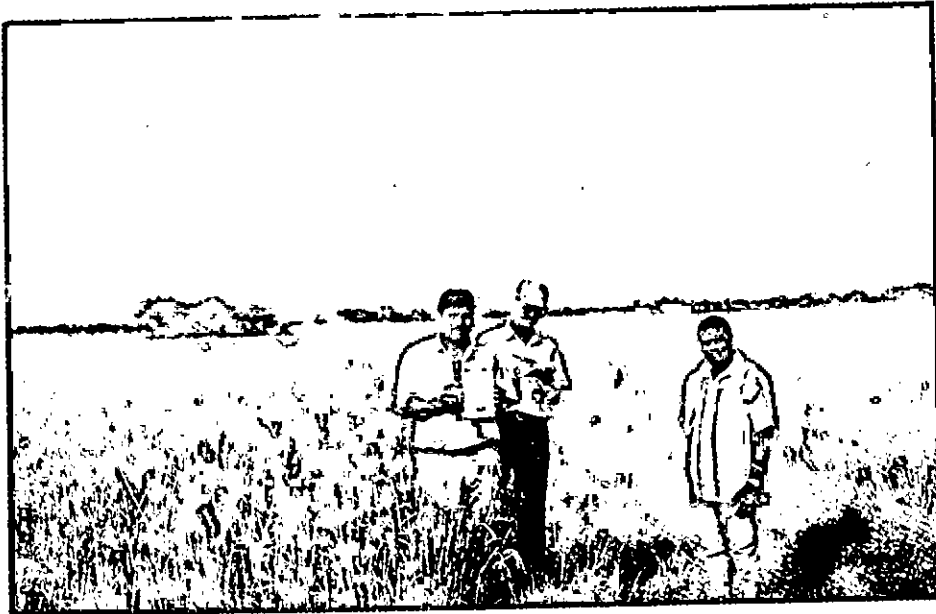
Photograph 4. Radiometric measurements of rice crop at Suglumpalli in Sriram Sagar command area

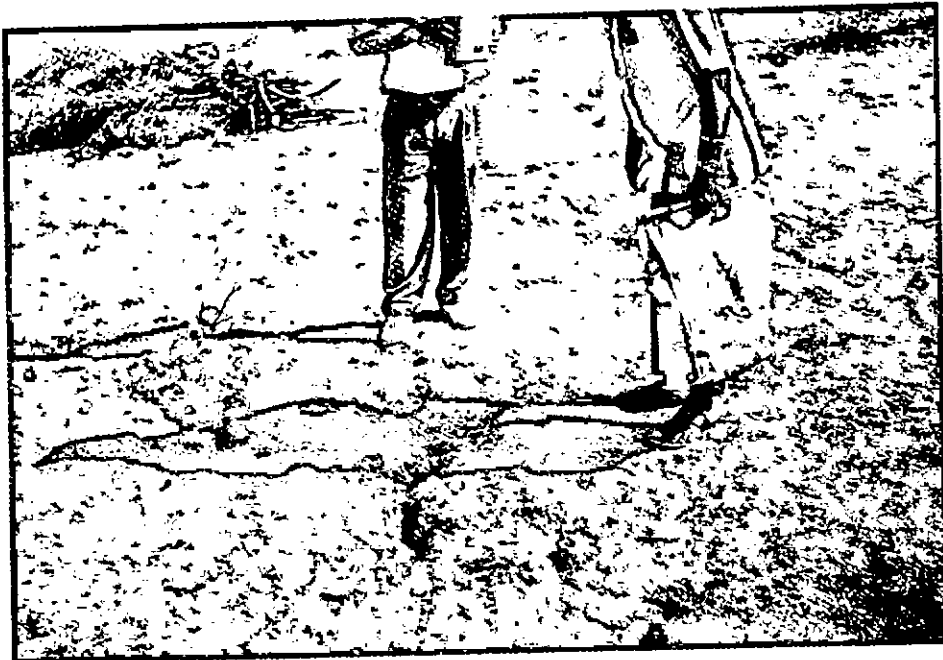
Photograph 5. Radiometric measurements of waste land (dry soil) at Appannapet in Sriram Sagar command area
