Borehole-Mediated Remediation of Contaminated Groundwater within the Vicinity of a Mining Operation in South Africa

ABSTRACT: Mining of ores involves the excavation of large quantities of waste rock from which the desired mineral ore is extracted. The waste rock forms the major source of most of the pollutions caused by mining. The contaminants, most often, are easily leached out and these have the potential to contaminate the surrounding environment including surface and groundwater. In this project, boreholes were sunk across the pollution plume as remediation measure to reverse the movement of the plume. Direct current (dc) resistivity equipment was used to precisely locate the migration of the plume and the borehole positions cited. The water quality parameters investigated included pH, EC, TDS, Ca^{2+} , Mg^{2+} , Na^+ , K^+ , Si , F^- , T/alk, Cl^- , SO_4^{2-} , NO_3^- and NH_4^+ . Samples were taken after every three months for a period of three years. Base flux assessment was also conducted. Piper hydro-chemical plots were constructed in order to determine whether any significant change in the hydro-chemical composition had occurred at a specific sampling locality. Reducti

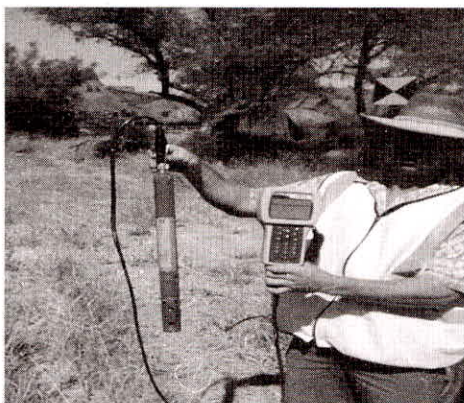
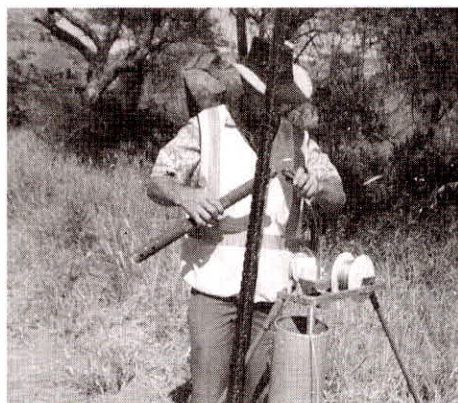
Fig. 2: Direct Current (DC) resistivity sensor (left) for boreholes citing and sludge testing (right)

Direct current (dc) resistivity equipment was used to precisely locate the migration of the plume. The equipment used is shown in Figure 2. It is based on the flow of electrical current in water. Borehole positions were cited using the equipment shown in Figure 2.

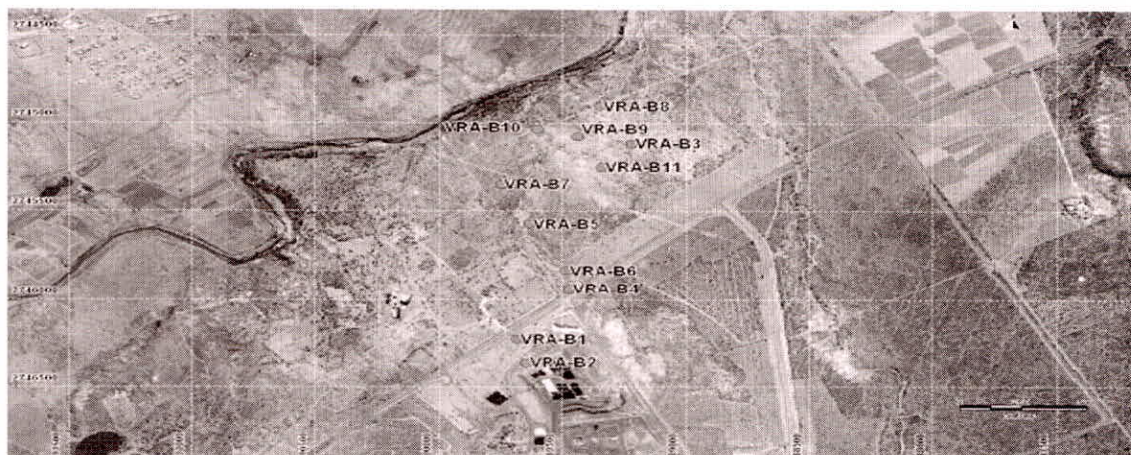
Fig. 3: Localities of boreholes around the plume

For water quality determination, water samples were collected from the following boreholes and surface sampling points located along the pollution plume: ABS-B1, ABS-B2, ABS-B3 and ABS-B4 as shown in Figure 3:

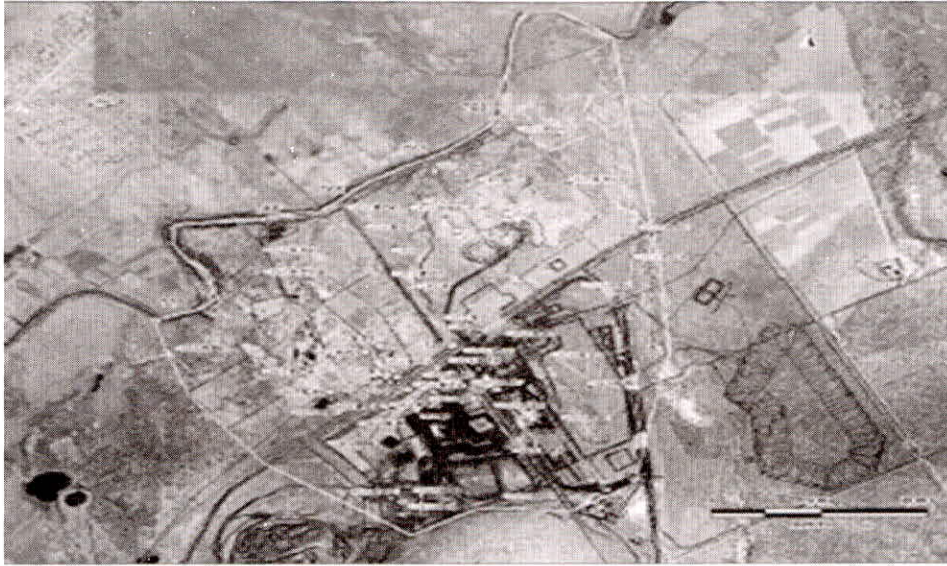
Fig. 5: Arbitrary aquifer delineation for water storage, salt load and base flux assessments

In order to standardise this assessment, an arbitrary aquifer lateral delineation was performed. Five flow lines from Figure 5 were selected to calculate groundwater gradients for base flux assessments. Positive gradients (groundwater gradient from the aquifer towards the Steelpoort River) existed along three of the lines and negative gradients (groundwater gradient from the Steelpoort River towards the aquifer) along two of the lines (Table 8). It follows therefore, that along two of the chosen flux lines, the aquifer was actually being fed by water from the river.

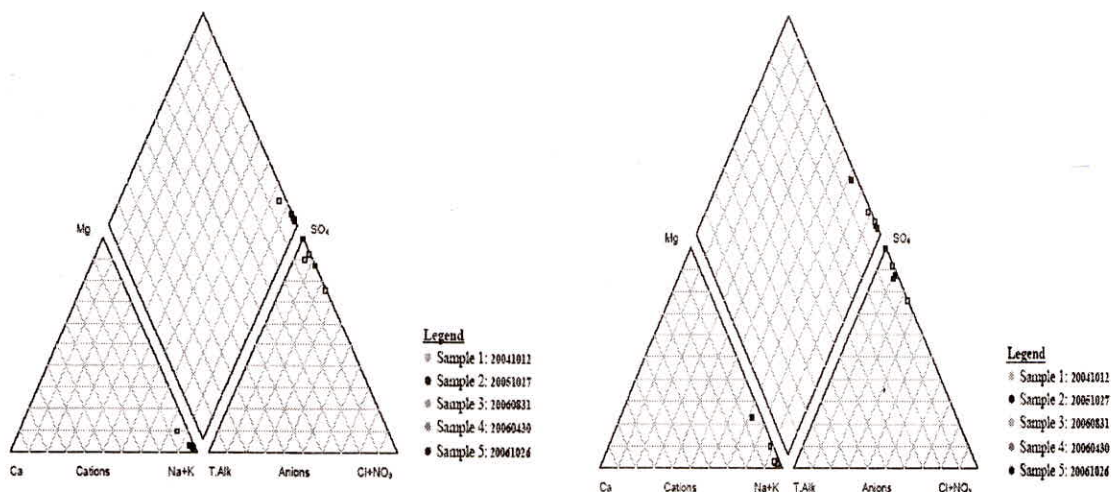
Fig. 6: Piper diagram for VNTP-B1 (left) and VNTP-B2 (right)

Piper plots were compiled for the mine pathway groundwater boreholes for the period 2004–2006 and the plots are shown in Figures 6–7. The purpose of this exercise was to determine whether a significant change

in hydro chemical composition had occurred at a specific sampling locality. A visual assessment of the composition plots for the monitoring period 2004–2006 show that the constituents of the boreholes were typical of mine water in this area. As can be seen from the diagrams, all the boreholes had similar water qualities. All boreholes selected can be classified as having stagnant groundwater conditions, characterised by Ca/MgCl₂ and Ca/MgSO₄ groundwater. These are influenced by external sources and caused by dominant recharge characteristics. Calcium (Ca²⁺), magnesium (Mg²⁺) and Sulphate (SO₄²⁻) were the dominant cations and anion respectively. These can be attributed to the natural geological formation where dolomites are present.

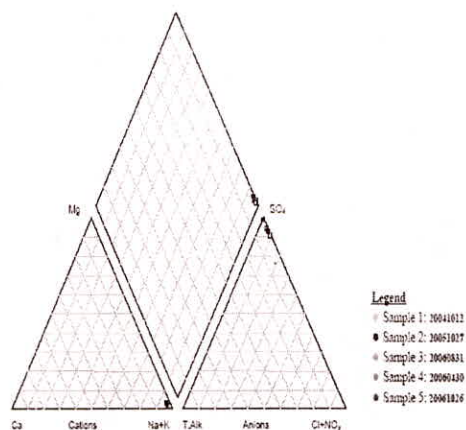
Fig. 7: Piper diagram for VNTP-B3

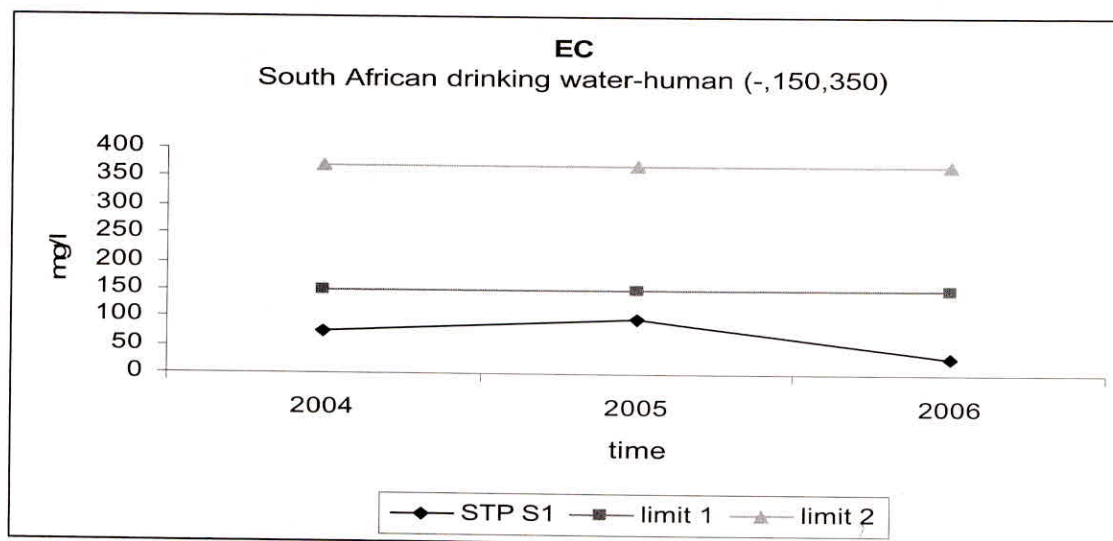
Fig. 8: EC for STP-S1 against the SA drinking water standards

downstream with the standard limits. Figure 8 compares the Electrical Conductivities between 2004 and 2006 against the South African Standard limits. It can be seen from Figure 8, that the STP-S1 (downstream) was within the South African Standard limits 1 and 2 (DWAF, 1996a).
