**HYDROLOGICAL INVESTIGATIONS FOR CONSERVATION OF
LAKES: A CASE STUDY OF LAKE PICHHOLA, RAJASTHAN**

Dr. S. D. Khobragade
Scientist-E1, NIH, Roorkee

Three Days Training Course on
**HYDROLOGICAL INVESTIGATIONS FOR
CONSERVATION AND MANAGEMENT OF LAKES**
(26-28 March, 2012)

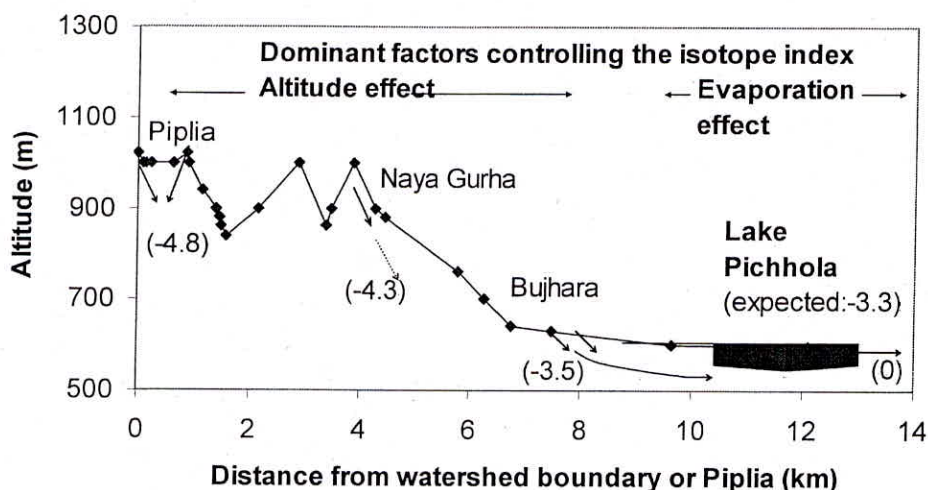
Fig 10. Direction of groundwater flow between Piplia and Lake Pichhola

Thus, isotopic characterization of groundwater in the catchment area of the lake indicates that; the major component of the groundwater flow is in the west to east direction along Bujhara-Pichhola Lake. The lake receives its base flow from the groundwater recharged in the area near Bujhara. The lake is losing major fraction of its water due to evaporation and sub-surface losses, in addition to the regulated surface out flows. One of the causes for drying of the lake is its sub-surface outflow due to lake water- groundwater interaction It can be controlled by shifting the tub-wells in areas where groundwater is not interacting with the lake water to the lake.

3. From the preliminary studies on the groundwater–lake interaction, it is observed that the water is being lost through the downstream end of the lake through seepage (particularly in the Jawahar nagar side). Exploitation of groundwater in this area through the tube well may be regulated to ensure that the overexploitation does not cause considerable reduction of the lake water.

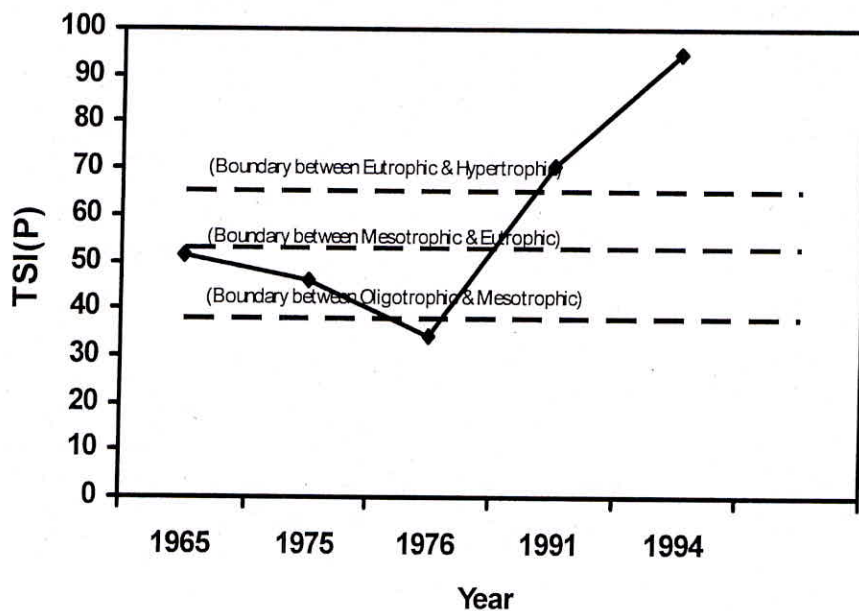
Fig. 12. TSI value of Pichhola lake based on Carlson (phosphorus) Index

The results of trophic state assessment indices indicate the present hypertrophic status of the lake. From the analysis of the phosphorus based index, it is observed that the lake was in oligotrophic to mesotrophic condition till the 80's (1965-76) and has advanced into the eutrophic to hypertrophic status thereafter (Fig. 12). Analysis of the secchi depth based indices indicates the similar status, although no secchi depth data are available to confirm the trophic status prior to 70's (Fig. 13). Analysis of the Carlson Bivariate Index indicate that the lake was in a strongly mesotrophic to eutrophic status during 1975-76 while it is in a hypertrophic state as on today All the indices indicate that at present the lake is in an advanced hypertrophic state.
