# **WATER CONSERVATION MEASURES IN THE ARID AND SEMI-ARID AREA OF HARD ROCK REGION**

**NATIONAL INSTITUTE OF HYDROLOGY  
JALVIGYAN BHAWAN  
ROORKEE - 247 667 (UTTARANCHAL)**

**1999-2000**

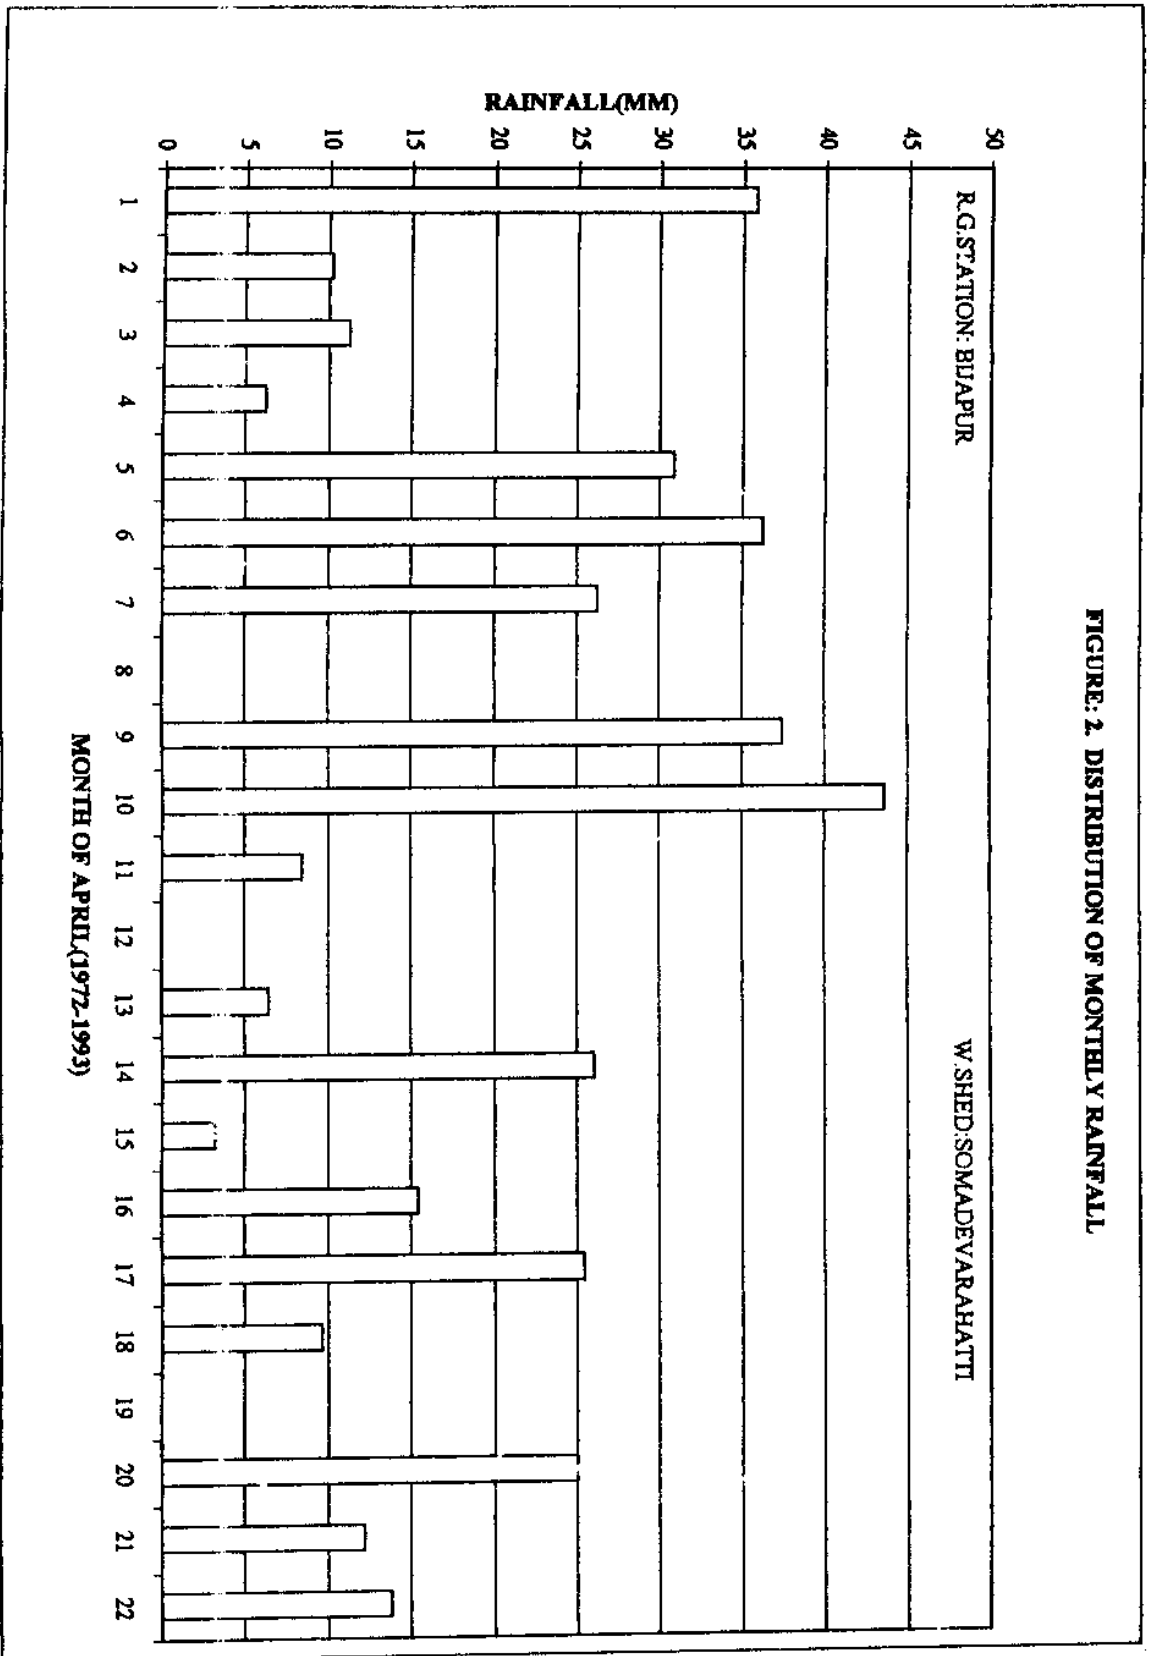
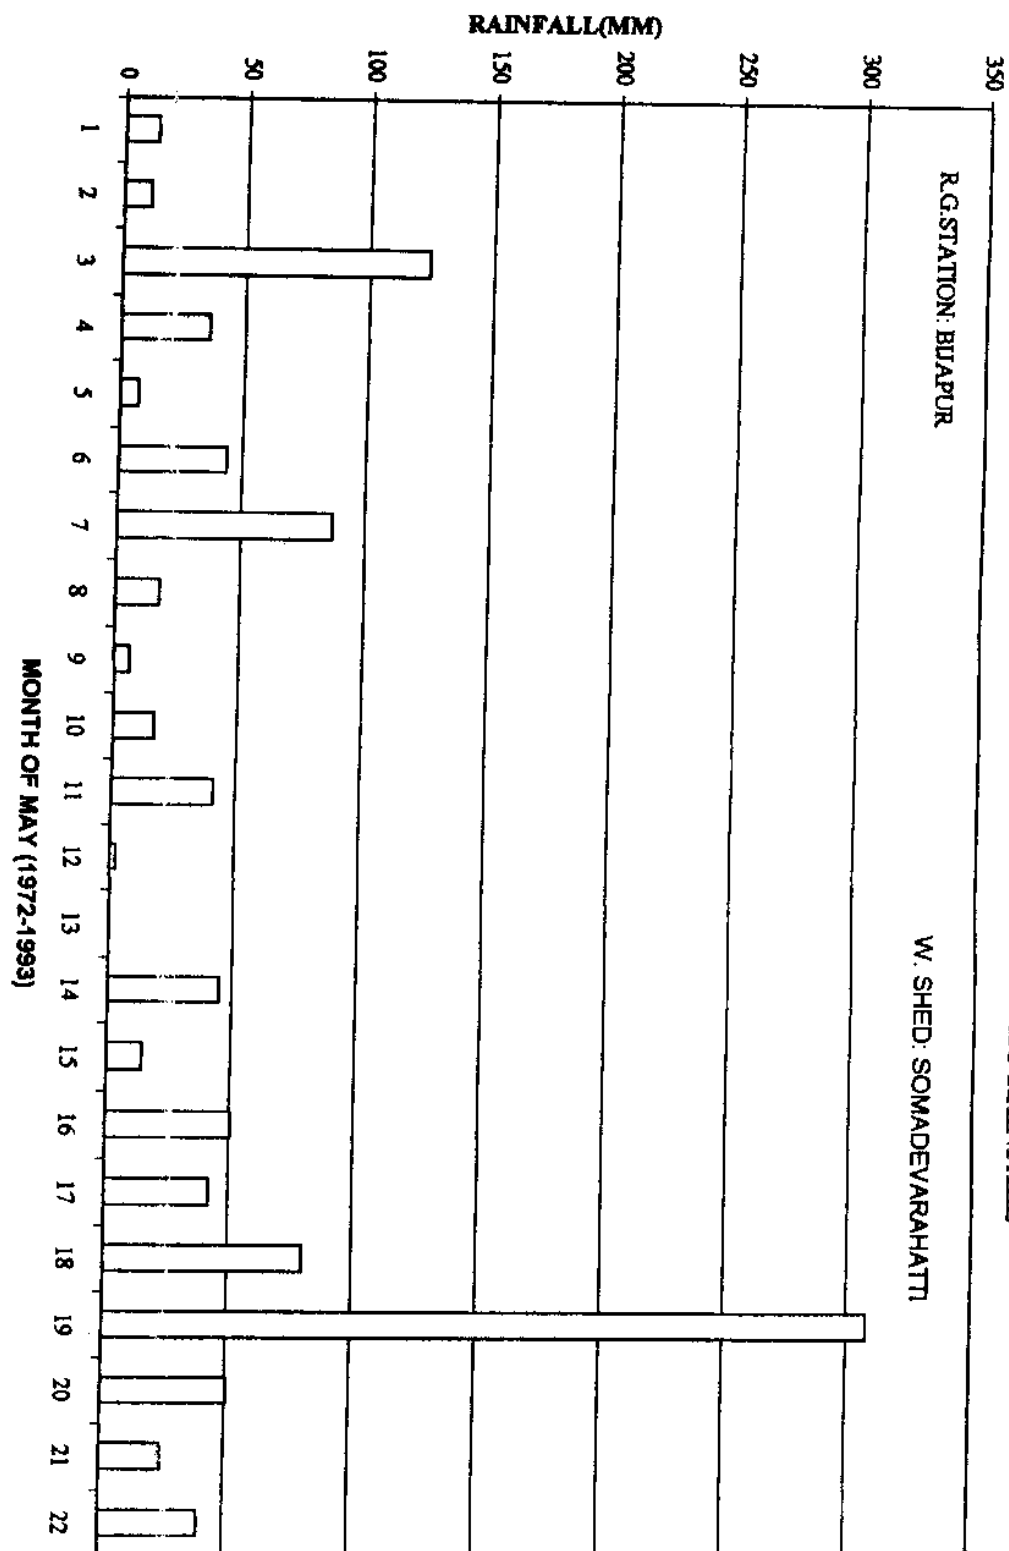
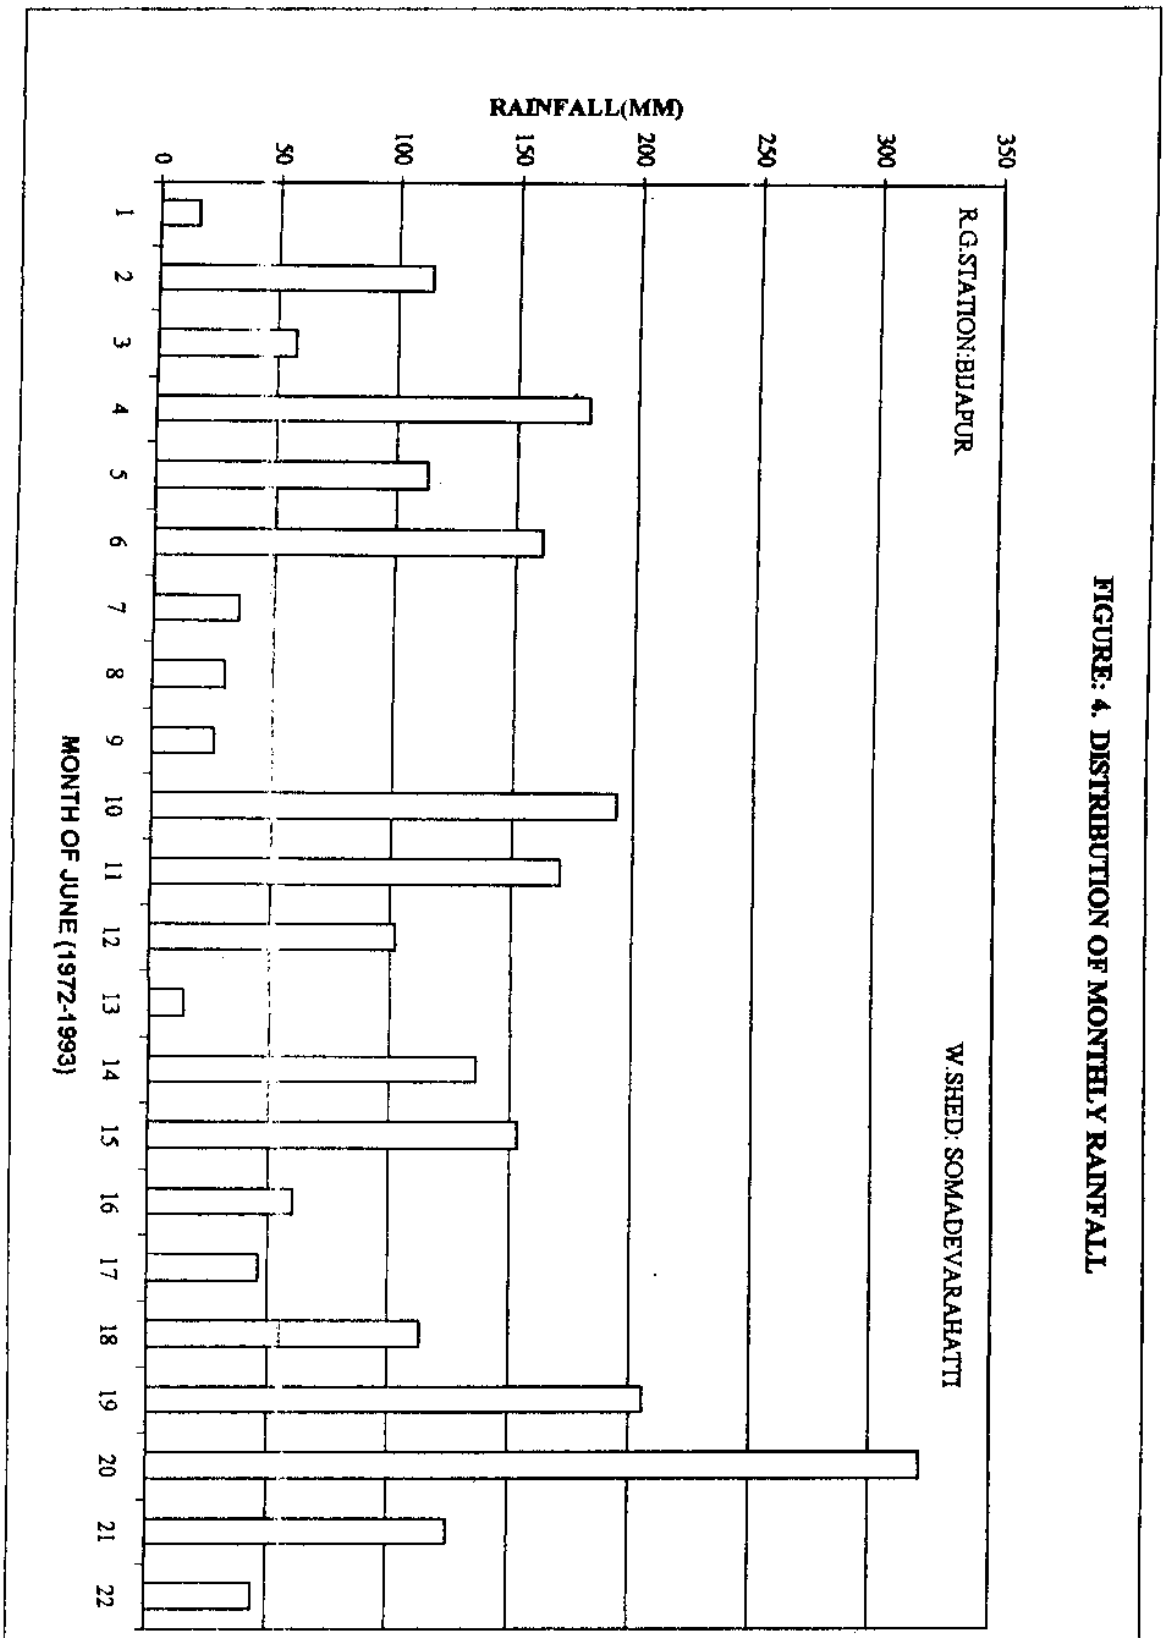
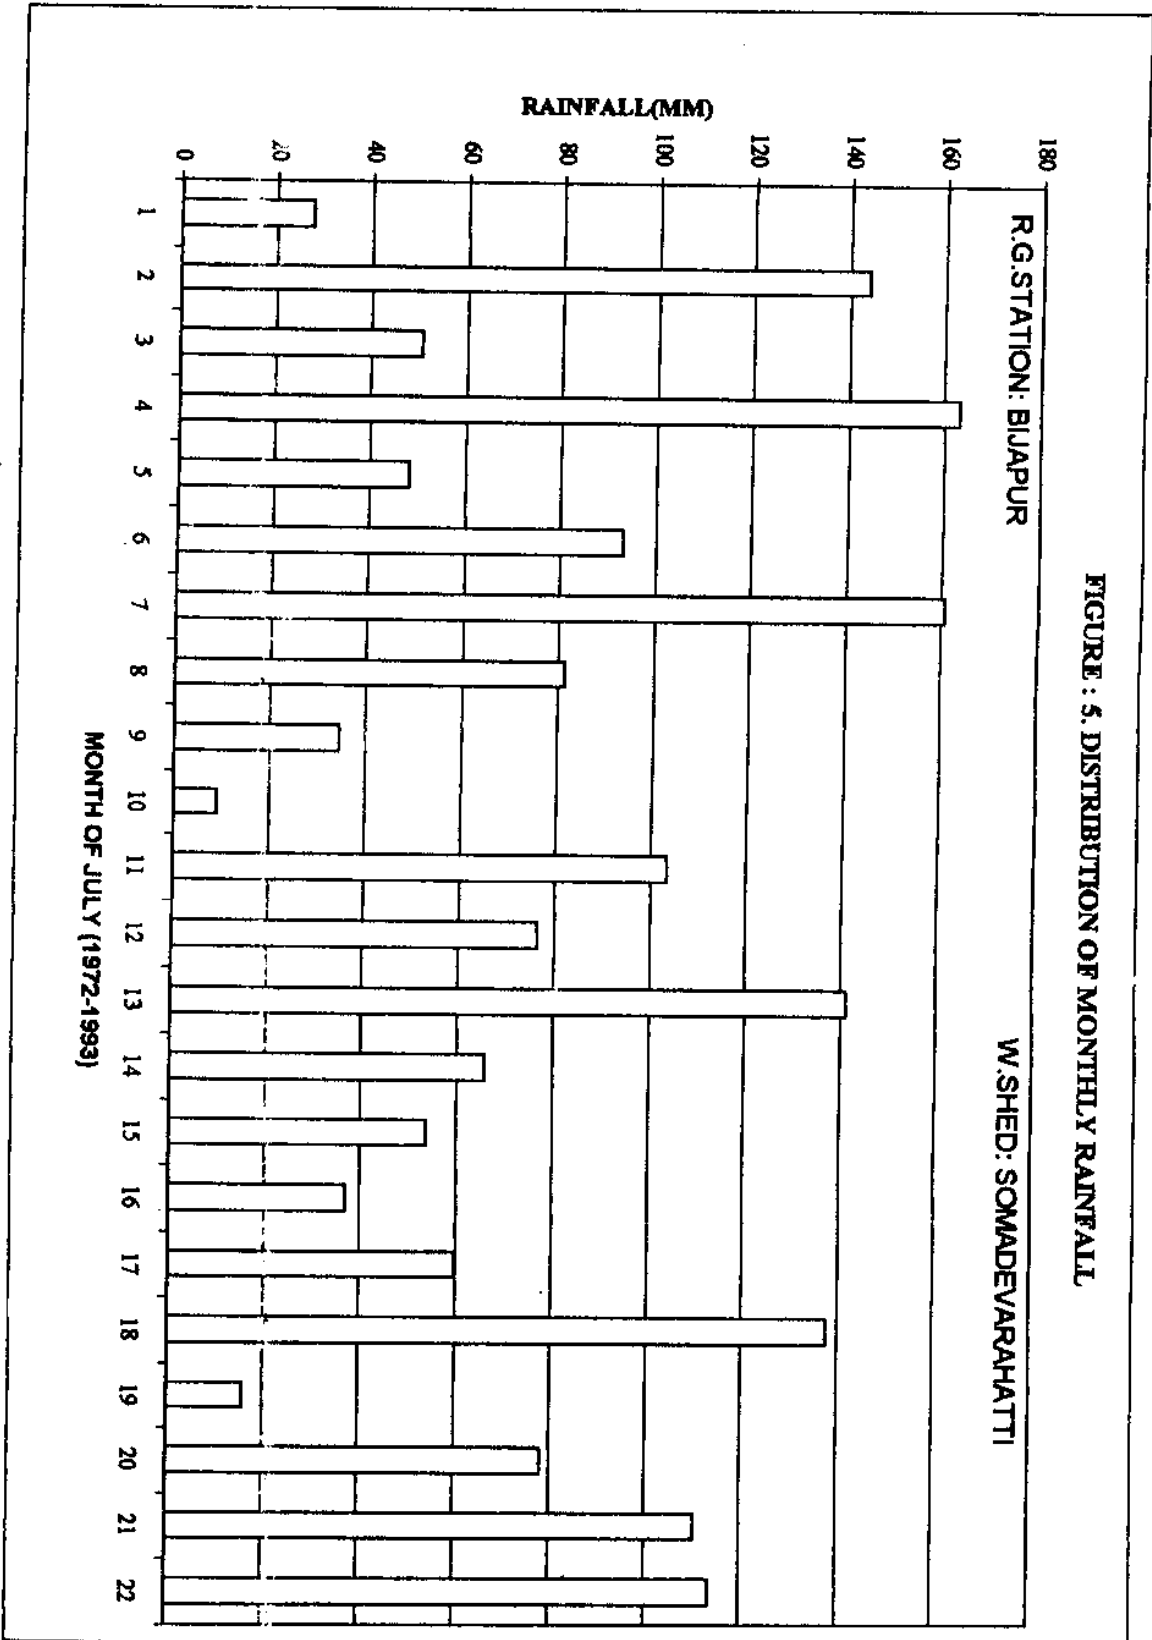
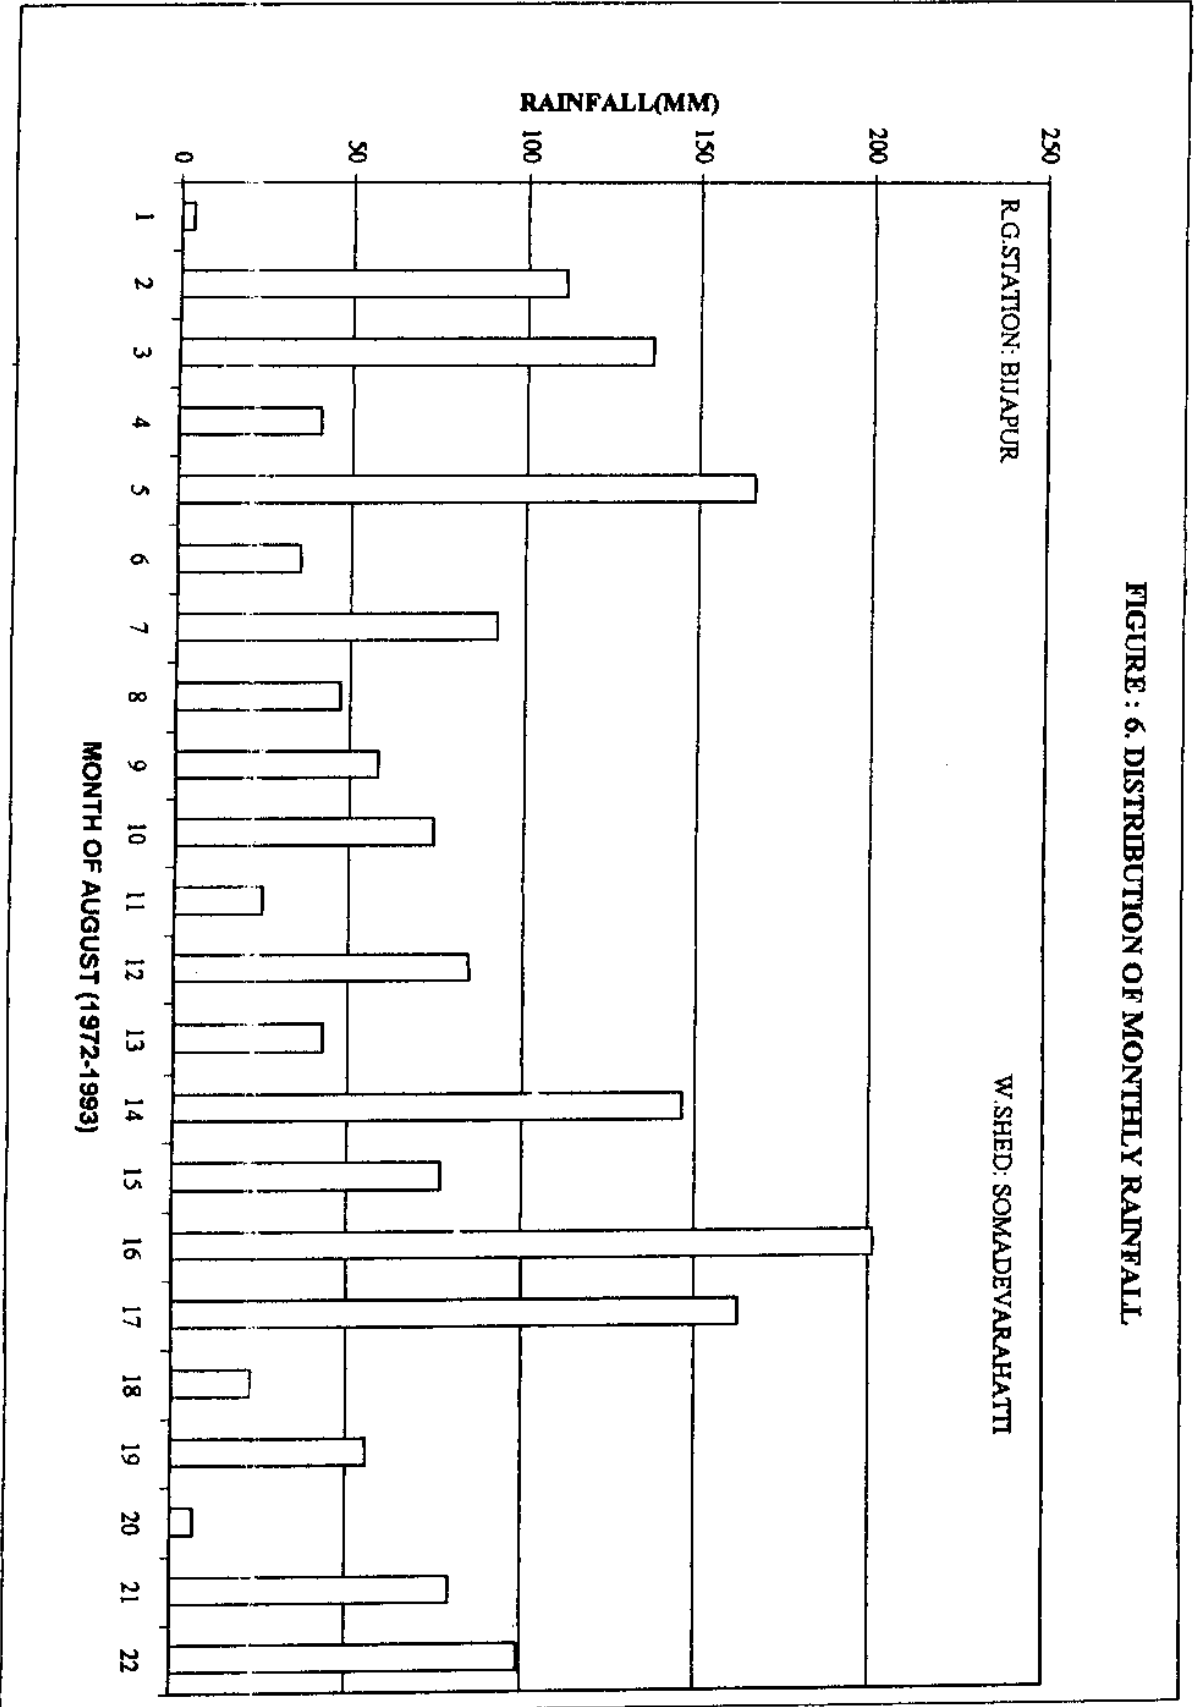
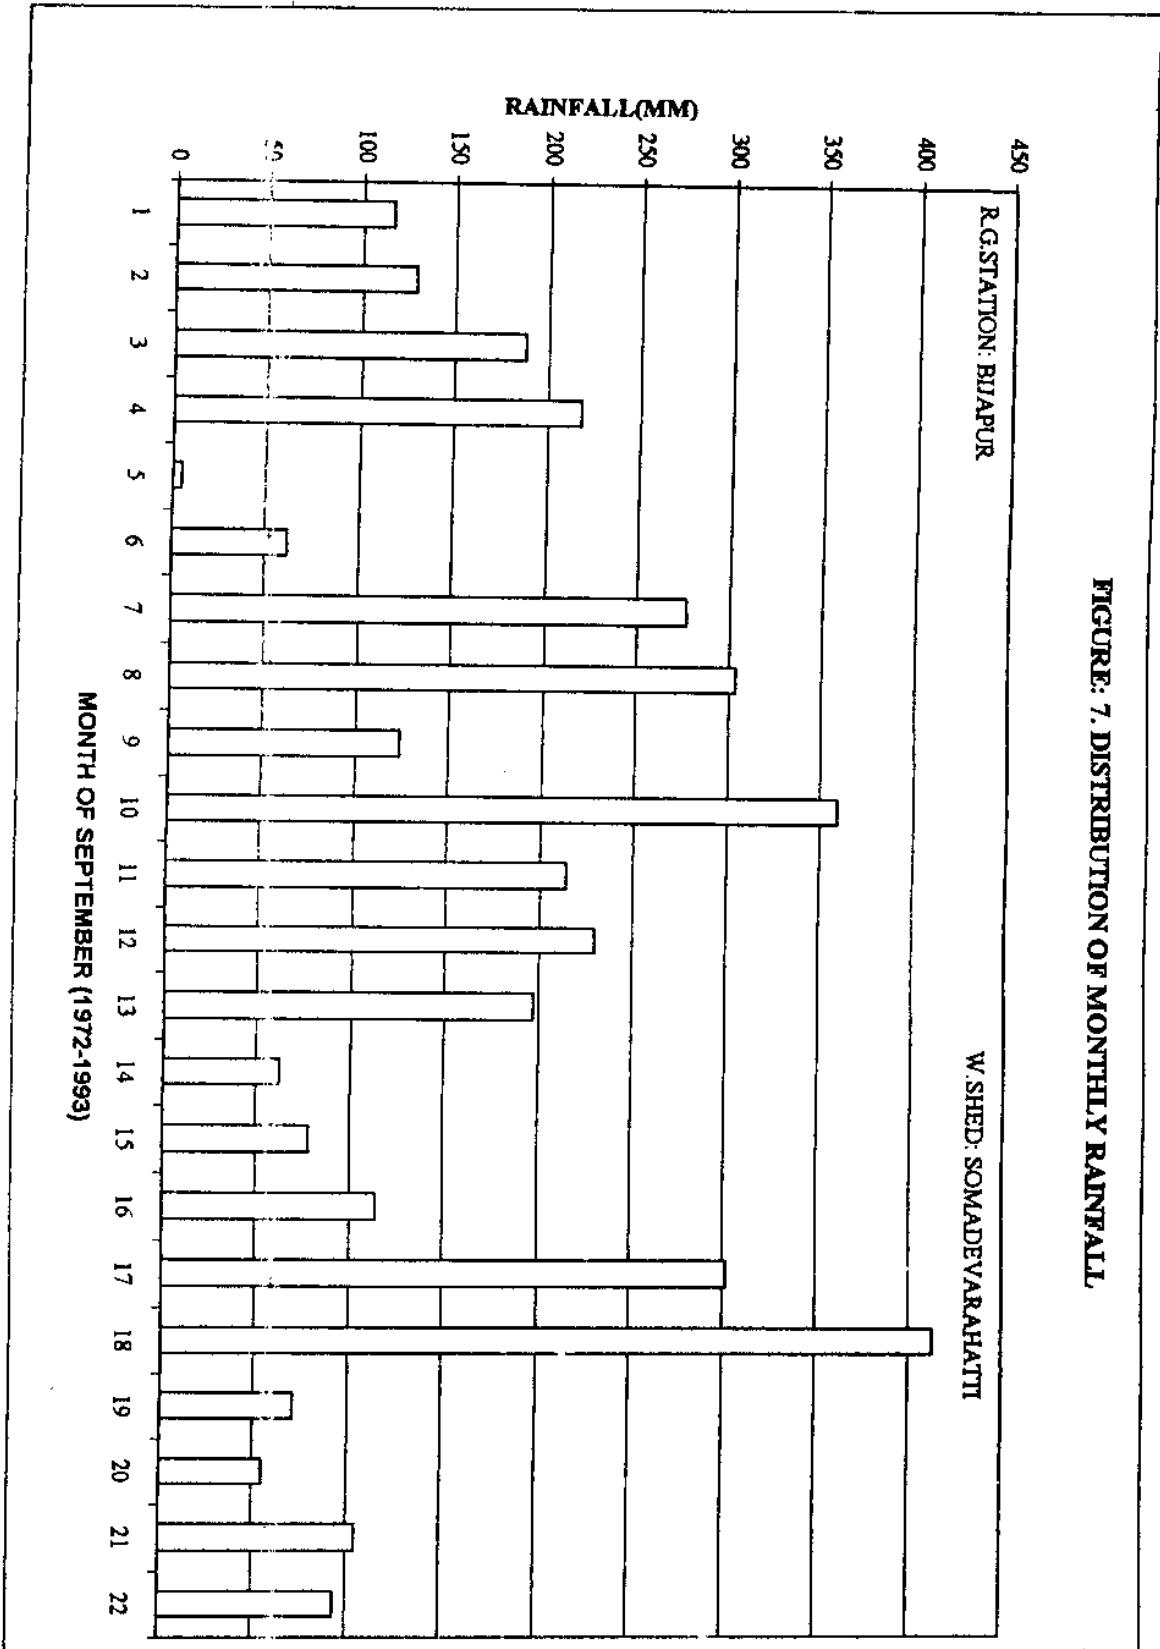
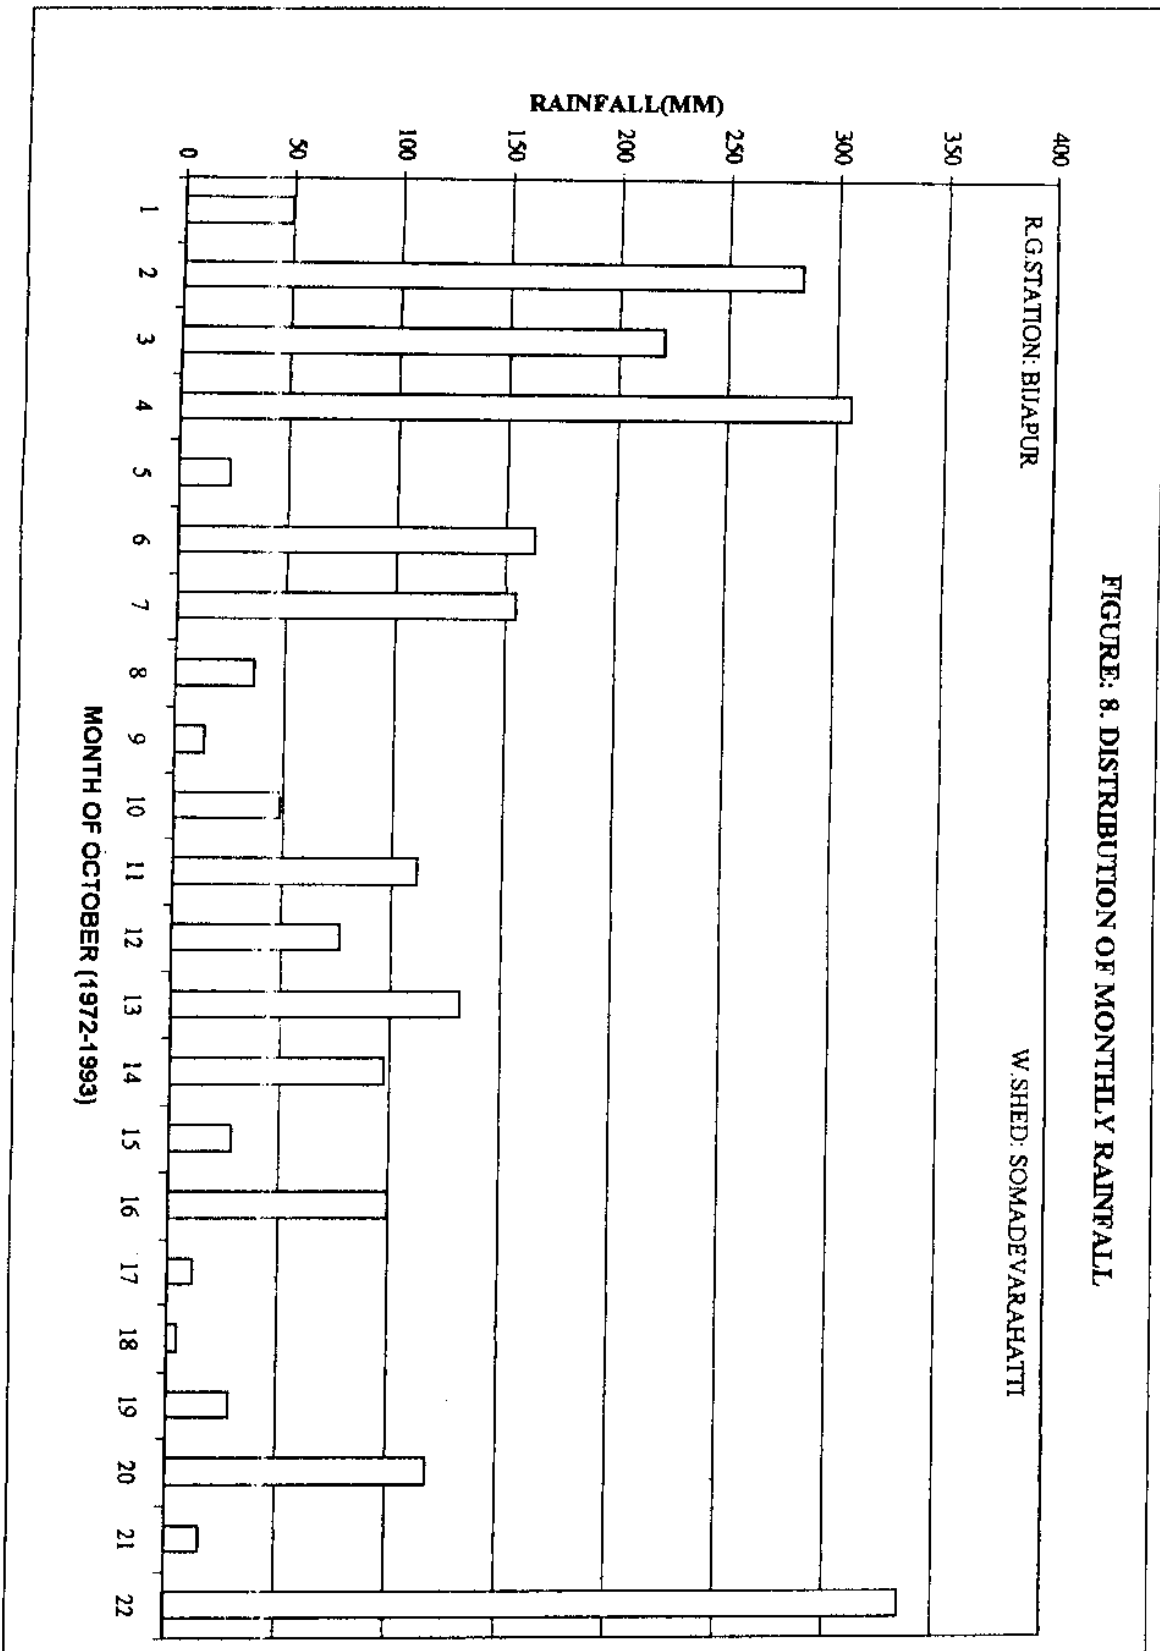
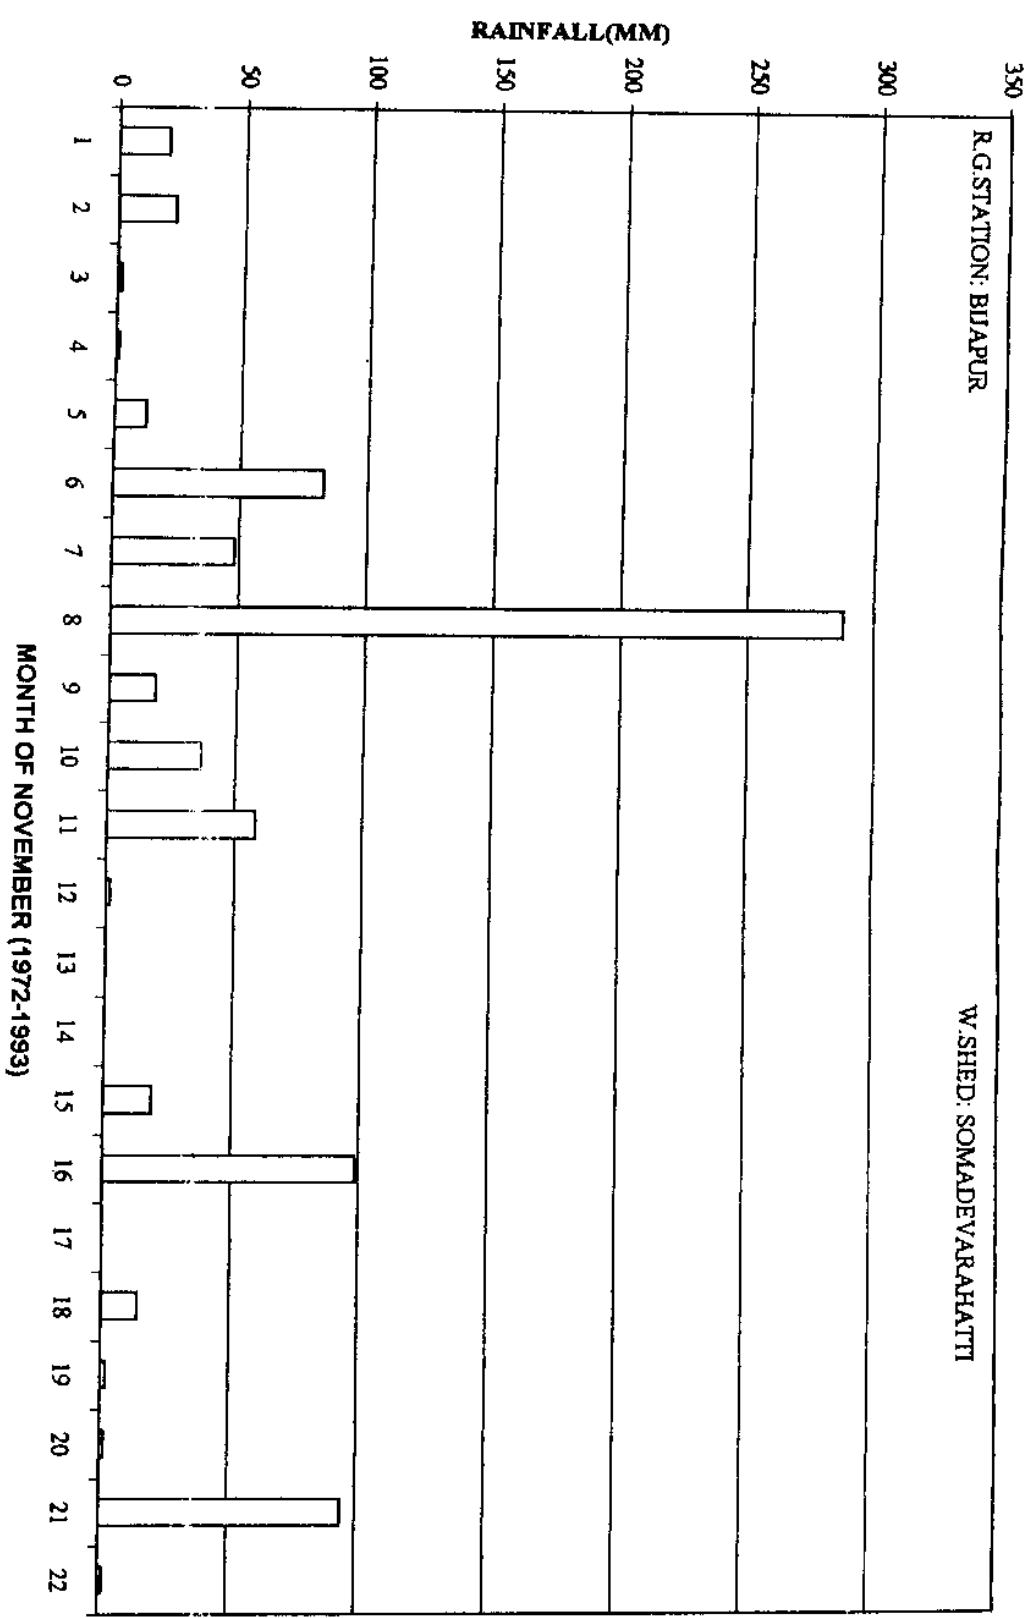
Monthly distribution of rainfall in Somadevarahatti watershed from 1972-1994 are plotted as shown in the figures from 2 to 9. There was no distinct trend found for the monthly rainfall over the years. The monthly rainfall were also used for the statistical distribution and presented in the table 3.
