# **WATER CONSERVATION MEASURES IN THE ARID AND SEMI-ARID AREA OF HARD ROCK REGION**

**NATIONAL INSTITUTE OF HYDROLOGY  
JALVIGYAN BHAWAN  
ROORKEE - 247 667 (UTTARANCHAL)**

**1999-2000**

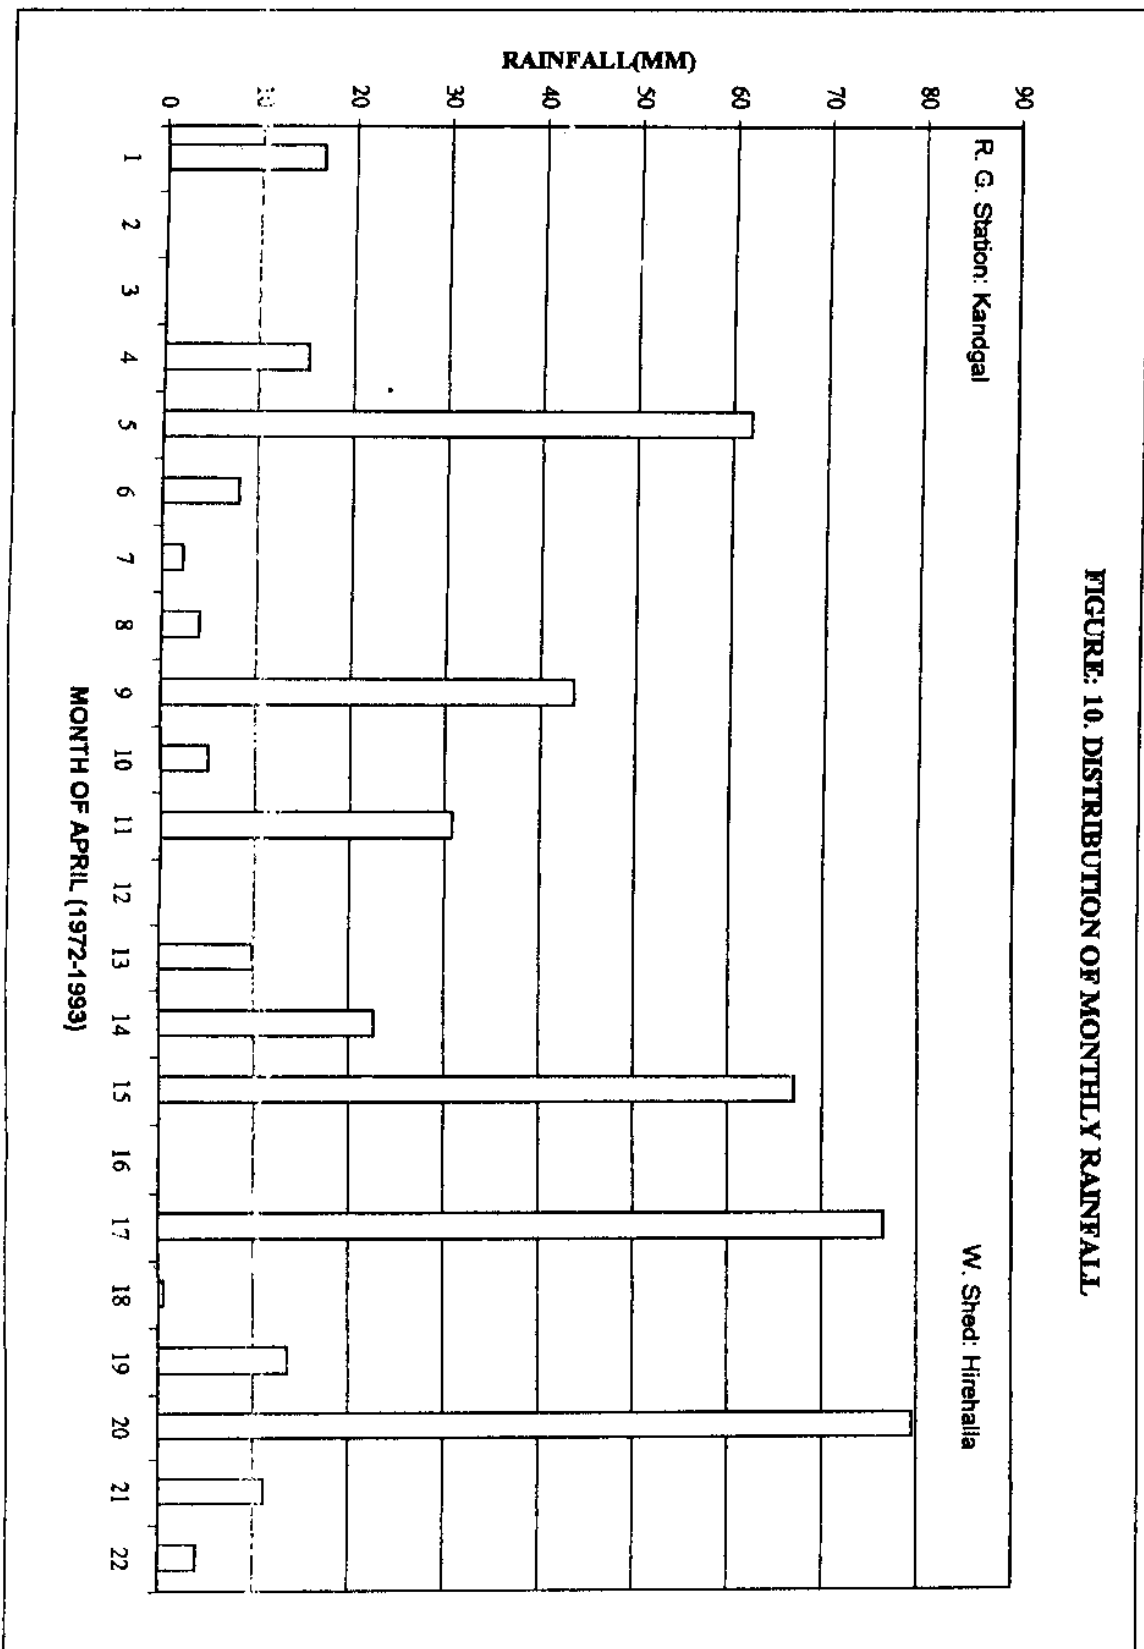
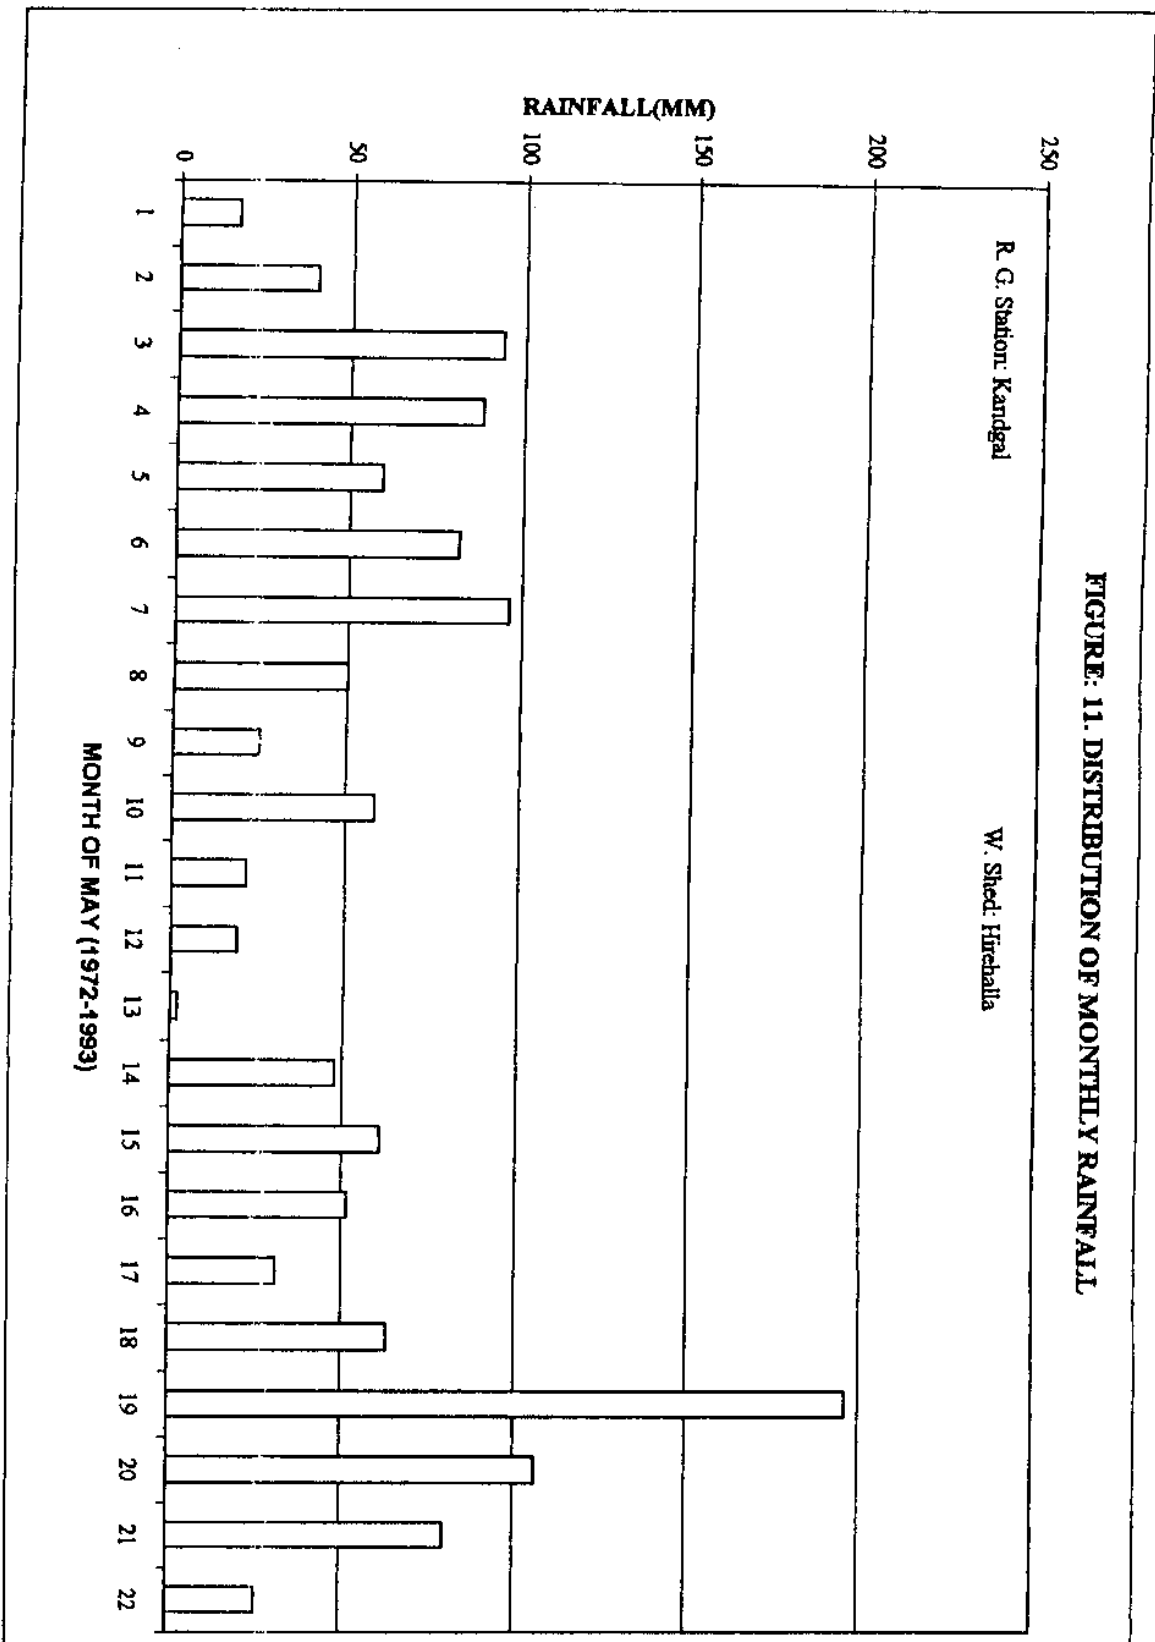
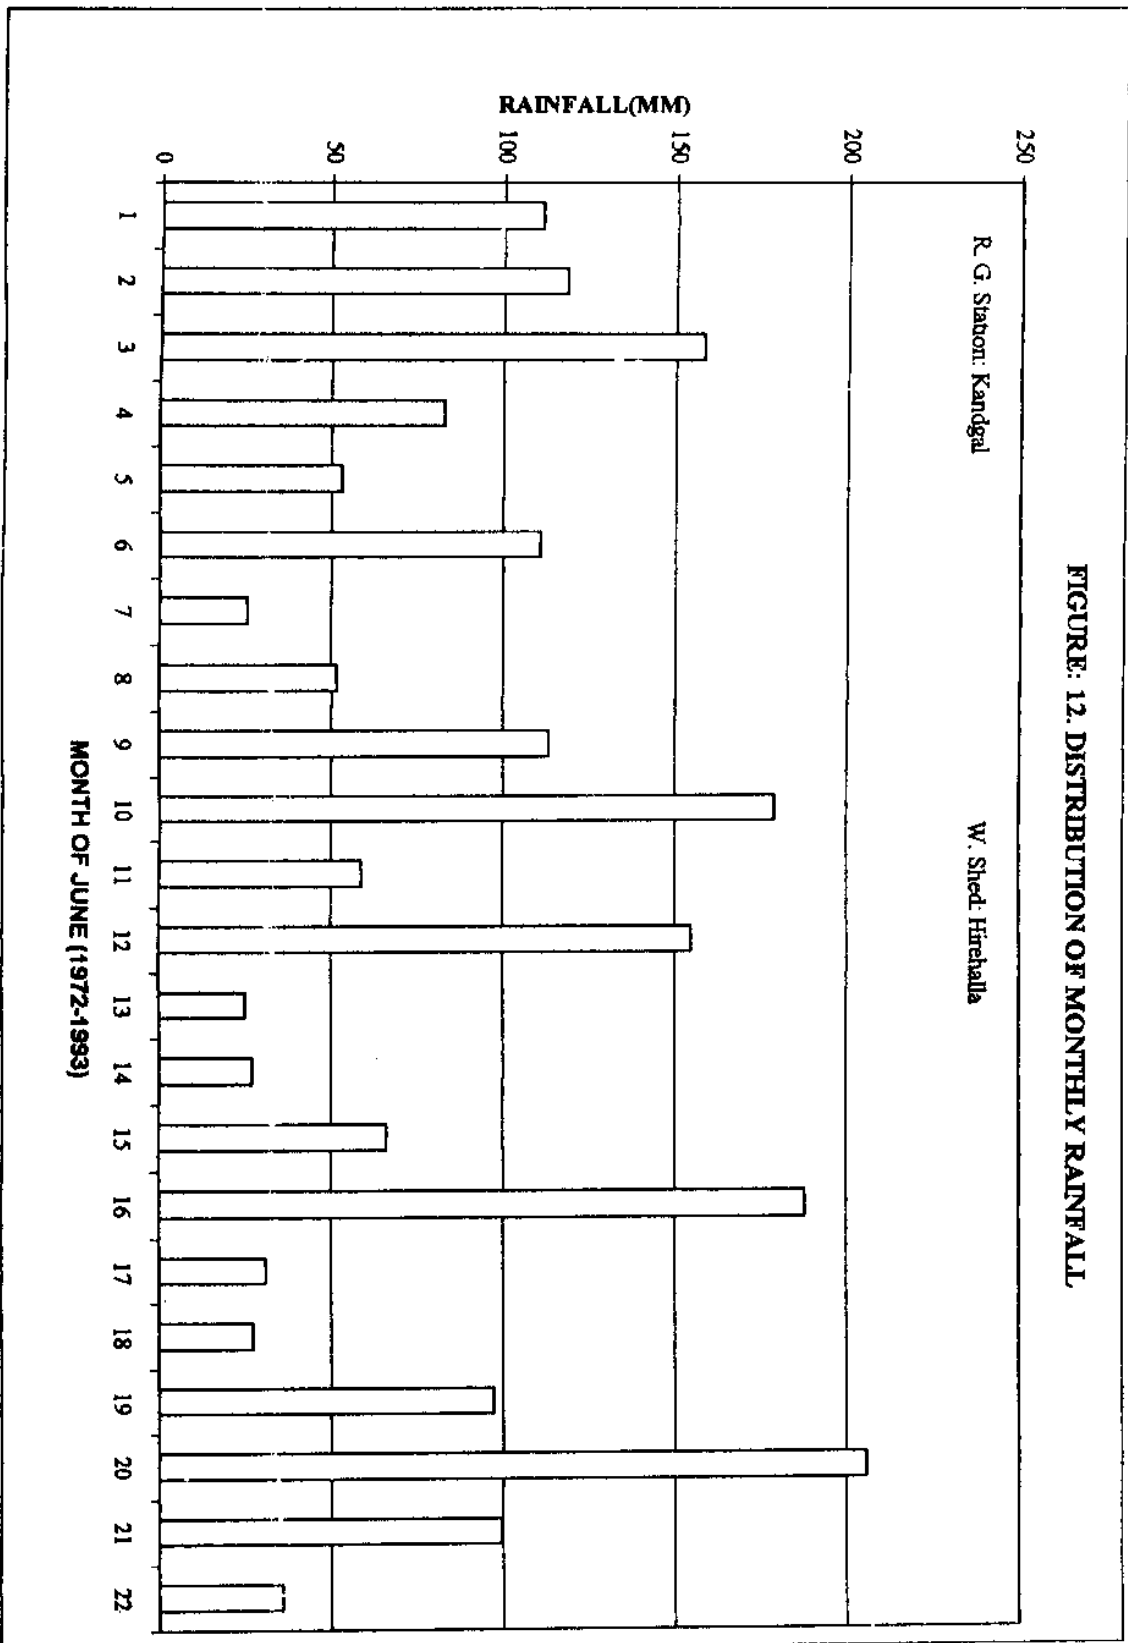
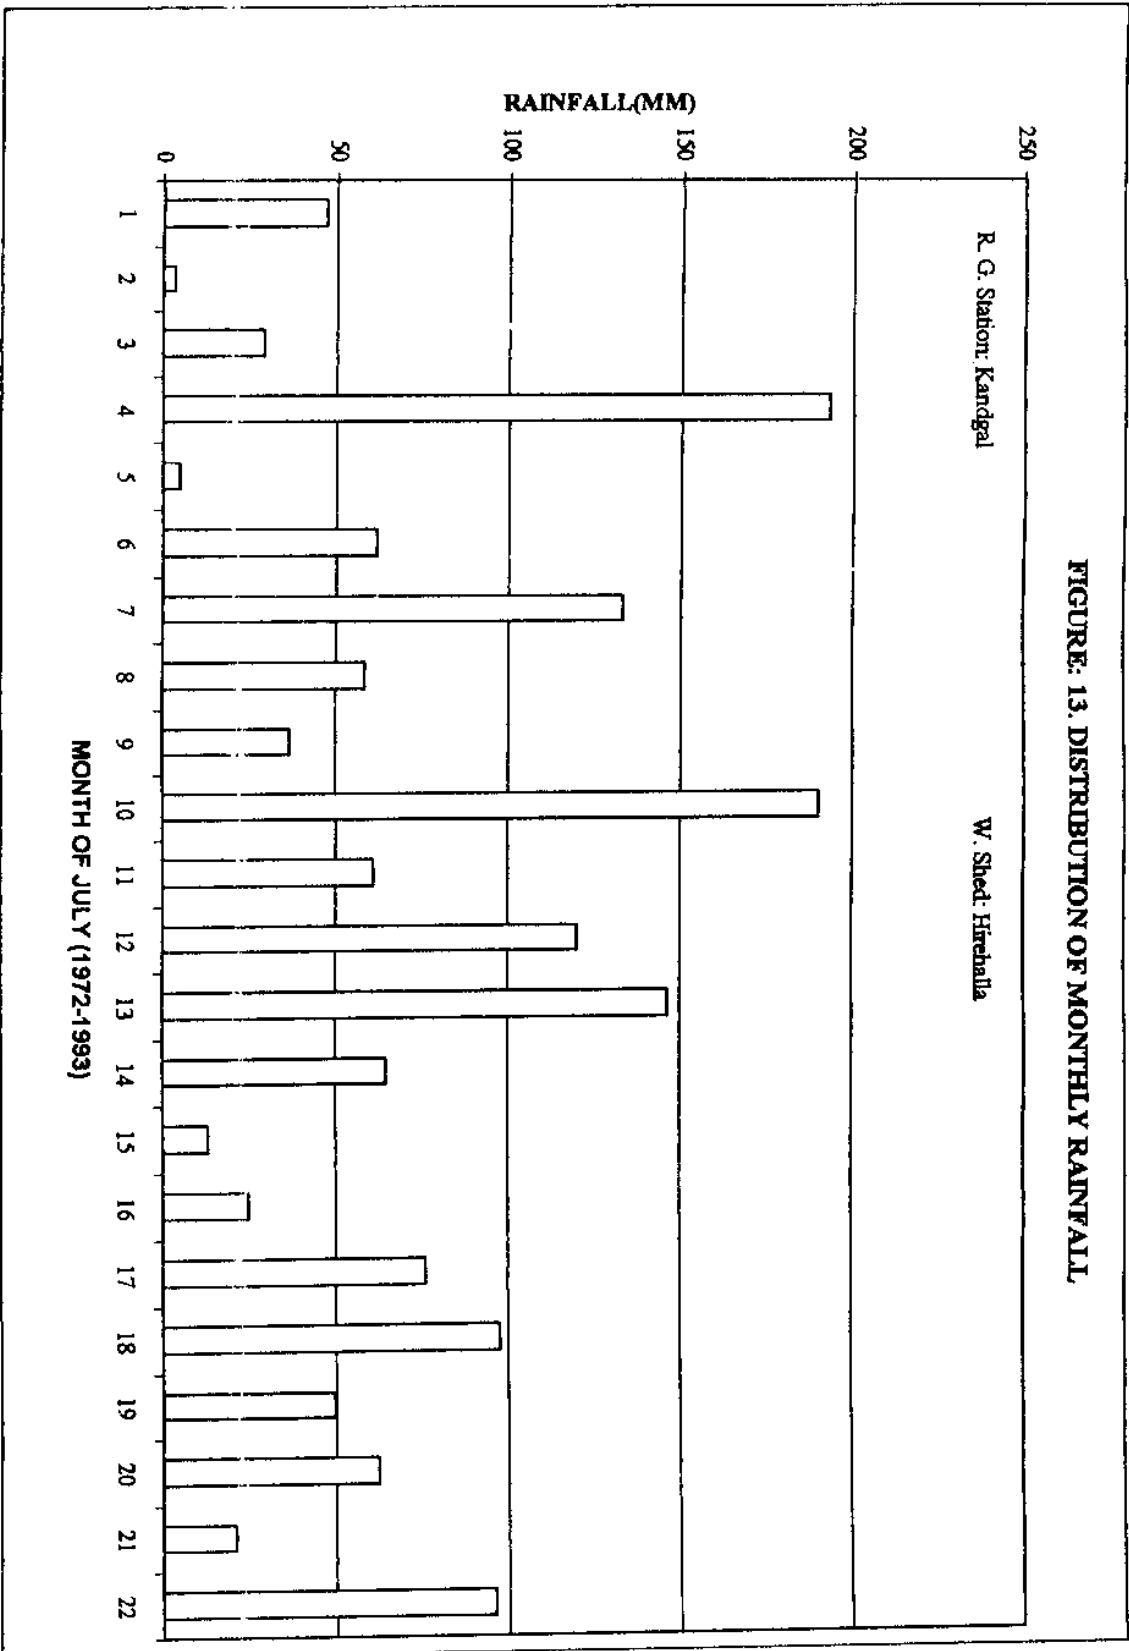
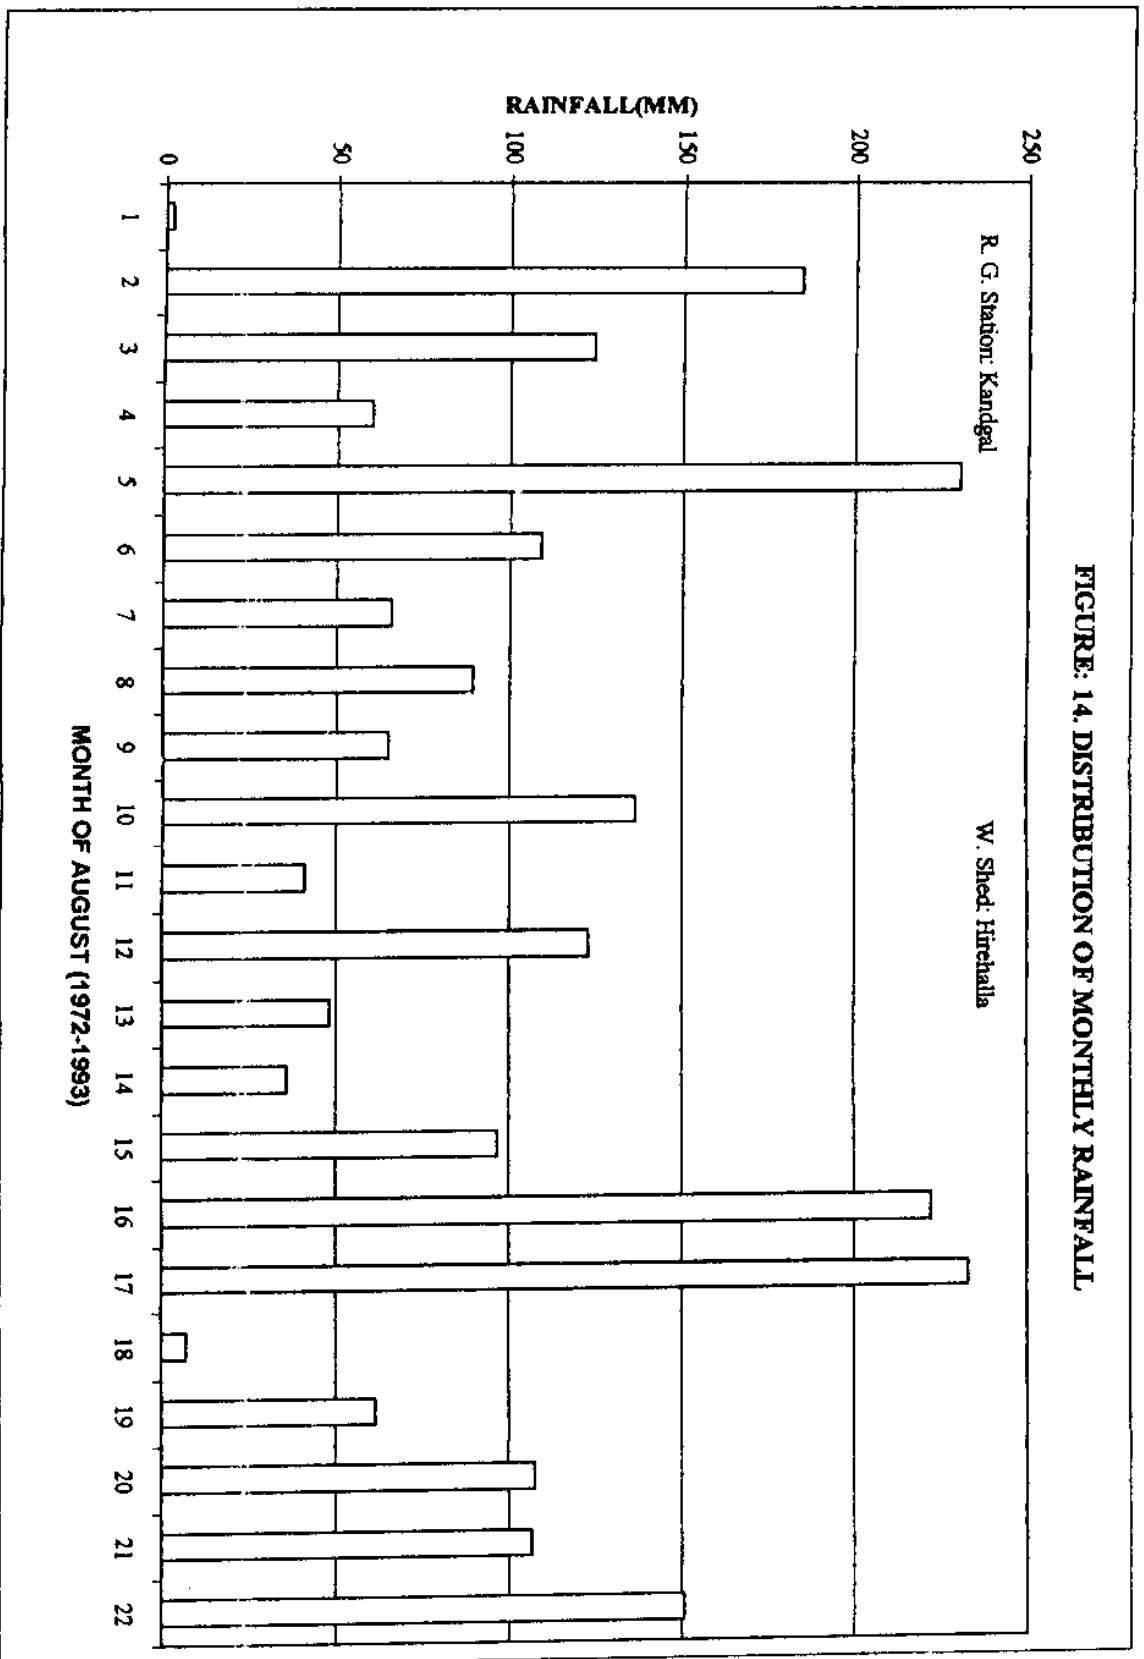
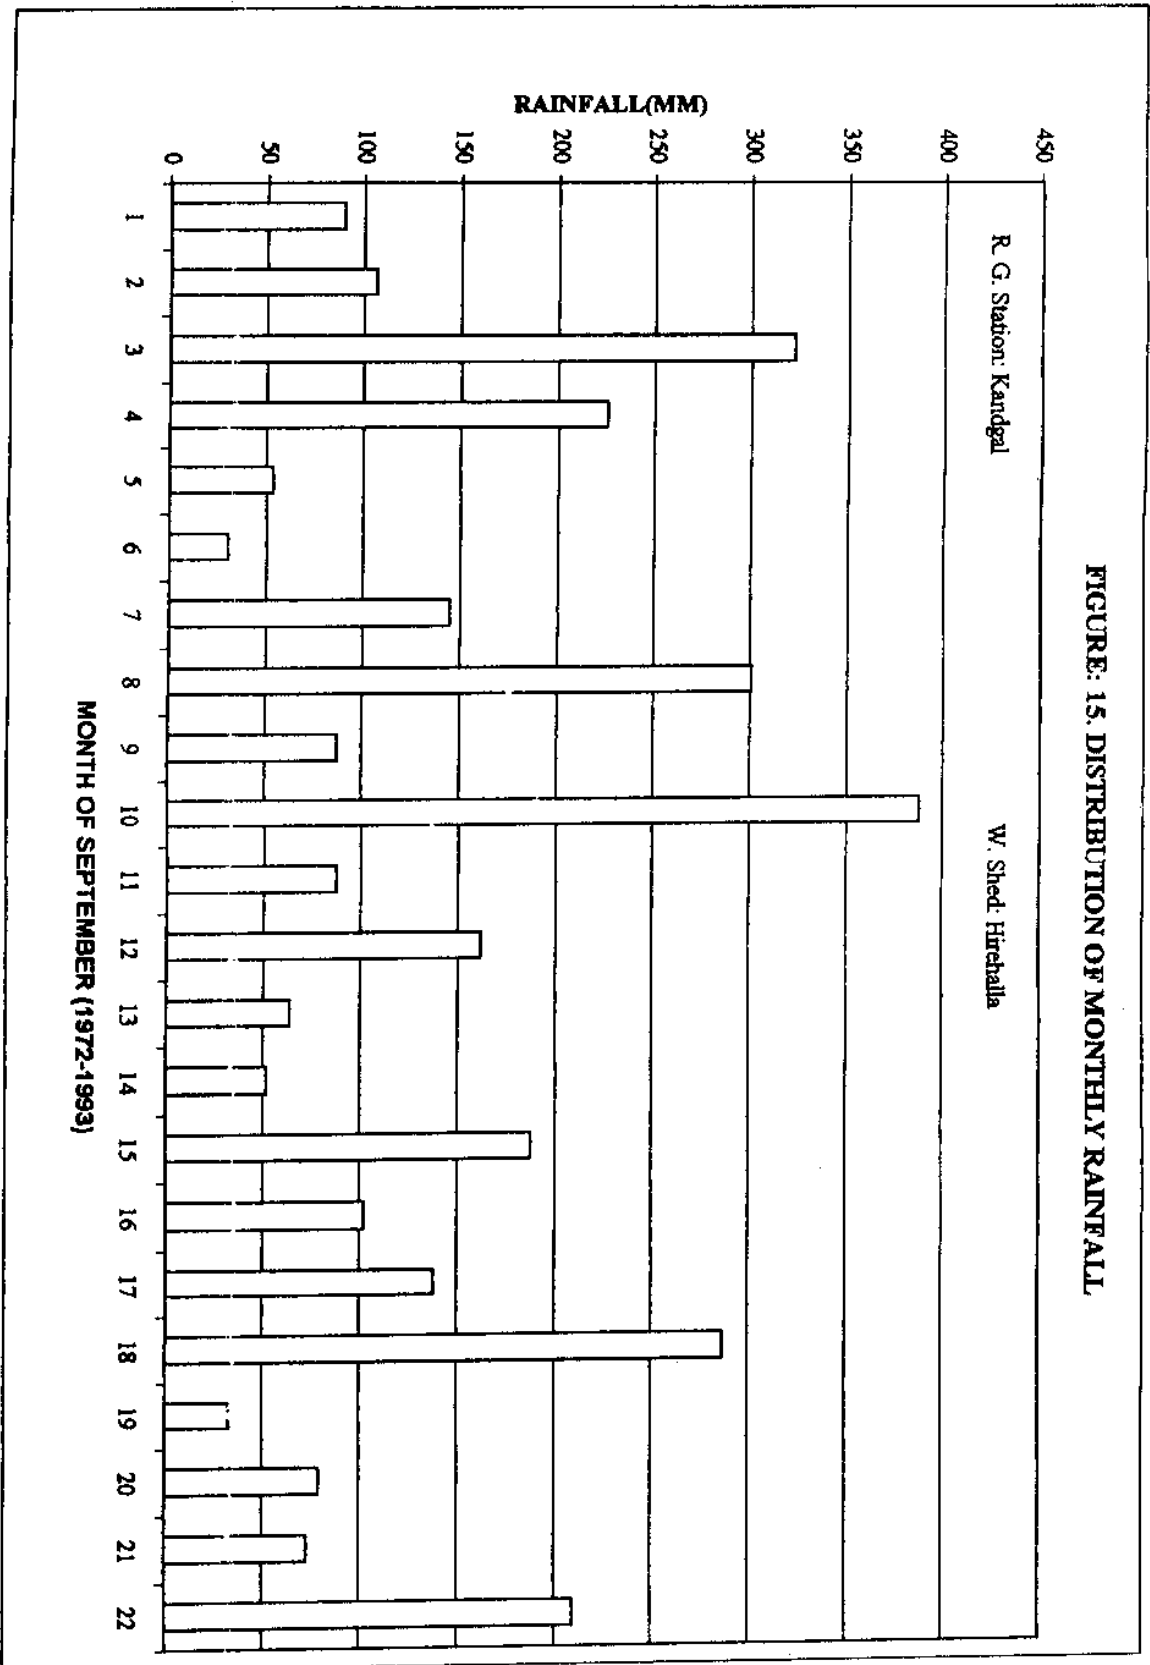
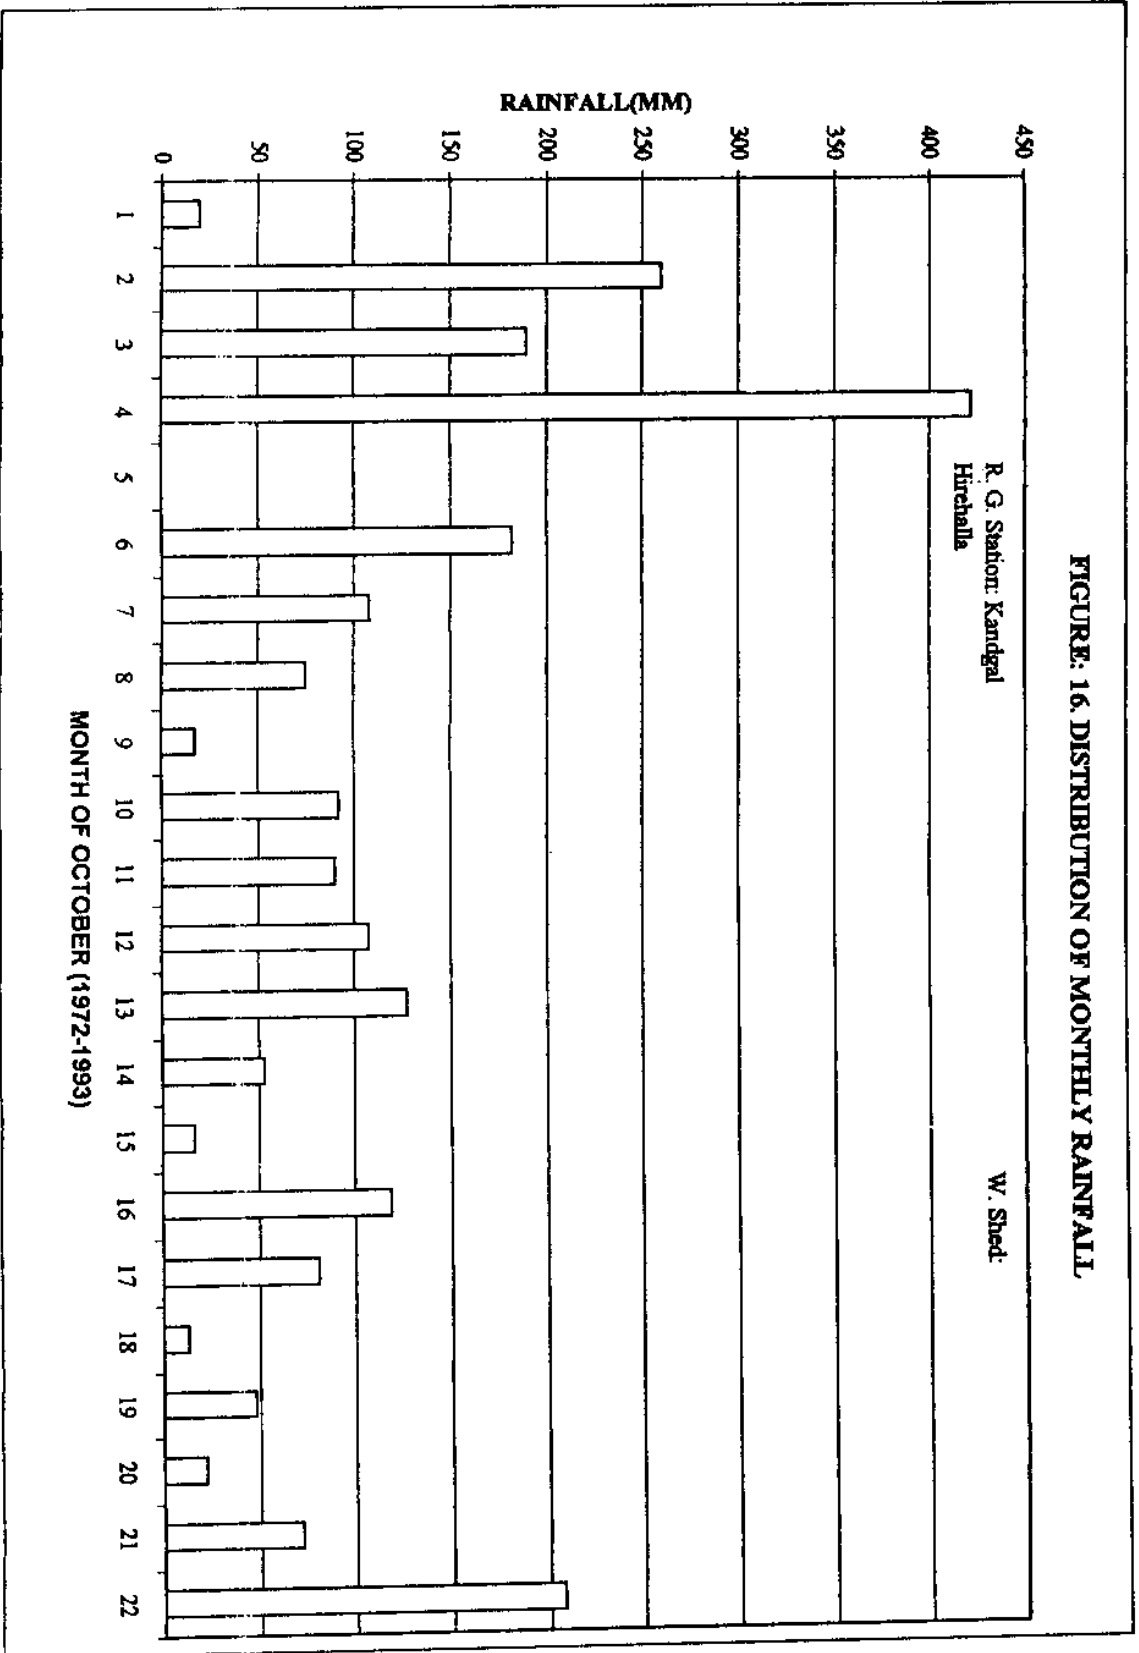
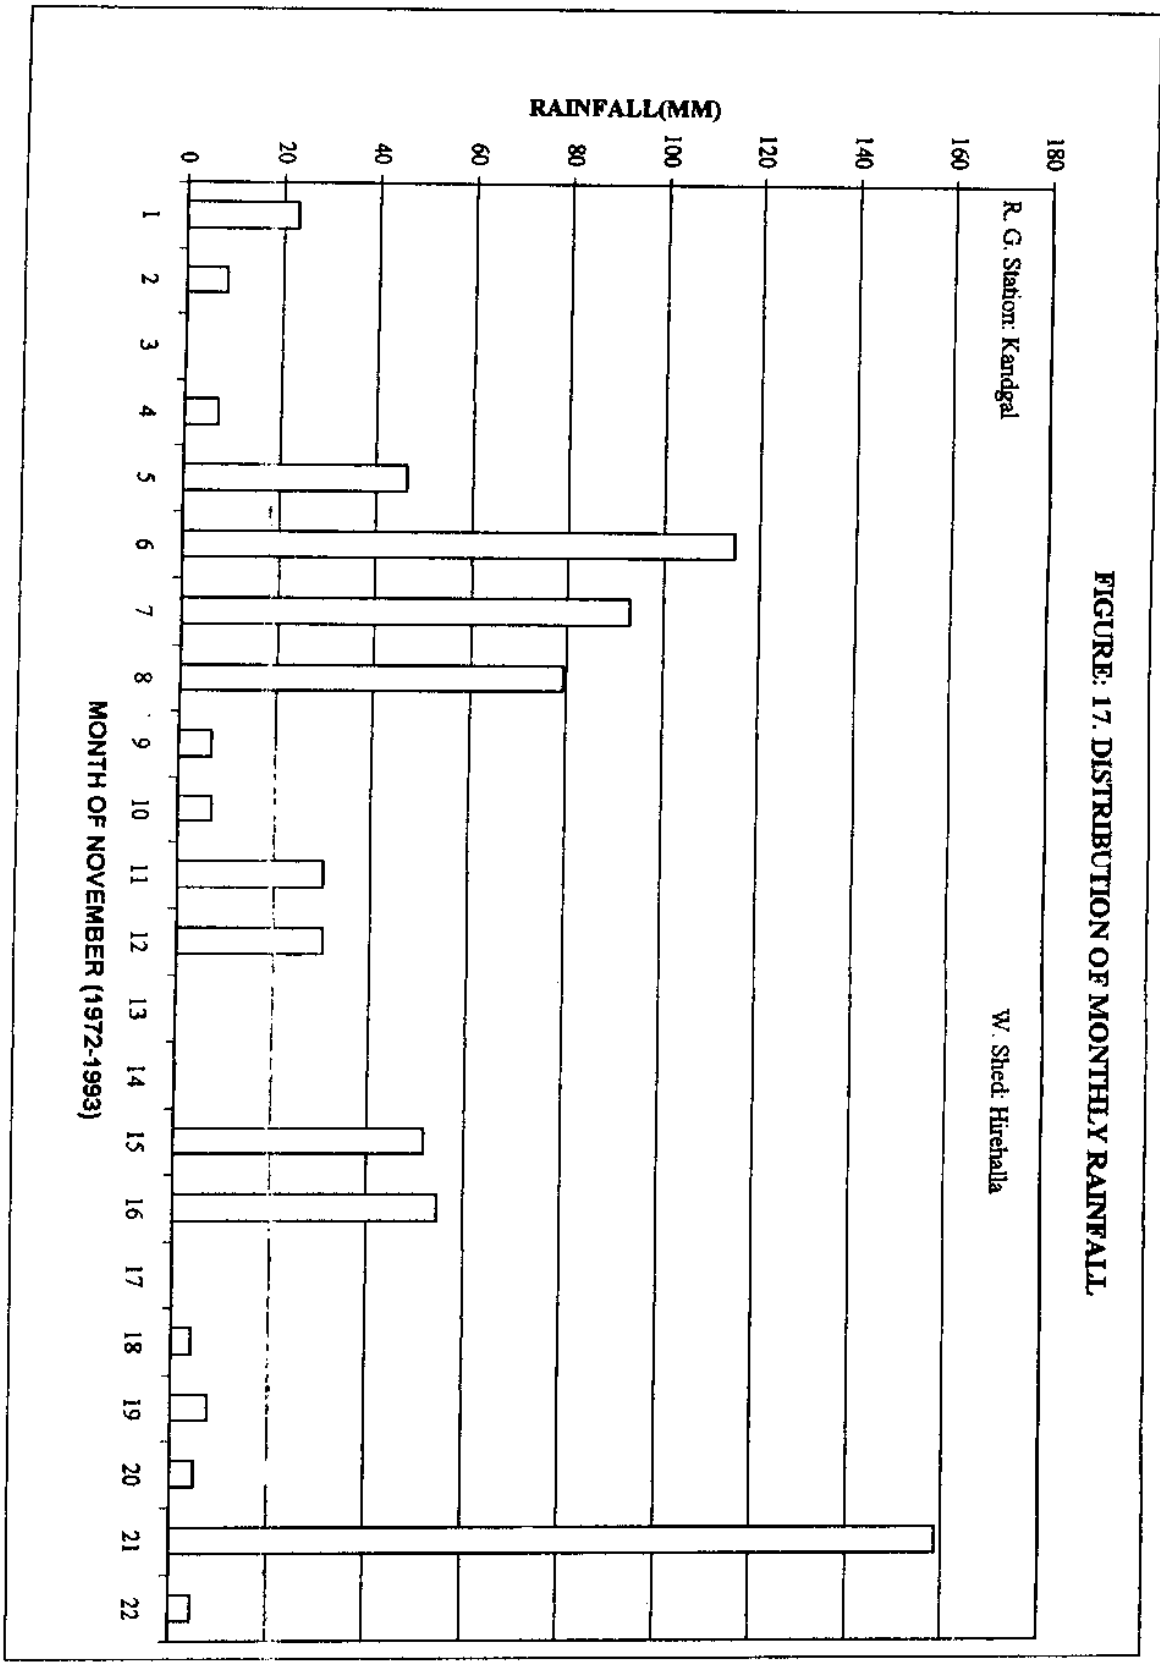
Rainfall is distributed from April to November and maximum is during months of June, July, August, September and October. Rainfall range of rainy months were presented in the table 5. Monthly distribution of rainfall from 1972-1994 were plotted as in the figures from 10 to 17. There is no clear monthly rainfall trend over the years found from the figures.

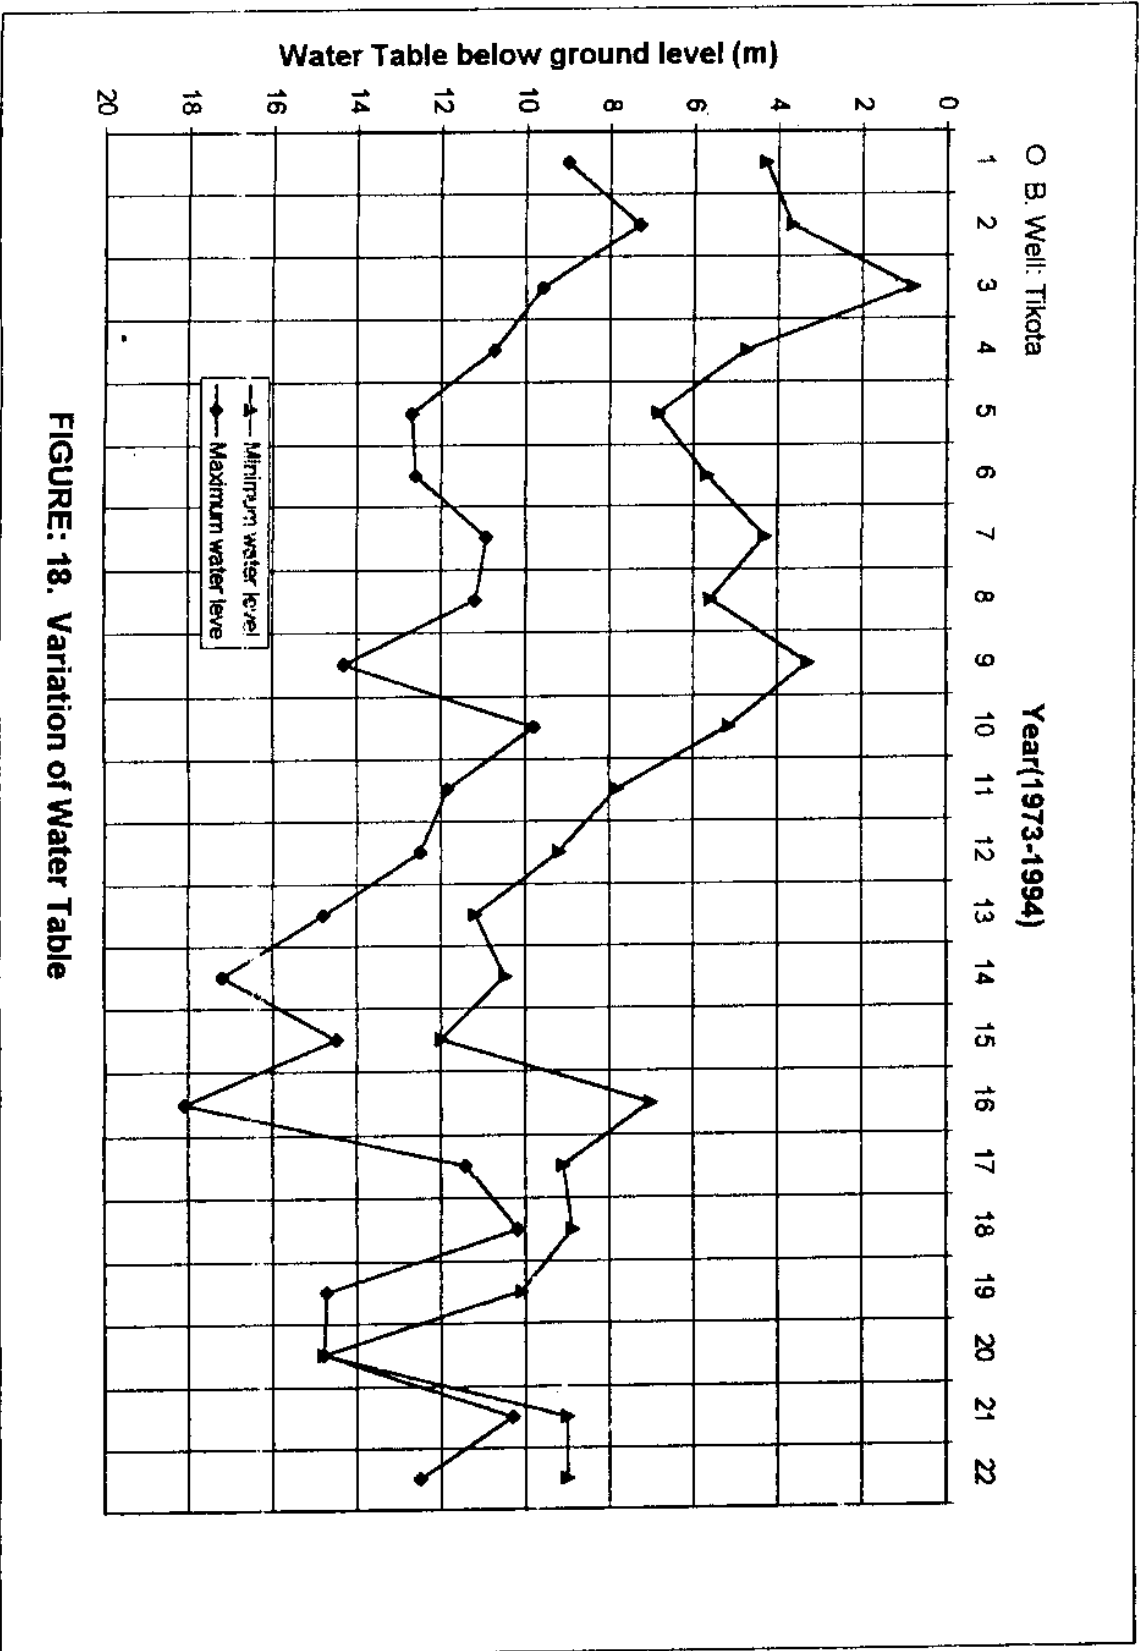
**FIGURE: 18. Variation of Water Table**

Monthly data from 1973 to 1994 is available for Tikota observation well which is only the observation well close to Somadevarahatti watershed. Minimum water levels are noticed generally in the month of May and maximum in the month of October. The fluctuation of water table varies from about 0 to 9m. The maximum and minimum water levels in a year were plotted over the years (1973-1994) as presented in the figure 18. The general trend of recharge and exploitation on water table level over the years were identified. It is also noticed from the figure that minimum and maximum water table follows same trend.
