# **WATER CONSERVATION MEASURES IN THE ARID AND SEMI-ARID AREA OF HARD ROCK REGION**

**NATIONAL INSTITUTE OF HYDROLOGY  
JALVIGYAN BHAWAN  
ROORKEE - 247 667 (UTTARANCHAL)**

**1999-2000**

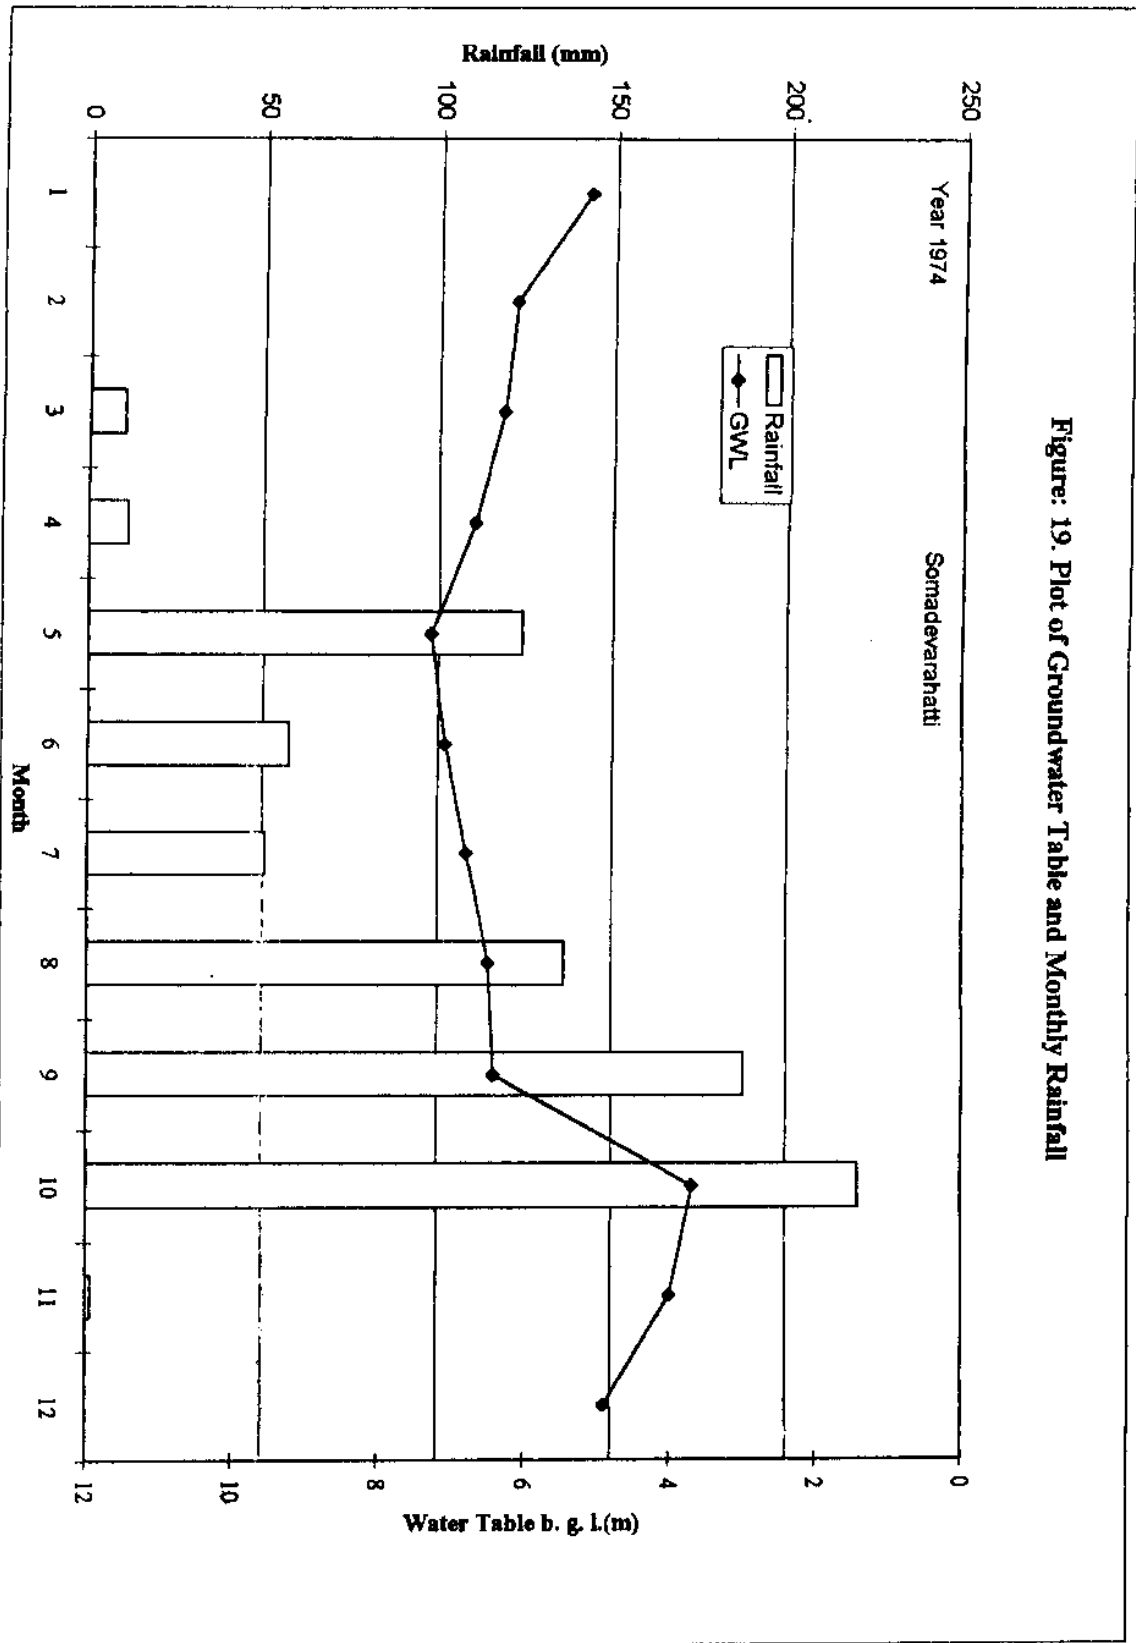
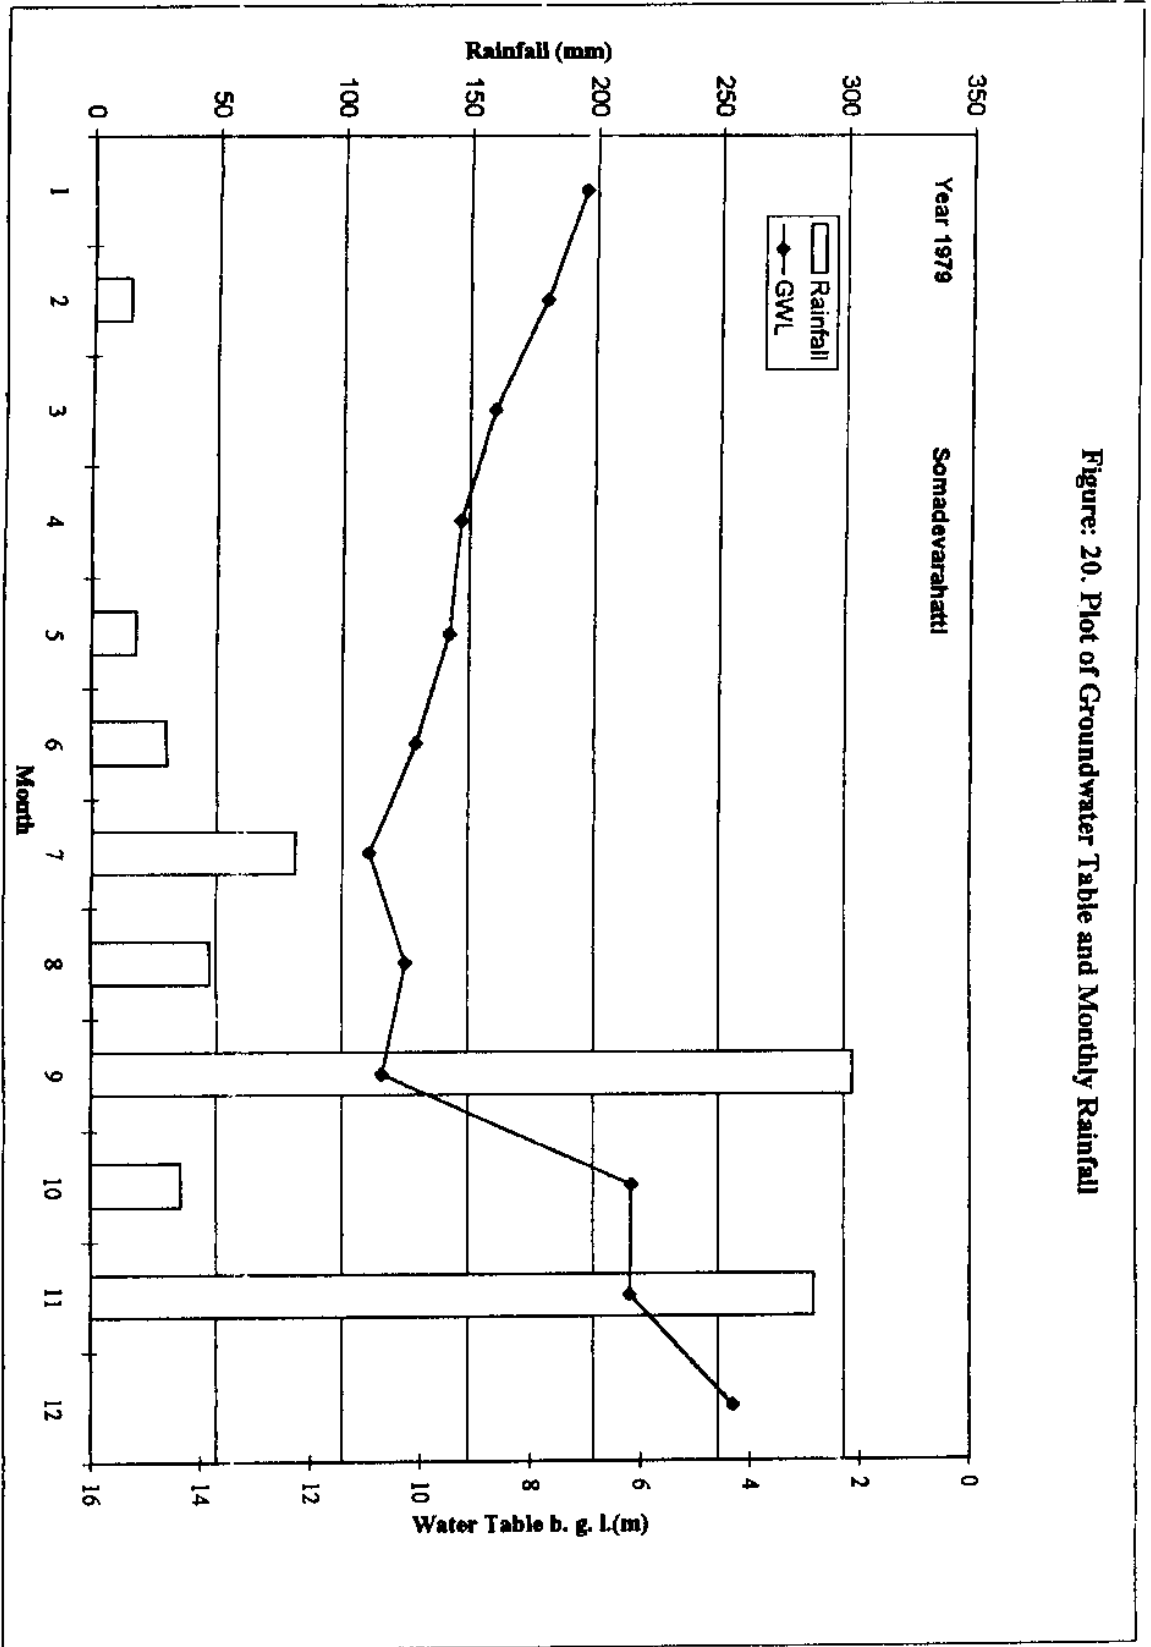
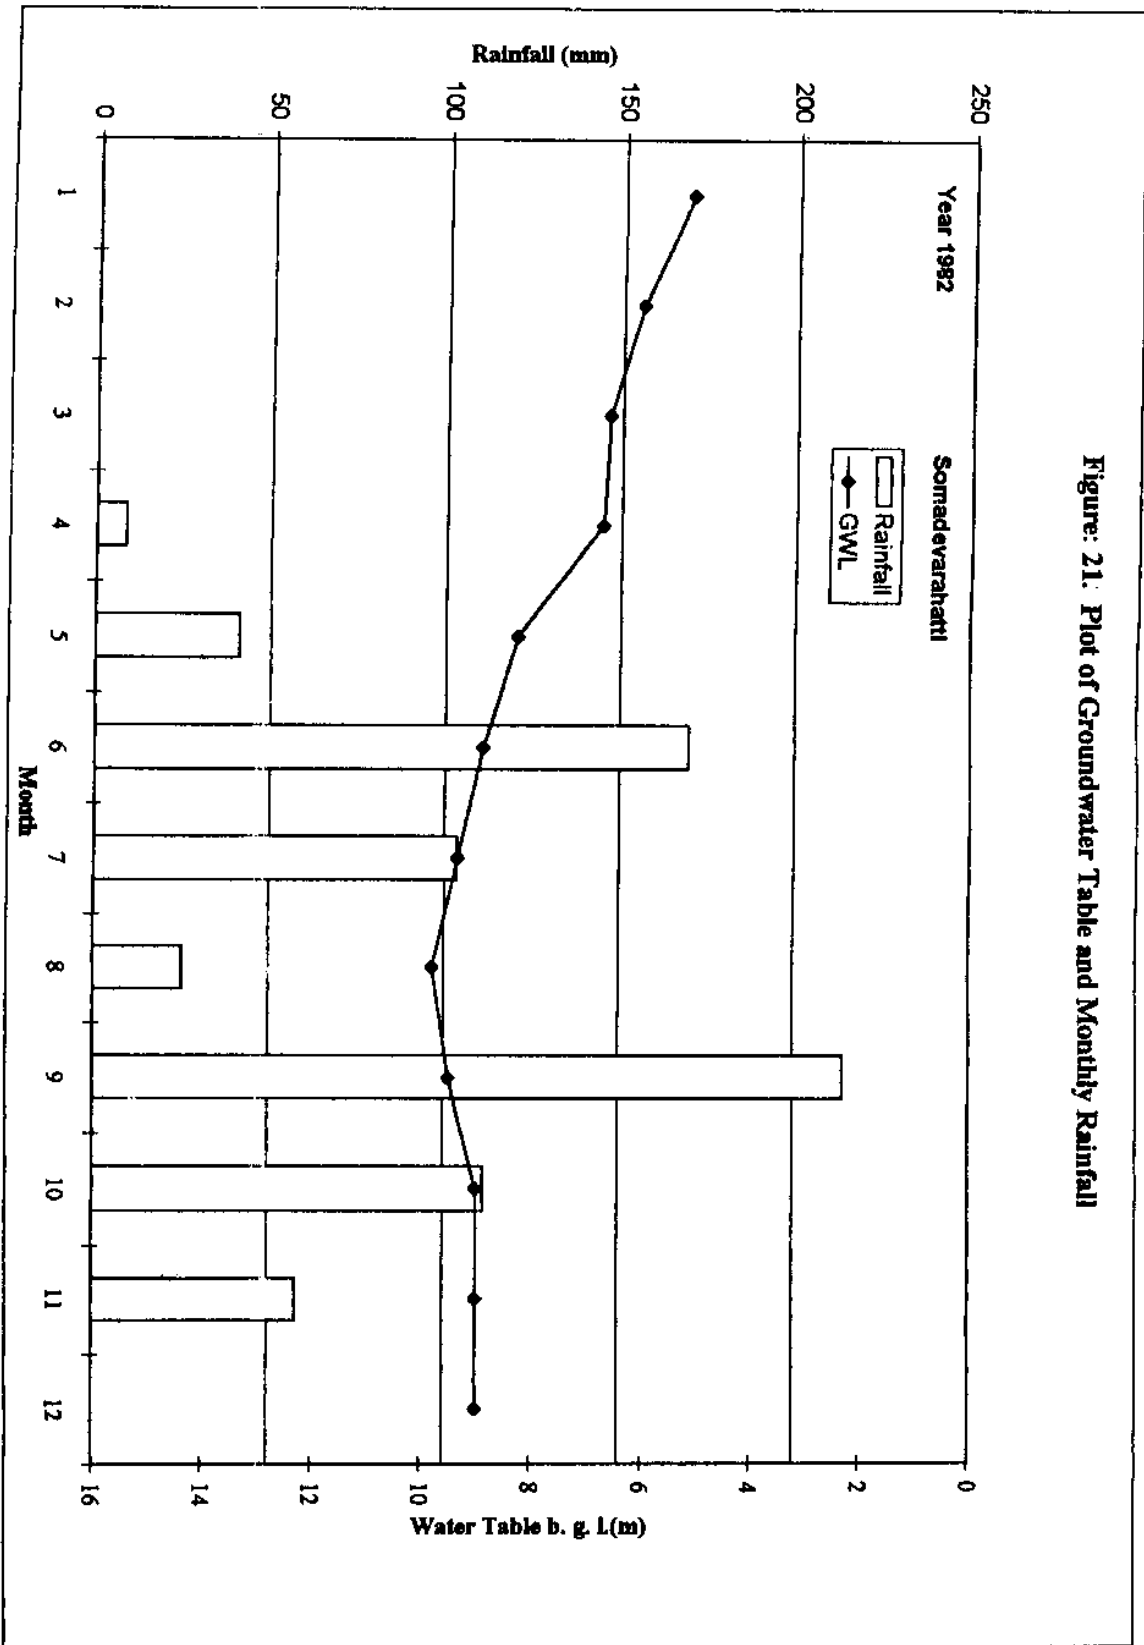
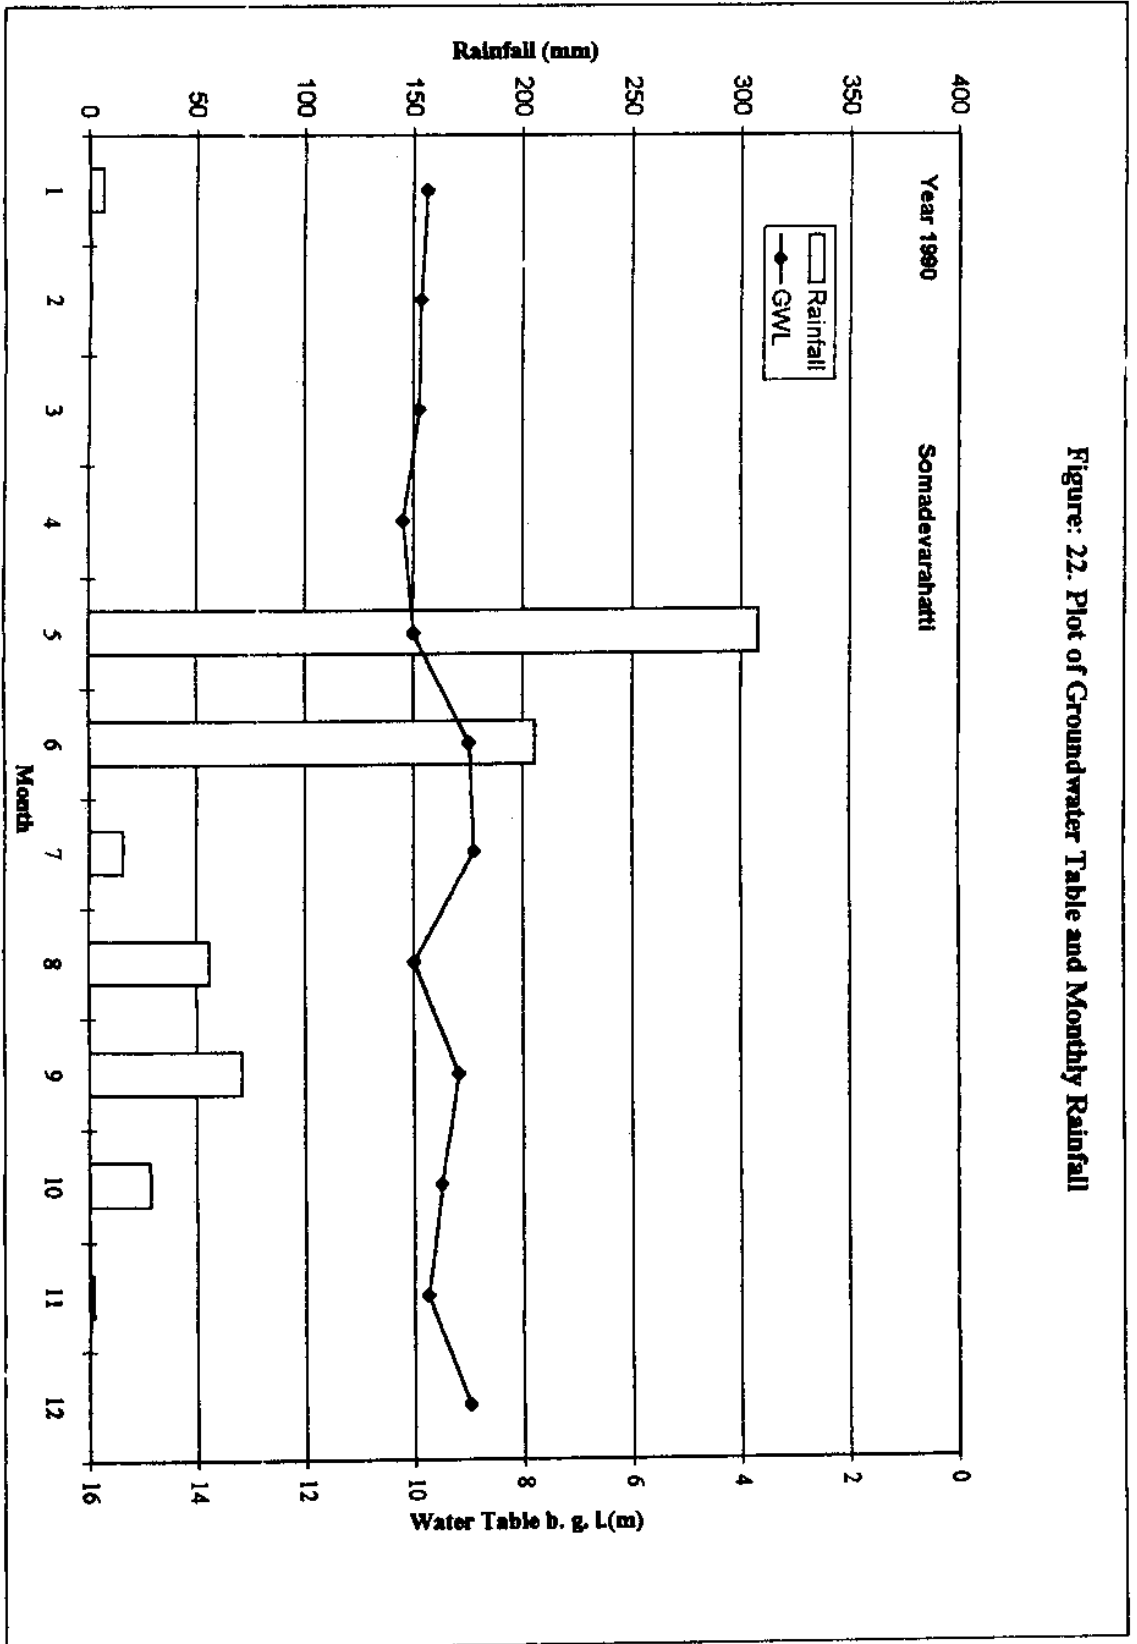
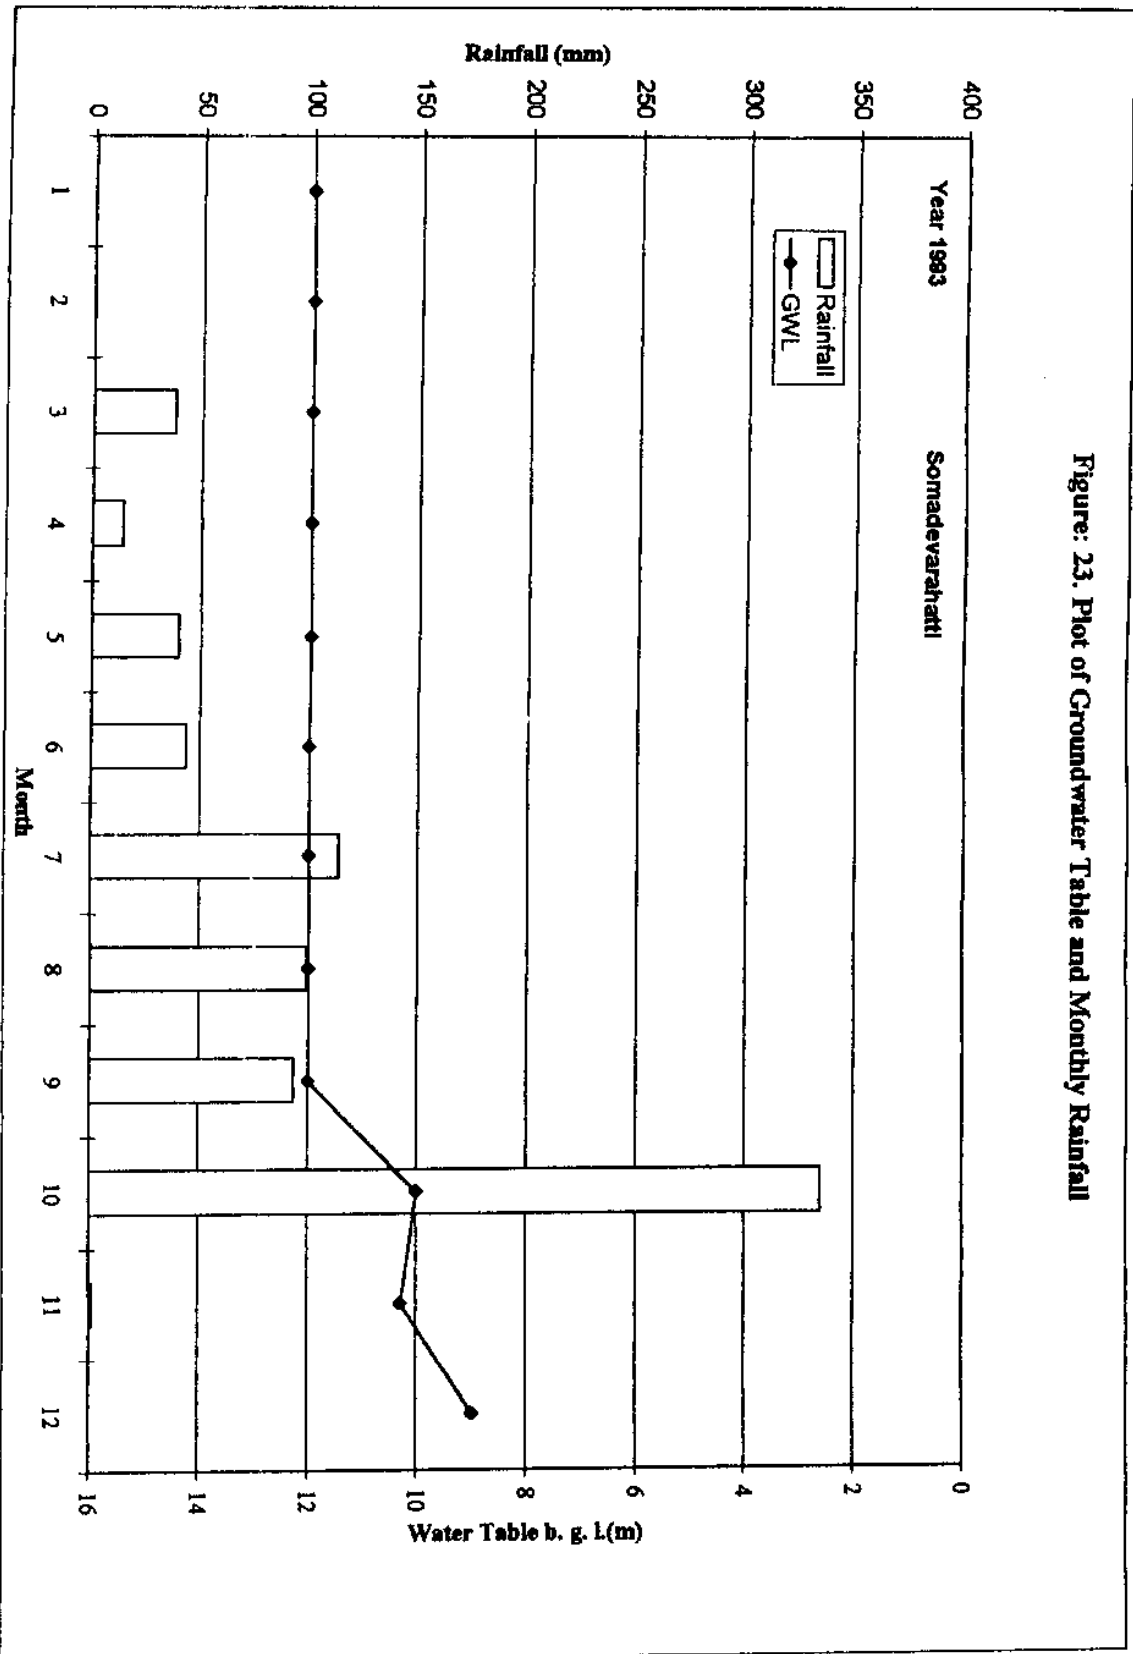
The monthly rainfall and water table levels have been plotted for few years (1974, 1979, 1982, 1990 and 1993) to understand the impact of monthly rainfall over recharge status of the groundwater from figure 19 to 23. From these figures, it shows that the recharge conditions of groundwater table were not having clear relationship with monthly rainfall in the later years. It may be attributed to the exploitation condition of groundwater.

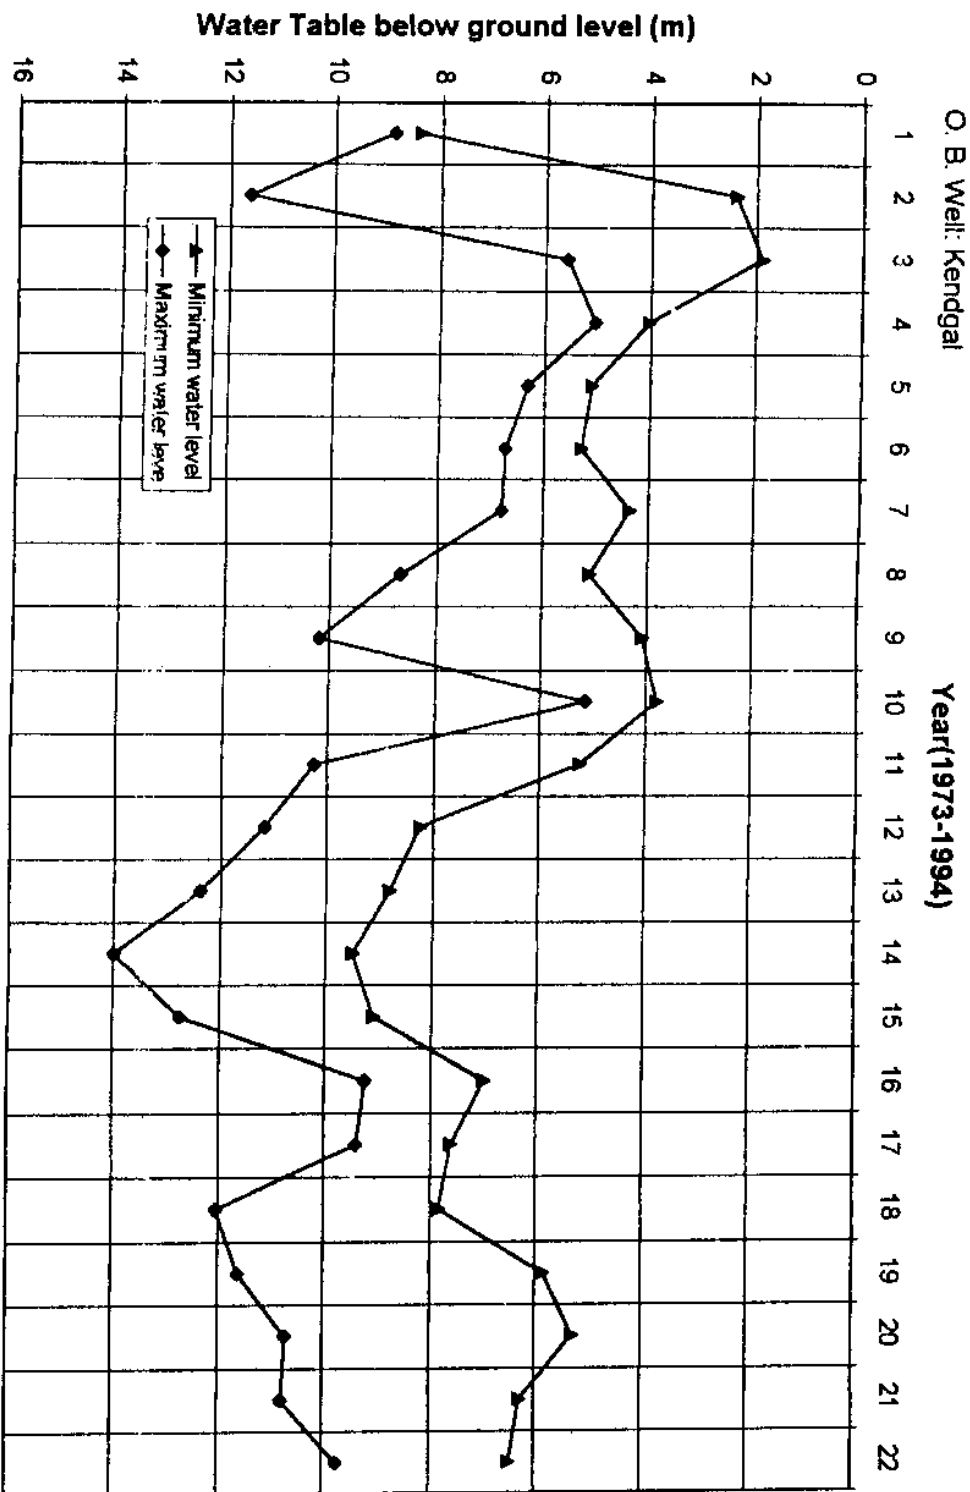
**FIGURE: 24. Variation of Water Table**

Monthly water table data from 1973 to1994 is available for Kendgal observation well which is only the observation well within the watershed. Minimum water levels are noticed generally in the month of May and June and maximum in the month of October and November. The fluctuation of water table varies from about 0.5 to 6m. The maximum and minimum water levels in a year were plotted over years (1973-1994) as presented in the figure 24. The general trend of recharge and exploitation on water table level over the years were identified. It is also noticed that from the figure minimum and maximum water table follows same trend. However, there were three different water table situations noticed over 22 years. In initial period (1973-1983), there is water table level at the higher level, middle of the period (1984 -1991) at the lower level and in the later period from 1992, water table at higher level.

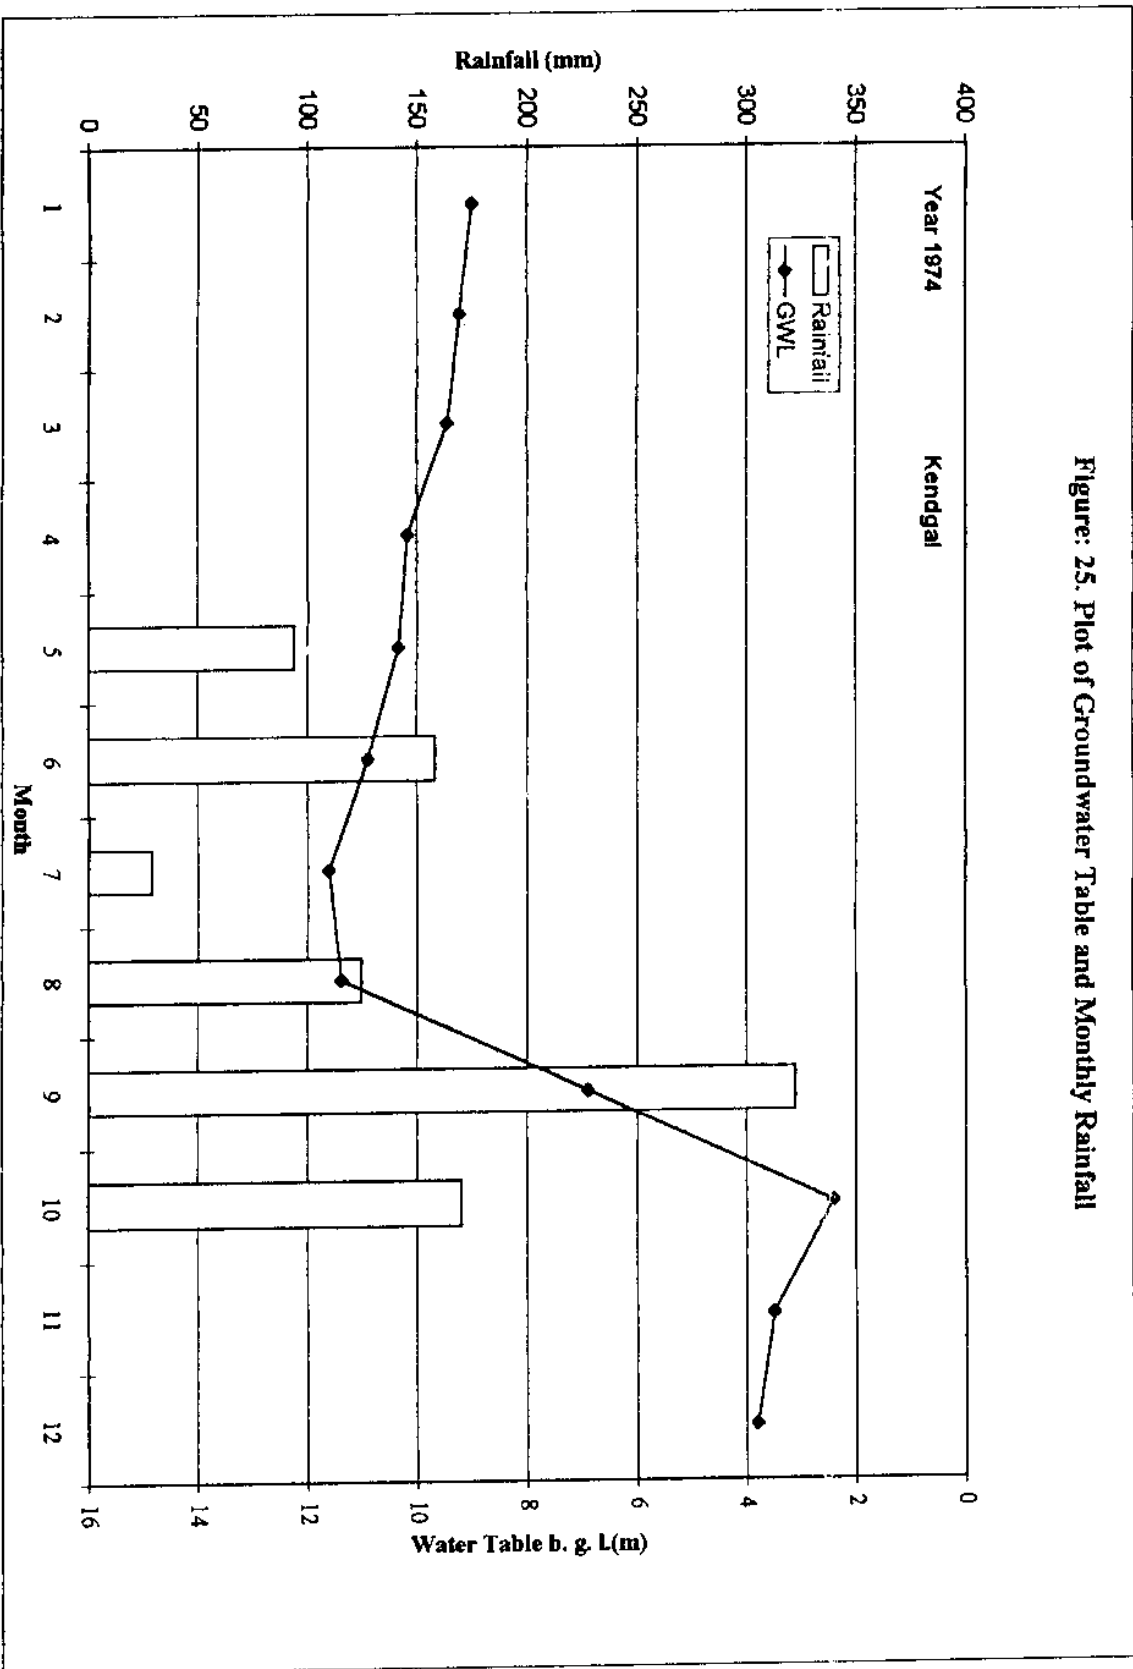
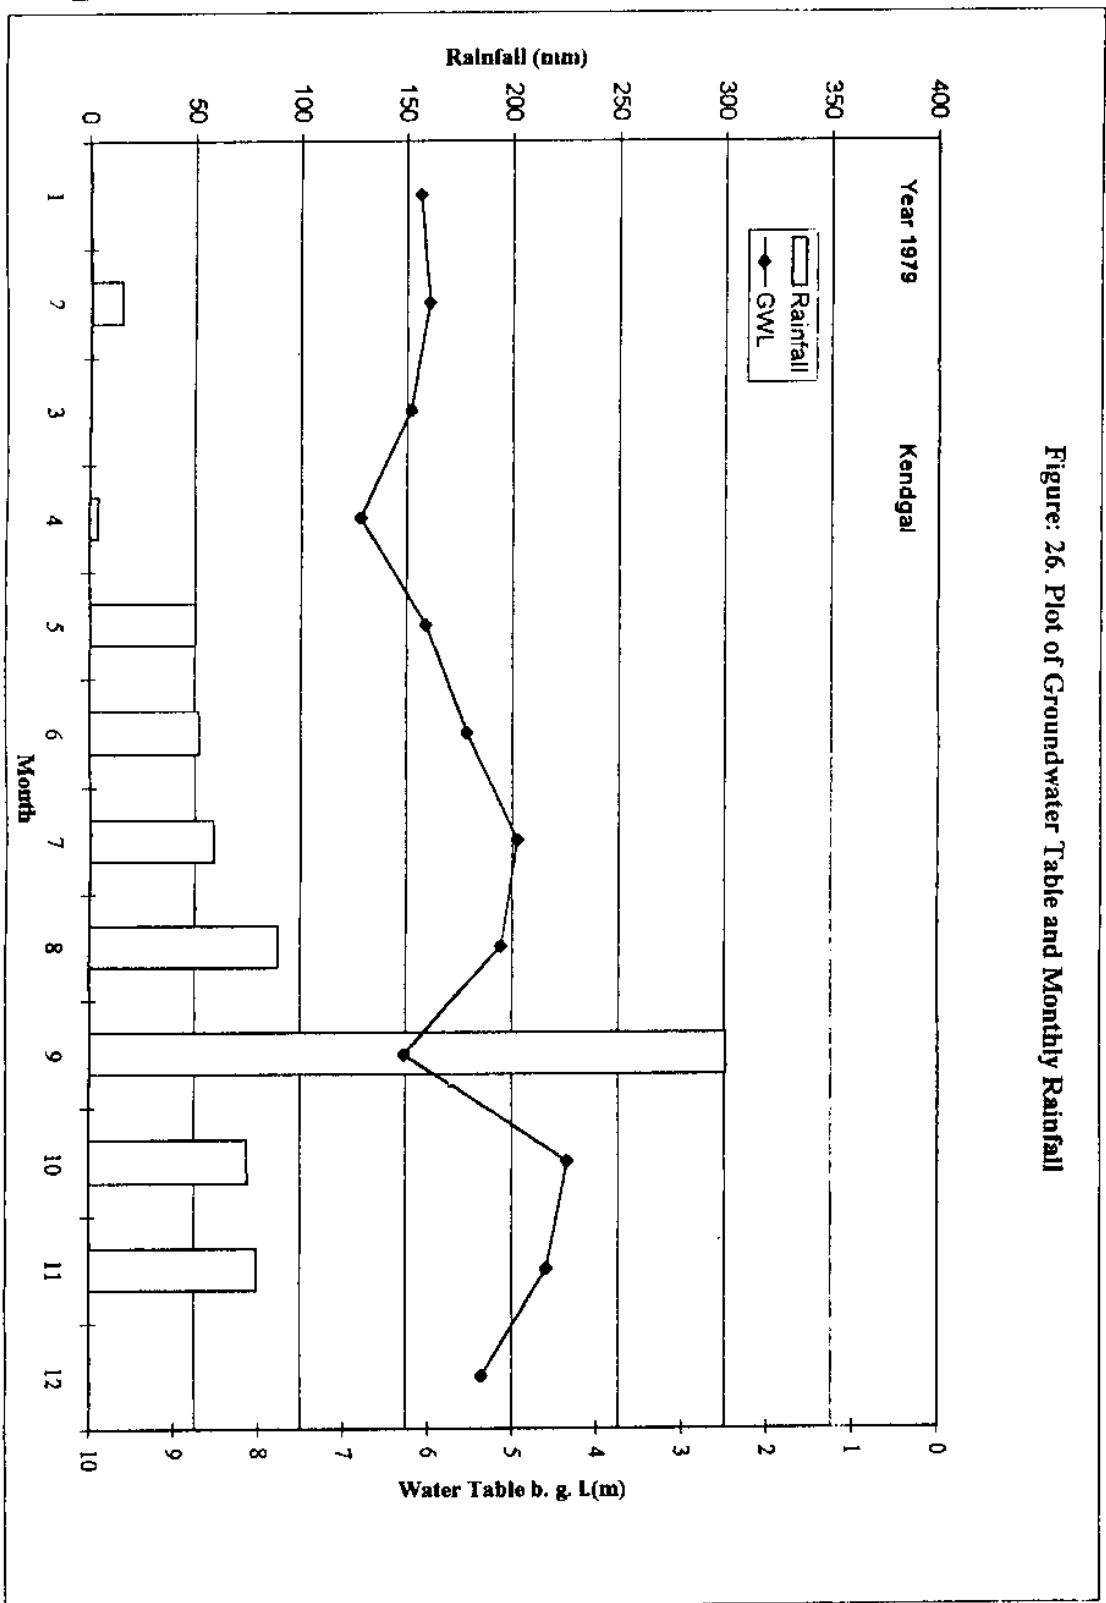
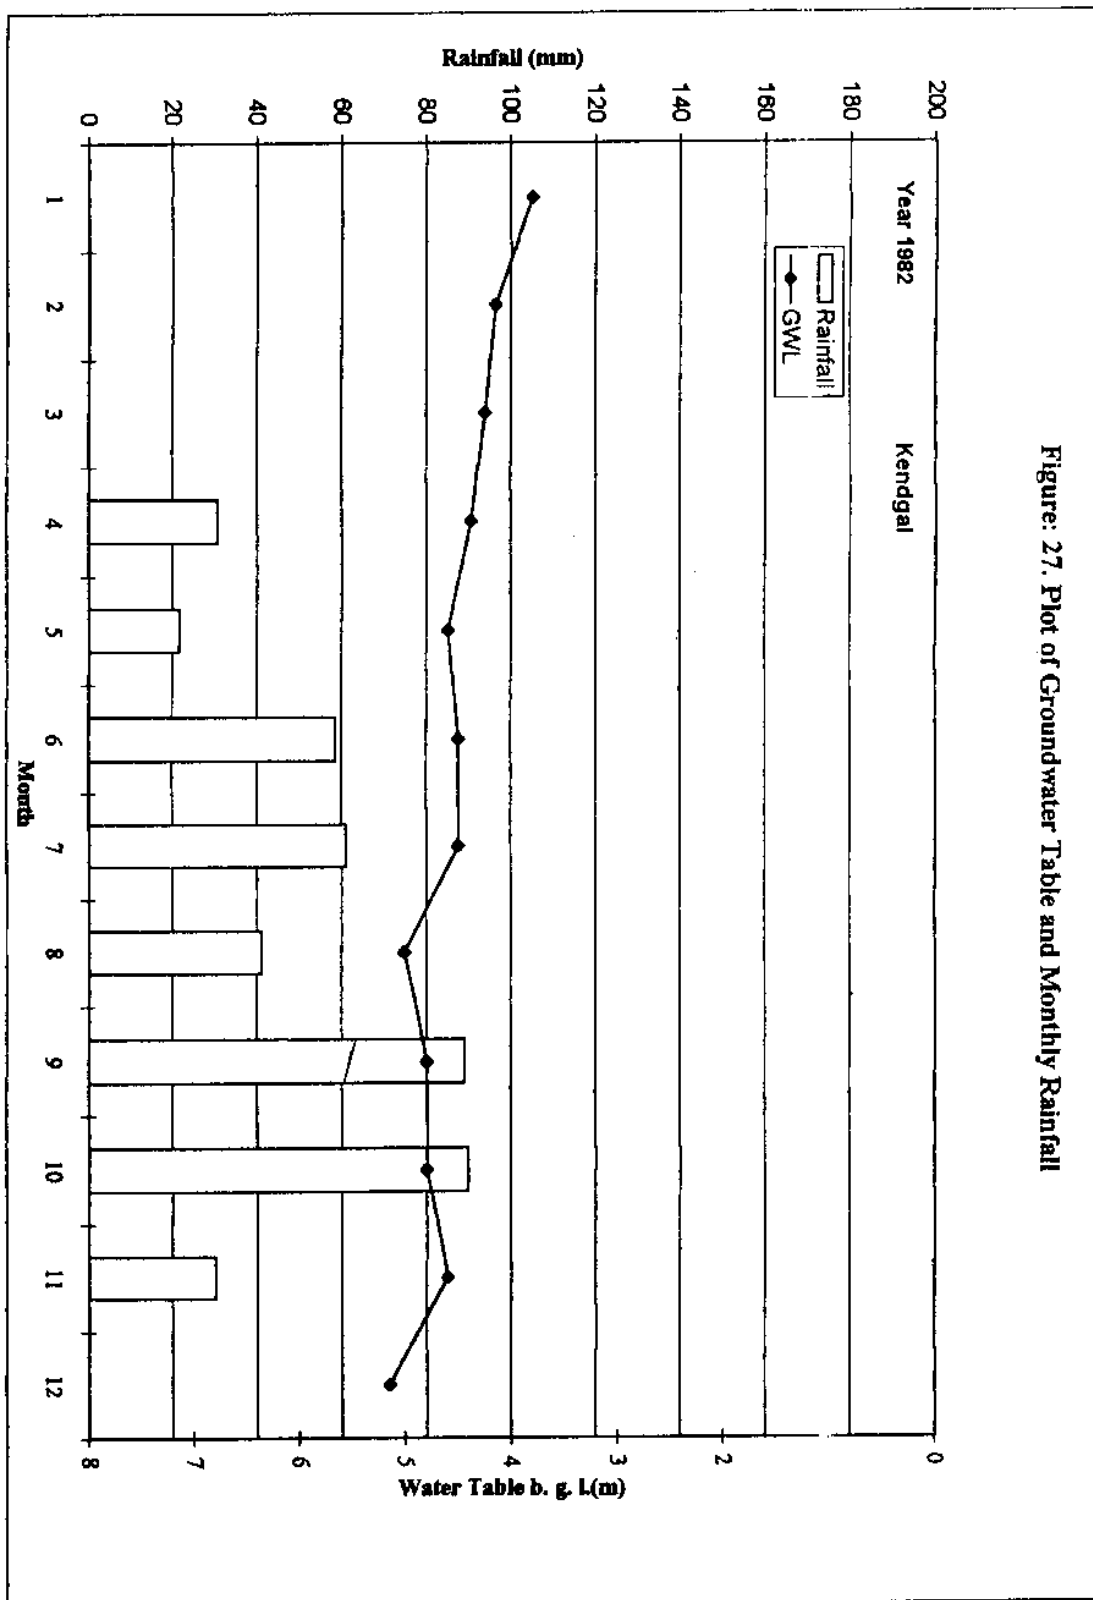
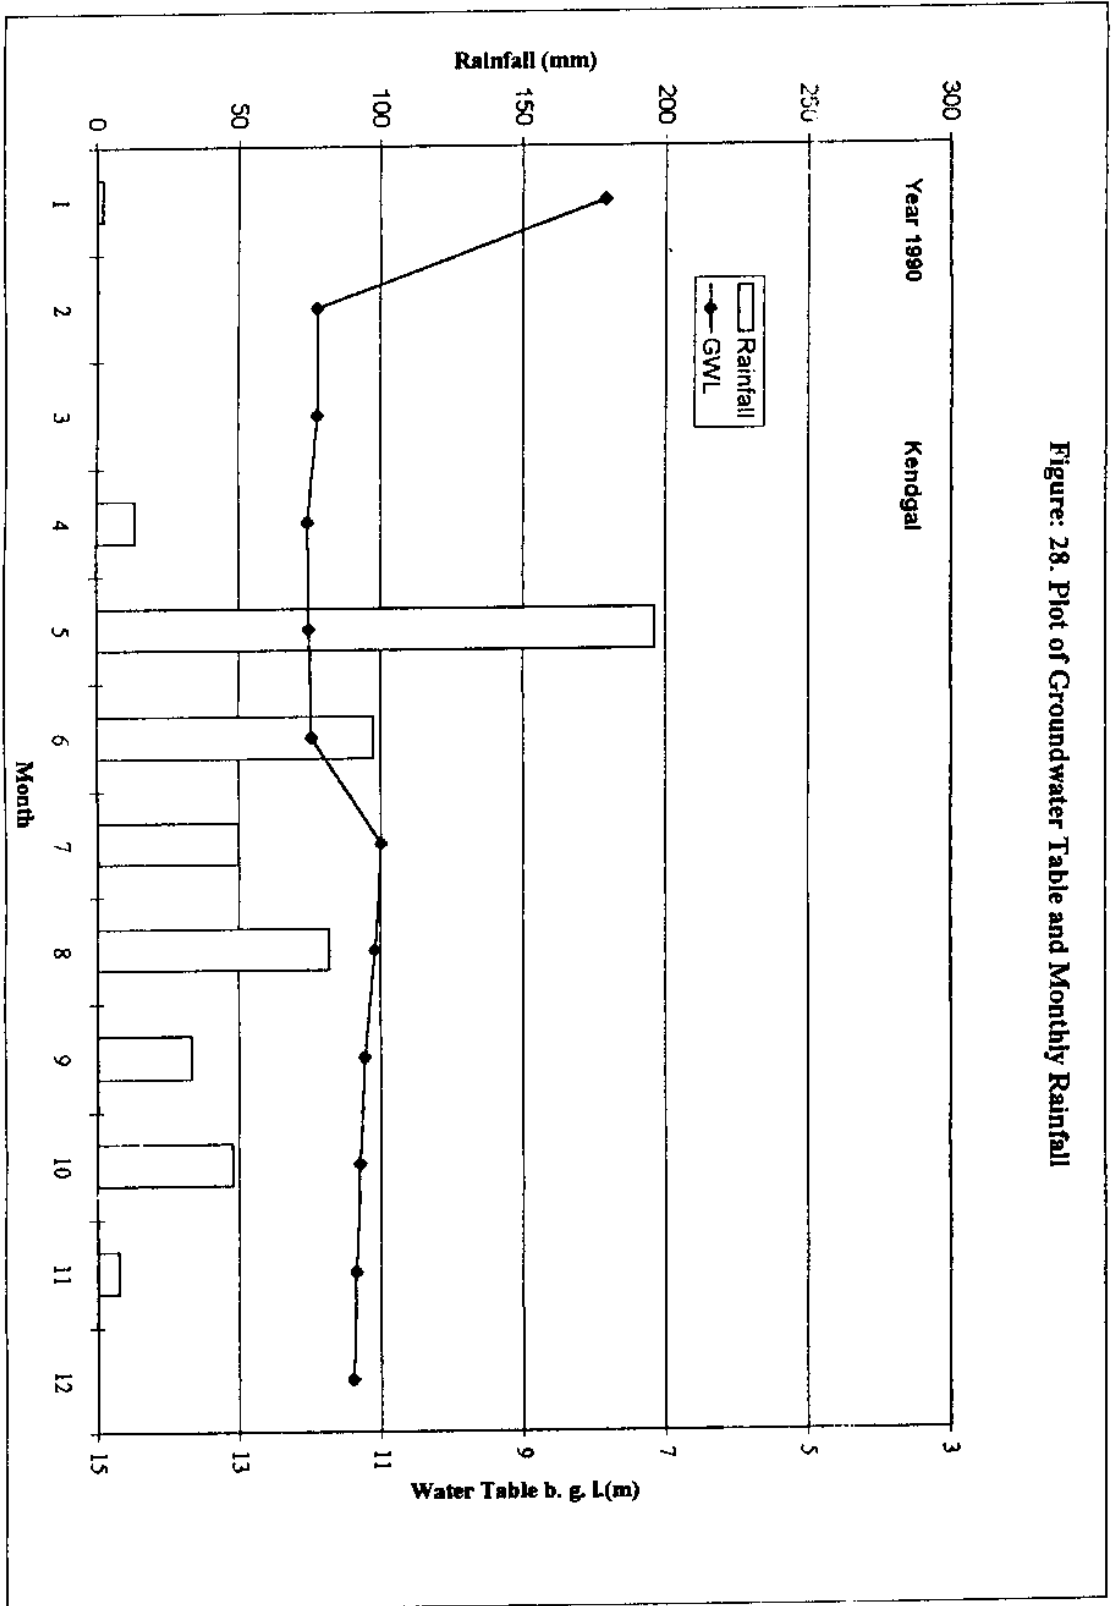
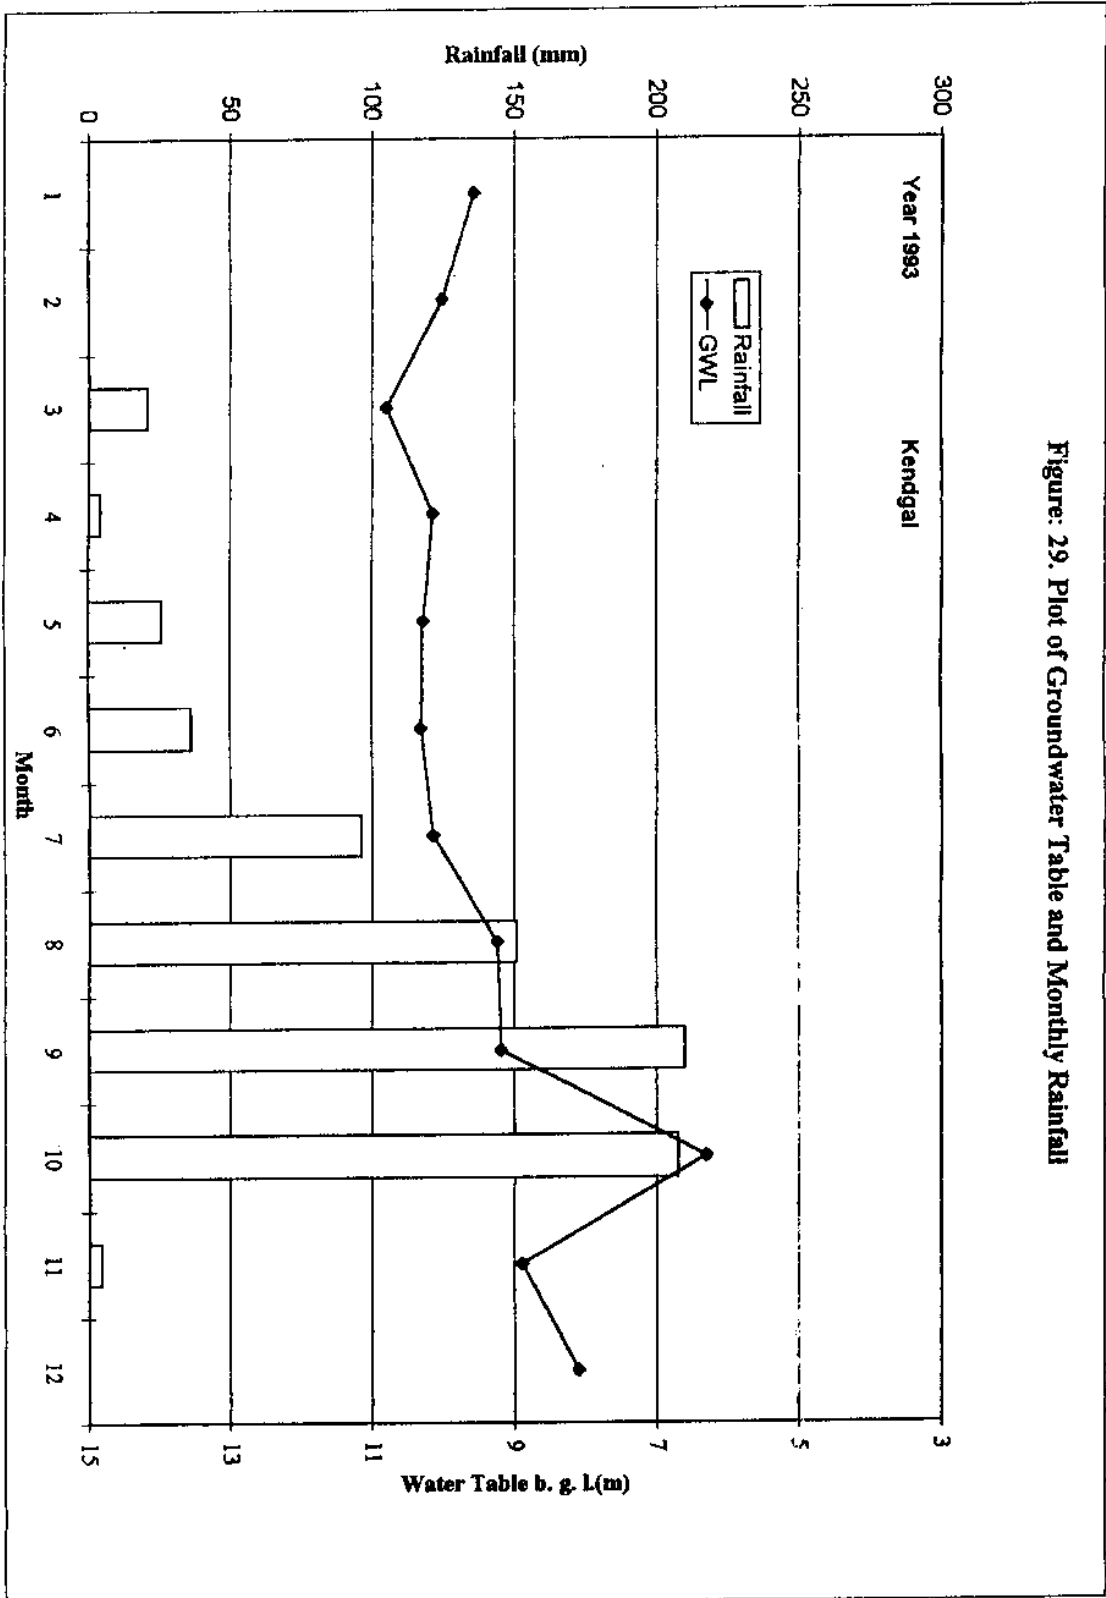
The monthly rainfall and water table levels have been plotted for few years (1974, 1979, 1982, 1990 and 1993) to understand the impact of monthly rainfall over recharge status of the groundwater from figures 25 to 29. From these figures, it shows that the recharge conditions of groundwater table were having clear relationship with a magnitude of monthly and annual rainfall. Therefore under the normal condition of rainfall over the watershed, normal recharge of groundwater is taking place.

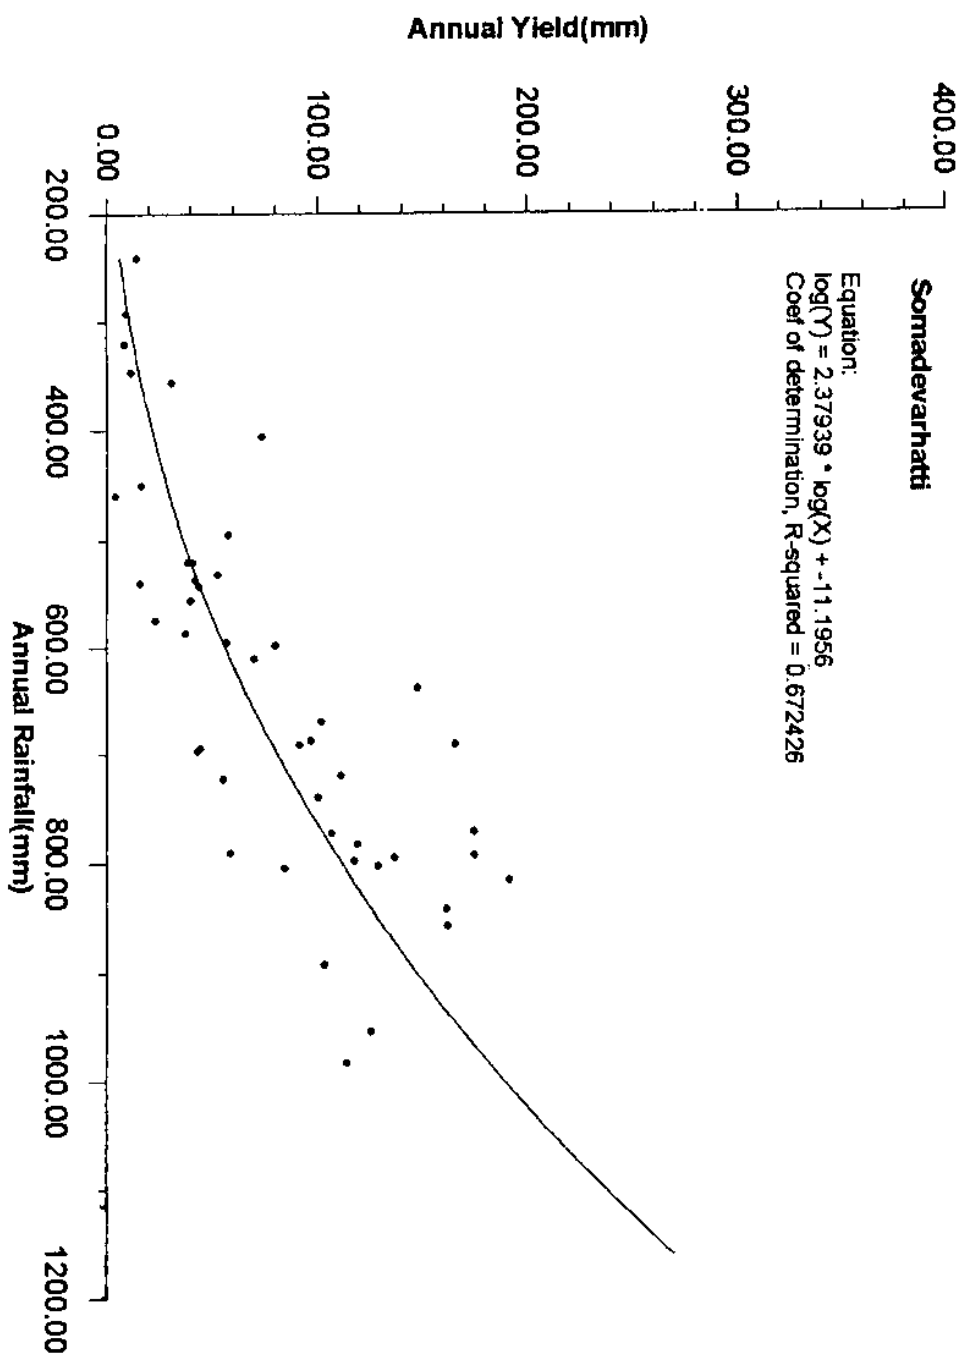
Figure 30. Relationship Between Annual Rainfall and Estimated Annual Yield
