# **WATER CONSERVATION MEASURES IN THE ARID AND SEMI-ARID AREA OF HARD ROCK REGION**

**NATIONAL INSTITUTE OF HYDROLOGY  
JALVIGYAN BHAWAN  
ROORKEE - 247 667 (UTTARANCHAL)**

**1999-2000**

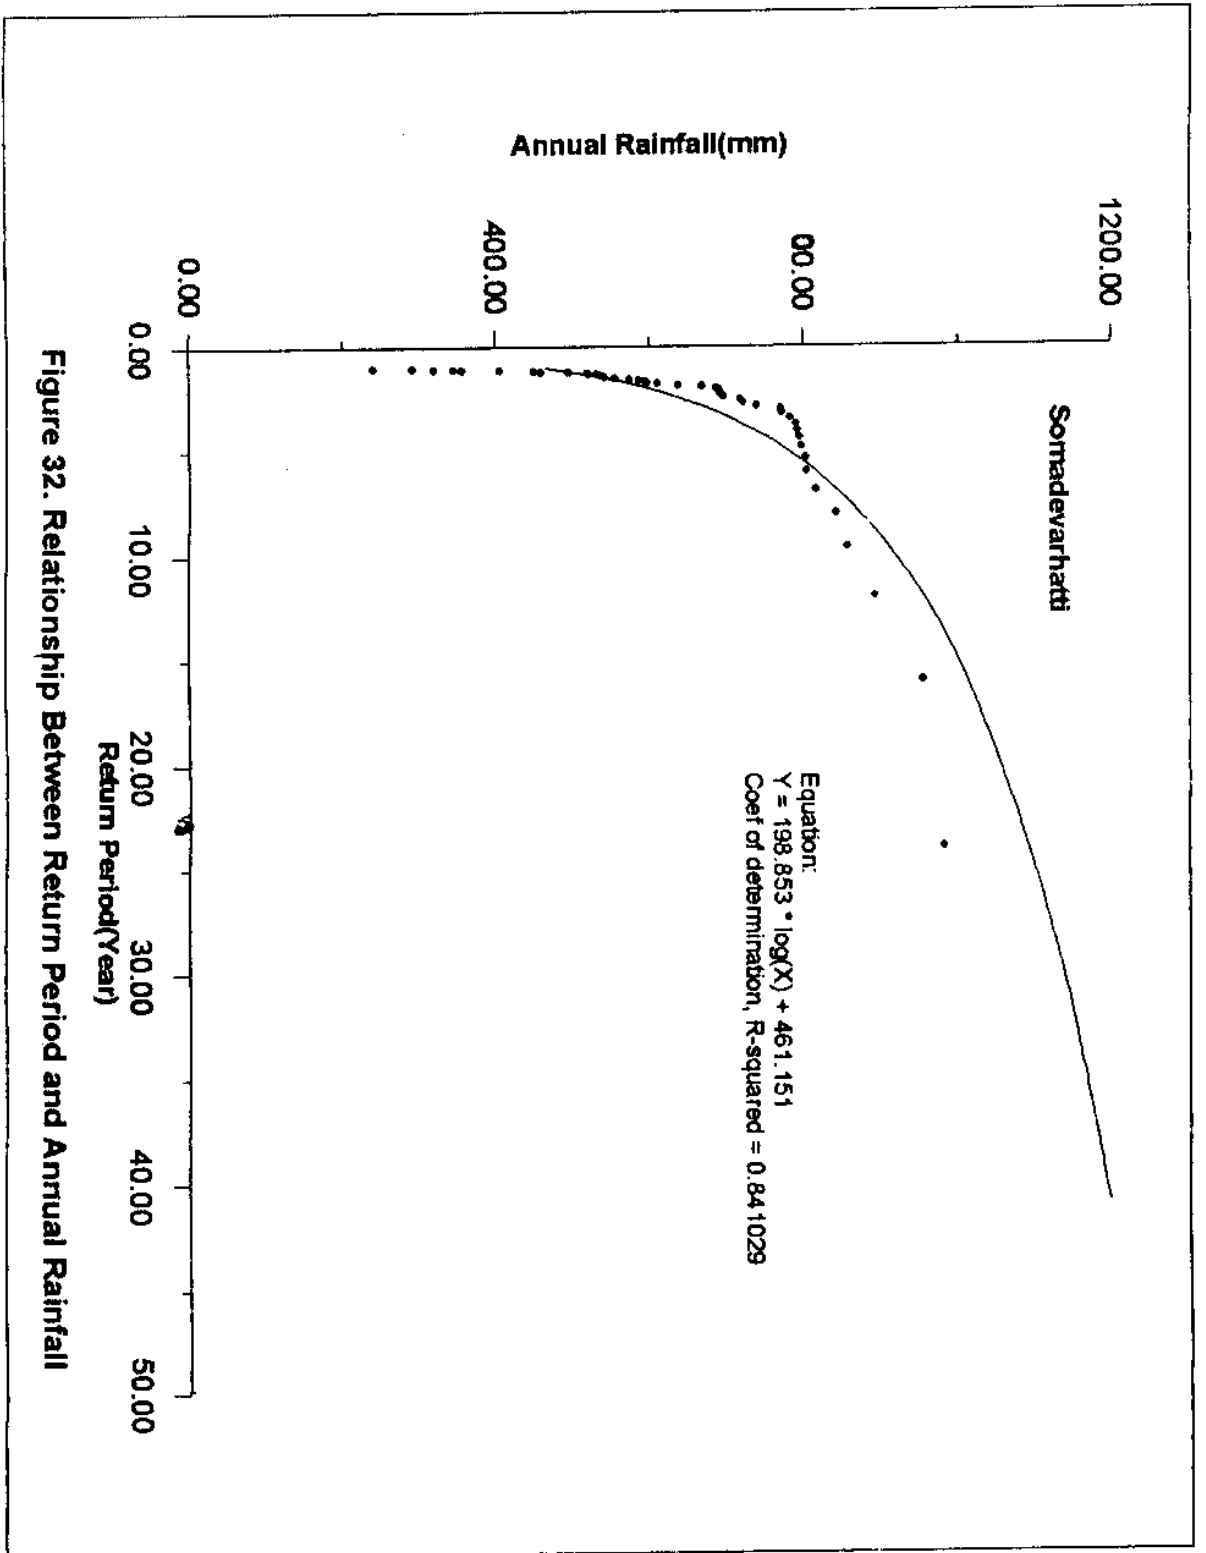
Figure 32. Relationship Between Return Period and Annual Rainfall

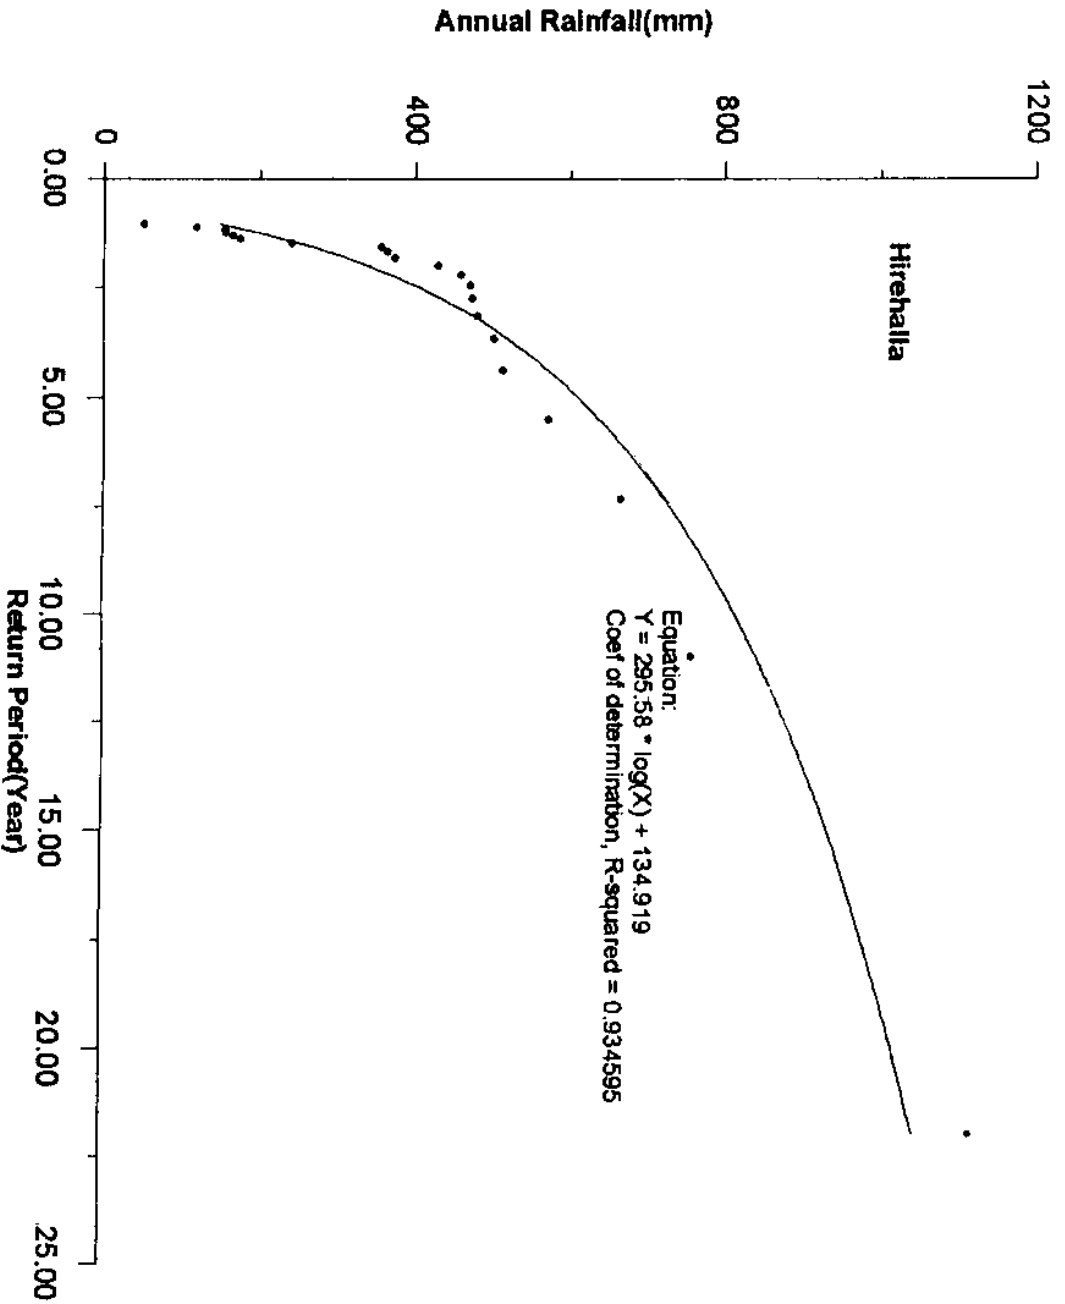
Figure 33. Relationship between Return Period and Annual Rainfall

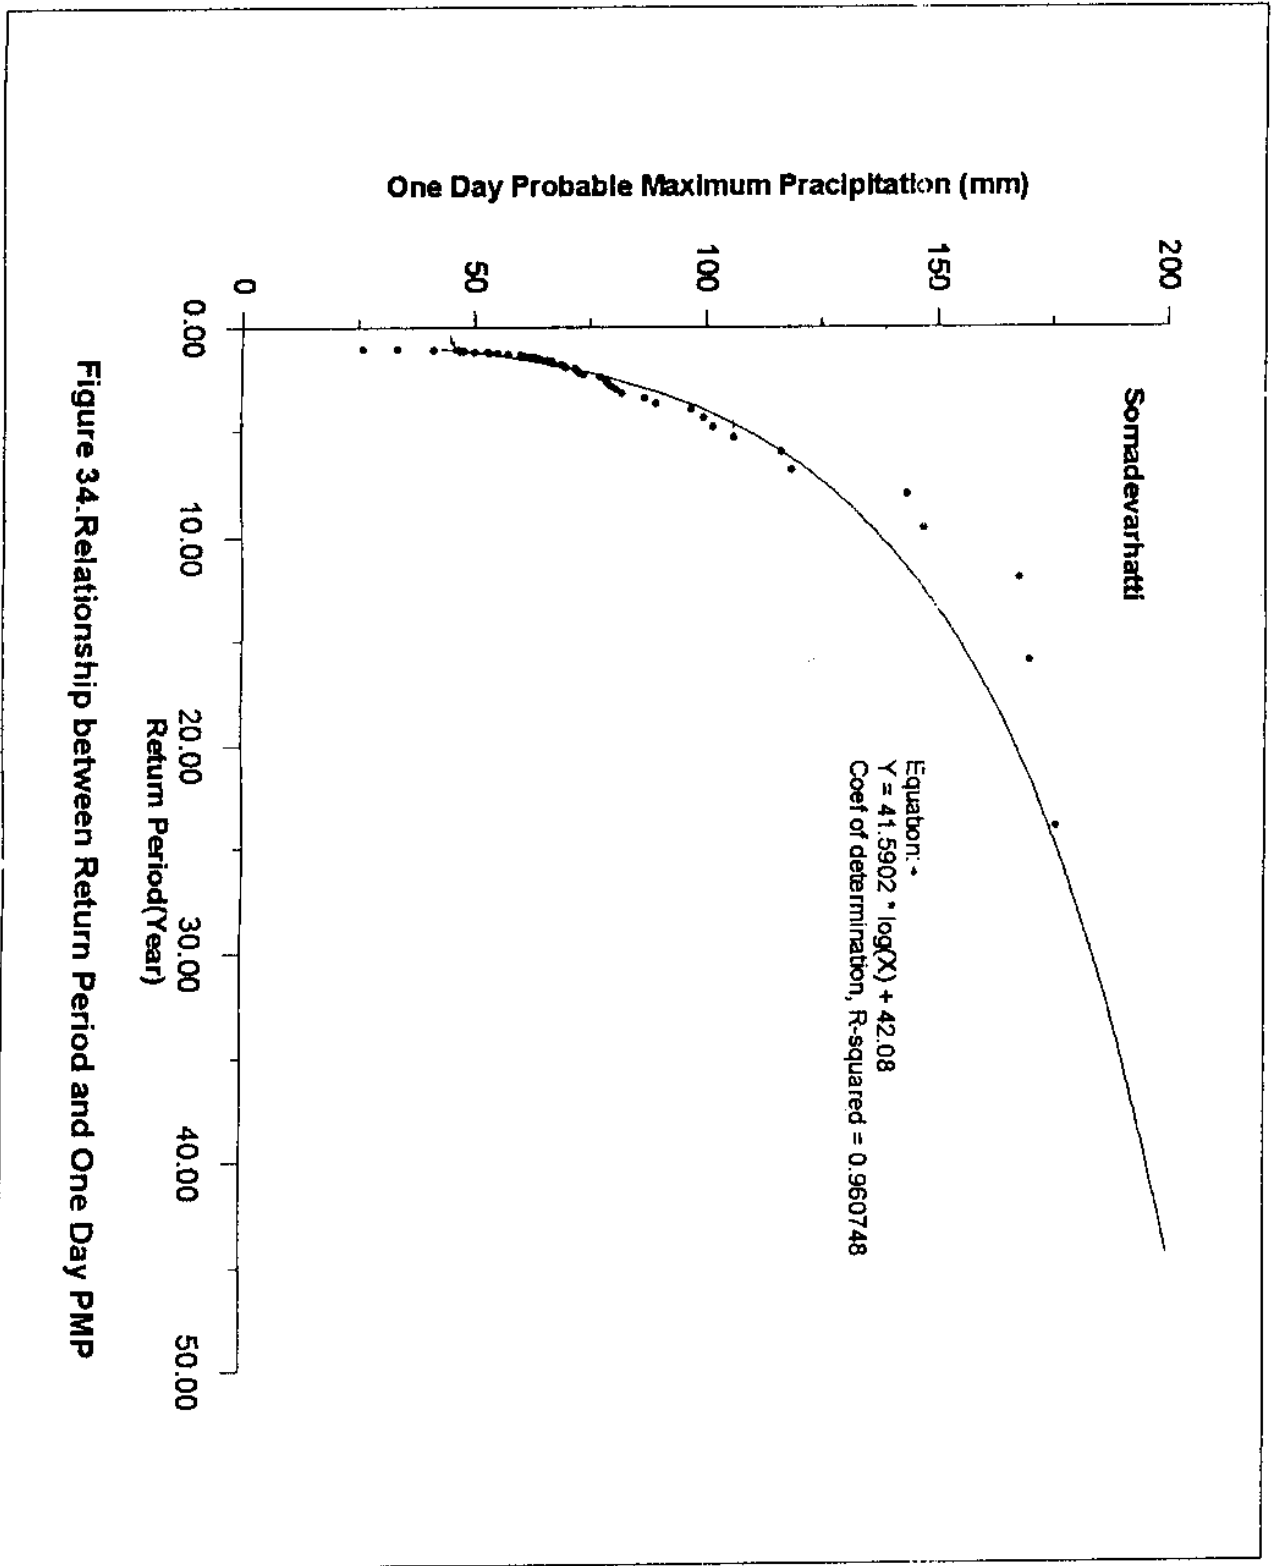
**Figure 34. Relationship between Return Period and One Day PMP**

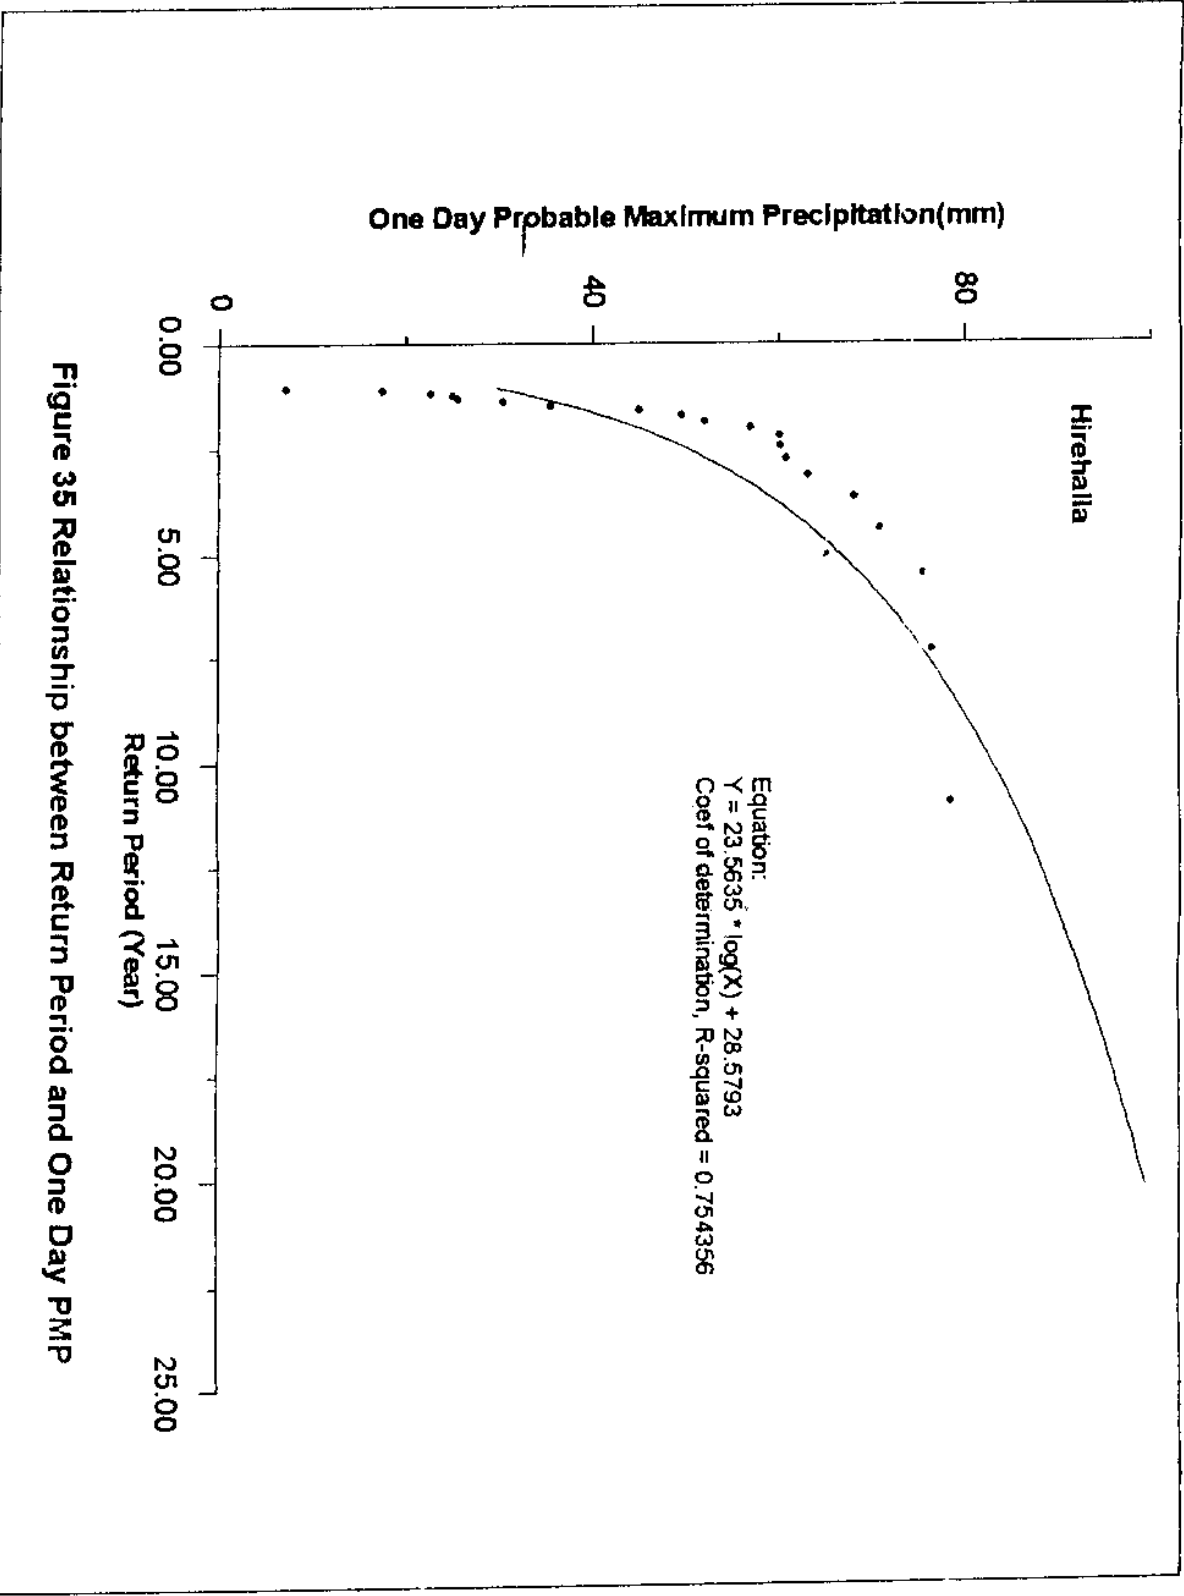
Figure 35 Relationship between Return Period and One Day PMP

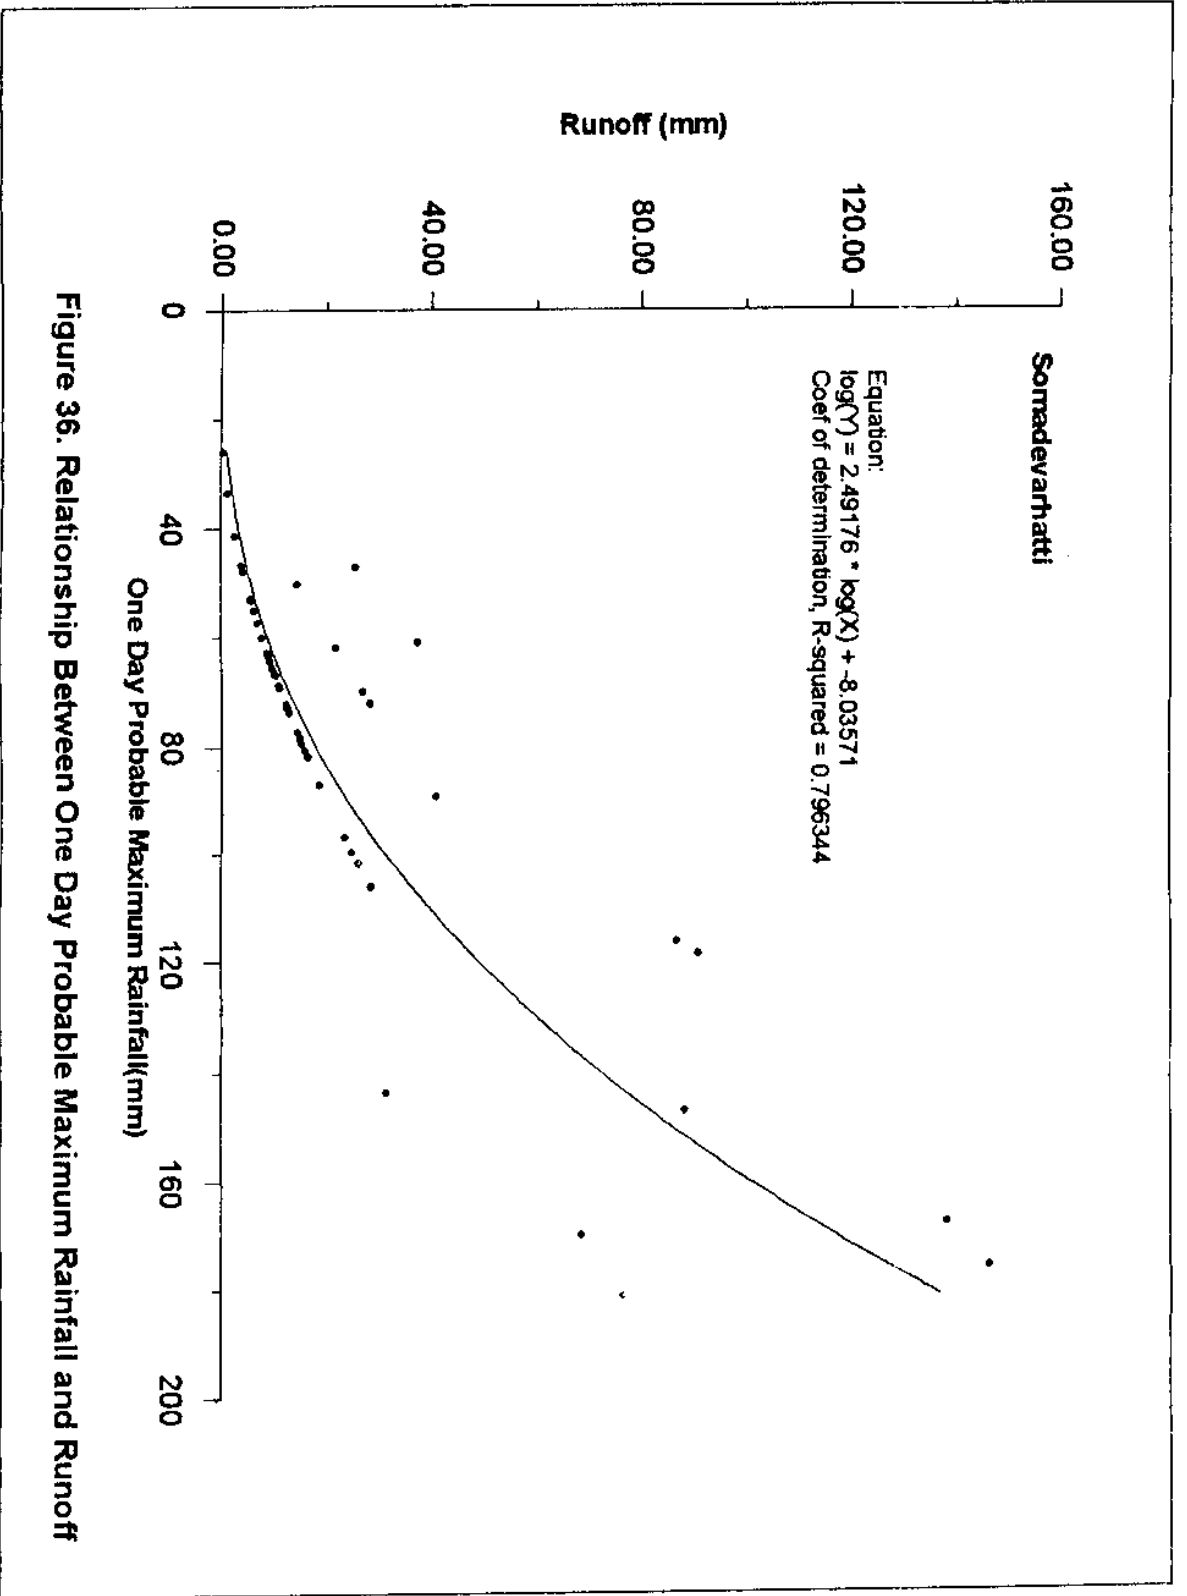
Figure 36. Relationship Between One Day Probable Maximum Rainfall and Runoff
